II.—THE TOWER.

By JOSEPH OSWALD and W. PARKER BREWIS, F.S.A.

BITCHFIELD : NORTHUMBERLAND .

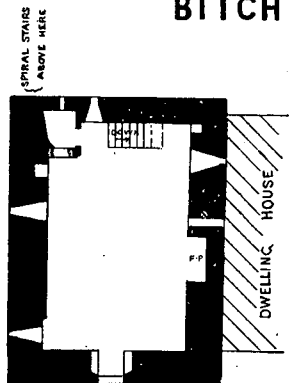
FIRST FLOOR PLAN
OF TOWER

GROUND PLAN
OF TOWER

CROSS SECTION
OF TOWER

MASONS' MARKS

- A
- B
- C
- D
- E

The tower measures externally 23 feet from east to west and 31 feet from north to south, nearly the same dimensions as those of Halton tower, but is a storey lower. The roof and upper part of the walls have disappeared. The highest portion left is at the south-east corner where it is about 34 feet high and displays the lower courses of corbelling for a circular 'bartizan.' The ground floor is, as usual in pele towers, occupied by a vaulted chamber, the west wall of which is 4 feet 7 inches thick and the south and east walls 4 feet thick. The north wall is 6 feet 10 inches thick over-all including staircase. On the exterior this wall displays a chamfered plinth at and near the north-east corner. The present door at the south end of the vaulted chamber is, of course, later in date than the wall it pierces. The original entrance was through the east wall, near the north-east corner; the inside of its pointed-arched head is still visible. The stairs ascend from this corner in the thickness of the north wall, as already stated. There is an arched recess utilizing part of the space under the stairs. The vault covering the chamber is of segmental barrel-form, of excellent masonry. There are two 'loops' in the west wall; the northern one has been roughly enlarged. There are loops in the east wall at the foot of the stairs and in the north wall at the top of the stairs; the latter cross-shaped, cut through one large stone in the outer face of the wall. Facing the stairs on the first floor is the door of a small closet (possibly a garde-robe) about 4 feet by 3½ feet on plan and 5½ feet high, covered by a flat stone ceiling. It has a small loop through the north wall which is reduced in thickness at the closet. An

opening has been roughly broken through the south wall of the closet. The apartment on the first floor occupies the whole internal area of the tower except the small closet just described and the stairs. It has a window in the south wall with stone seats against the jambs. The window opening has been a good deal tampered with. In the west wall are two loops and one in the east wall. Near the middle of the east wall is a fire-place; the masonry above it has been torn away exposing the flue. On the north side of the fire-place is a small aperture through the wall, the bottom of which slopes down from the room. It appears to have been a shoot for pouring away water. Above it is a protecting corbel. About eight feet above the floor of this apartment the east and west walls are reduced in thickness leaving a scarcement, on which, no doubt, the timbers of the floor above rested. Of this higher floor no trace remains. It was reached by stone stairs ascending in a parallel rake above those from the ground floor. Higher up, above the small closet at the north-west corner, are the remains of a spiral stair which gave access to the battlements and roof of the tower. The west wall at this part is very ruinous. The apartment on the second floor had a southern window or loop now built up, and a large ambry recess in the east wall towards its northern end, in which remain the grooves made to receive the shelves. There are several smaller recesses at various places in the walls. The walls of the tower vary very considerably in the quality of their masonry. For instance, the south wall for a height of about 22 feet from the ground consists of coursed stones, fairly large and rectangular, above which come 5 or 6 feet of irregular stones which have been levelled up at the top to receive superior masonry, including at the south-east corner the corbelling previously mentioned. Of this superior masonry only four courses remain, and near this corner only. Internally some traces of wall plaster remain in the first floor apartment near its south-west corner.

Sir Arthur Middleton has thoroughly searched the tower for masons' marks and has found more than fifty. About 47 of them are of the form marked A on diagram. They are all on the soffit of the vault. One (form B) is on the east side of the vault on the third course above the springing line; two (form C), of which one is on a quoin of the window at top of stairs; one (form D) on east wall of the vaulted chamber below the springing at north end; also two (form E) not very distinct. Mr. Bates in 'Border Holds'¹ figures two of the forms enumerated by Sir Arthur Middleton.

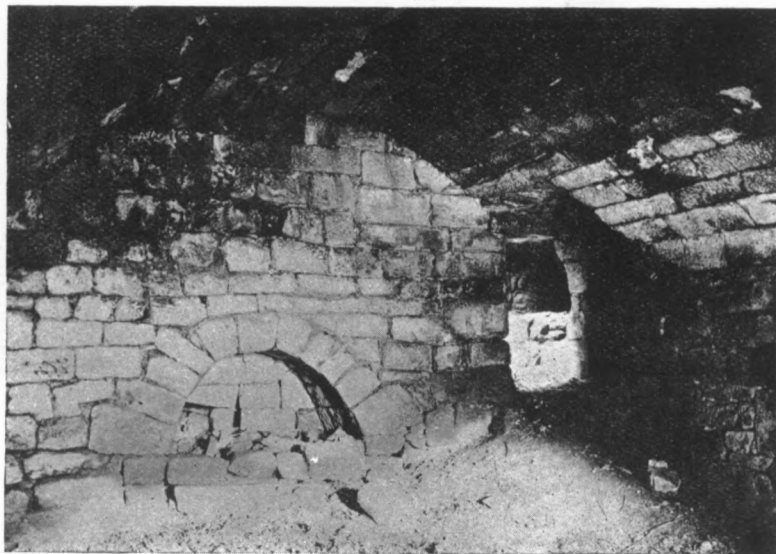
BASEMENT OF TOWER.
BITCHFIELD.

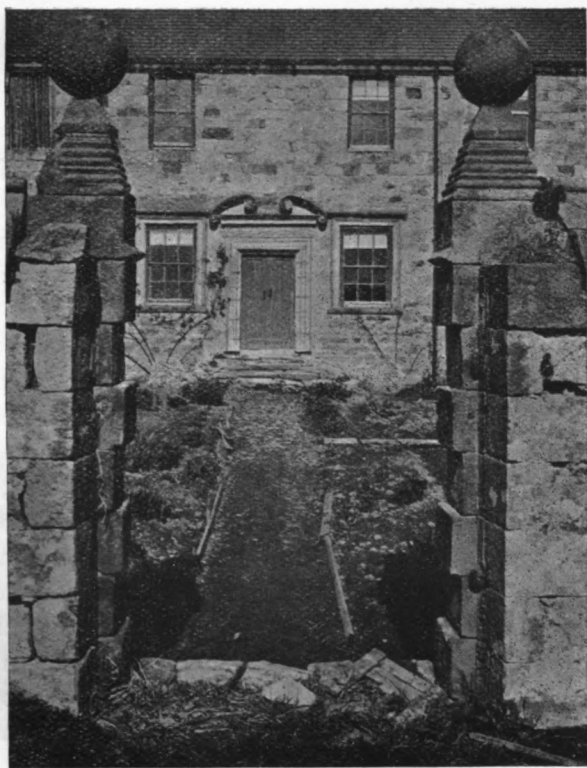
FRONT OF 17TH CENTURY HOUSE AND GATE-PIERS.

It is situated in a lonely position, accessible by field roads only, one mile south of Belsay tower. Like the latter and the tower at Halton a later dwelling-house has been built against it. At Bitchfield this is on the east side of the tower and probably dates from the close of the seventeenth century, although differing characteristics of the walling point to more than one building effort. The lower storey of the south front contains an entrance door and three windows on each side of it having architraves and other embellishments of considerable architectural merit. There is some internal woodwork of similar character. The formal garden in front of the house has south, east, and west gateways of some pretensions, the latter two being similar. The coping of the garden wall is somewhat elaborate, consisting of two ashlar courses, splayed, with roll on top. The back of the house has two very massive chimney stacks. Inside the eastern room on the ground floor (now the kitchen) there exists in the east wall a blocked-up door opening with stone head bearing the inscription R F 1622 I F. This stone probably came from an earlier building and was inserted thus for preservation. Sir Arthur Middleton, the owner, says 'against that wall a small
