INVERMARK CASTLE. By W. DOUGLAS SIMPSON,
M.A., D.LITT., F.S.A.SCOT.

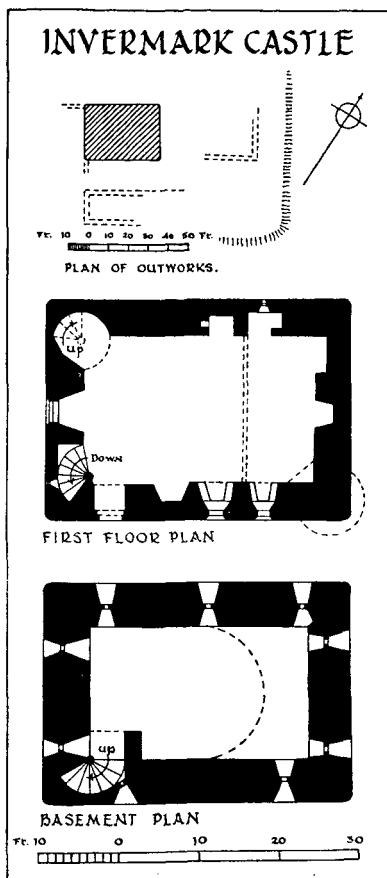
Fig. 2. Invermark Castle: Plans.

The tower (see Plans, fig. 2) measures 38 feet 6 inches long and 27 feet 3 inches broad, and its walls in the basement are 5 feet 6 inches thick. It contains four storeys and a garret, each consisting of a single room, and the basement alone being covered with a plain barrel vault on the long axis, 8 feet 6 inches high. The entrance (fig. 3) is on the first floor, on the south side near the west end, and at a height of 9 feet above the present ground-level. It is a plain but well-formed round arched portal with a 4-inch chamfer, and measures 6 feet 4 inches high and 2 feet 10½ inches in exterior width. The portal was doubly defended, first by a wooden door that has disappeared, and next by the interesting iron *yett* which still remains

To the south and east of the tower (see Plan, fig. 2) foundations of

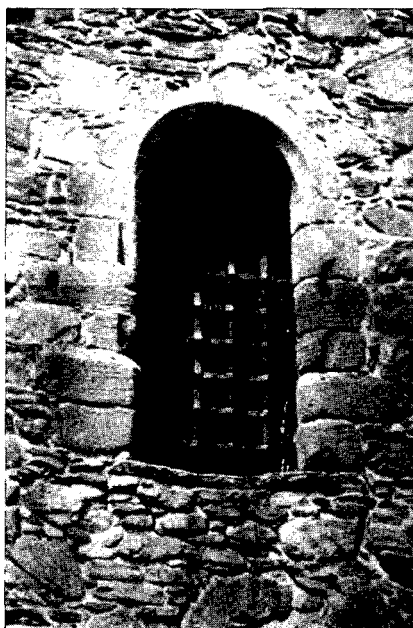
Fig. 3. Invermark Castle: Entrance and Iron Yett.

The yett (figs. 3 and 7) consists of six vertical and nine horizontal bars, the mode of penetration as usual being reversed in diagonally opposite quarters. It is swung on two hinges, and is secured by a stout bolt and hasp sliding in two staples midway in the height of the yett. Near the top there is also a single staple to which no bolt-hole corresponds in the wall. From this fact, and also because the yett is

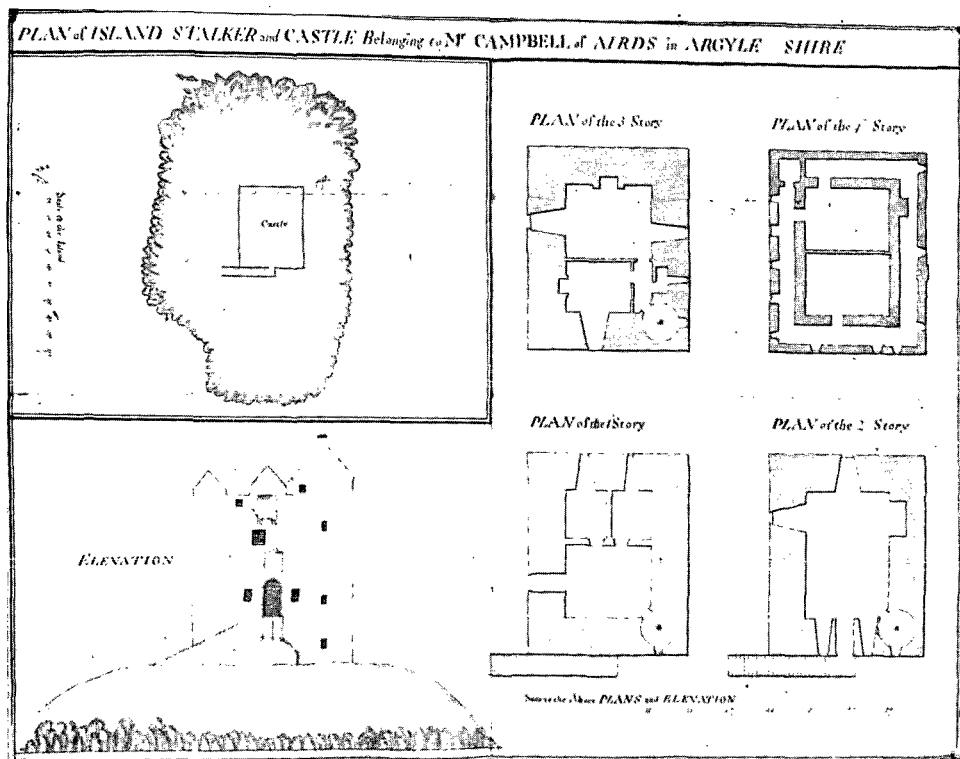
Fig. 4. Castle Stalcaire, Appin, from an Old Survey in the British Museum,

¹ A stone stair with a wooden gangway is shown in an old survey of Castle Stalcaire, Appin, now in the British Museum, and reproduced herewith (fig. 4). (I am indebted to Mr James S. Richardson, F.S.A.Scot., for drawing my attention to this survey.) At Castle Stalcaire batholes very like those at Invermark still exist (see MacGibbon and Ross, *Castellated and Domestic Architecture of Scotland*, vol. iii. p. 164).

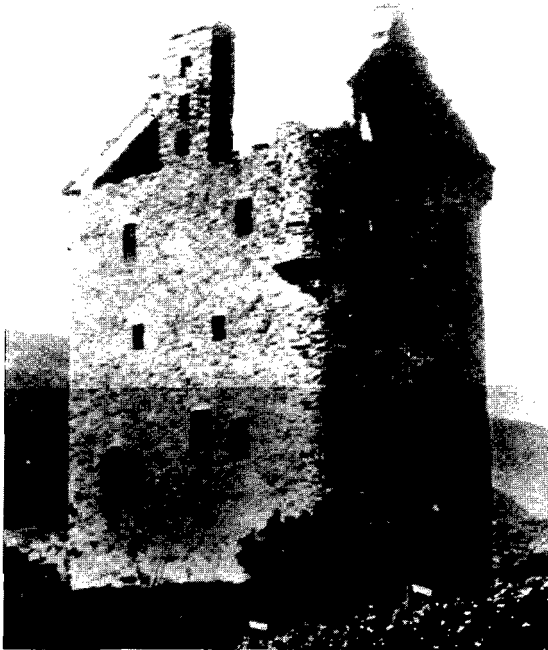
Fig. 5. Invermark Castle: View from South-east.

Externally (figs. 5 and 6) the tower is built with rounded angles and a pronounced batter, giving a very robust effect. At the eaves-level the angles are corbelled out to the square, above which the gables are finished with flat skews and projecting curved "peat stones." On the wall-head is a chamfered cornice. The four chimneys—one on each gable and one in each front—have a plain blocking course with

sloped cope. In the south chimney are two voids, the lower one lighting the garret-chamber and the upper one ventilating the roof timbers, while over all is a sunk empty panel. The north chimney has a similar panel above a single void. At the south-east angle of the tower a large and tall round turret of two storeys is carried out on bold continuous corbelling; it is equipped with small circular pistol-

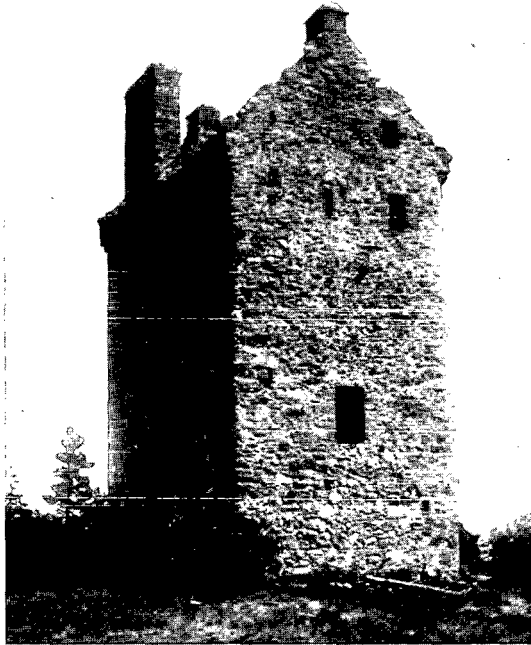
Fig. 6. Invermark Castle: View from West.

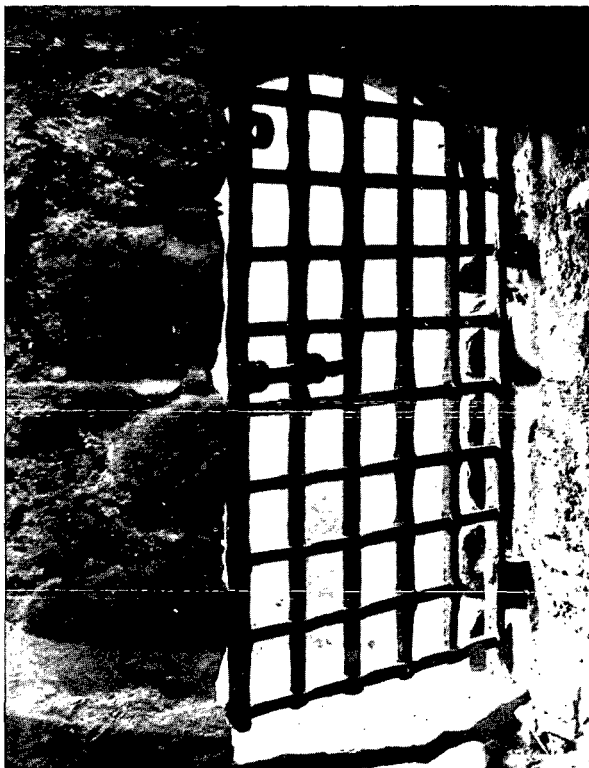
Fig. 7. Invermark Castle: Interior View of Iron Yett.

incomplete on the top, showing the commencement of an arched head much too large to fit the door of the tower, it seems probable that the yett was brought hither from somewhere else—perhaps from Edzell. It is said to have been of local workmanship.¹
