A medieval logboat from the River Conon: towards an understanding of riverine transport in Highland Scotland

ABSTRACT

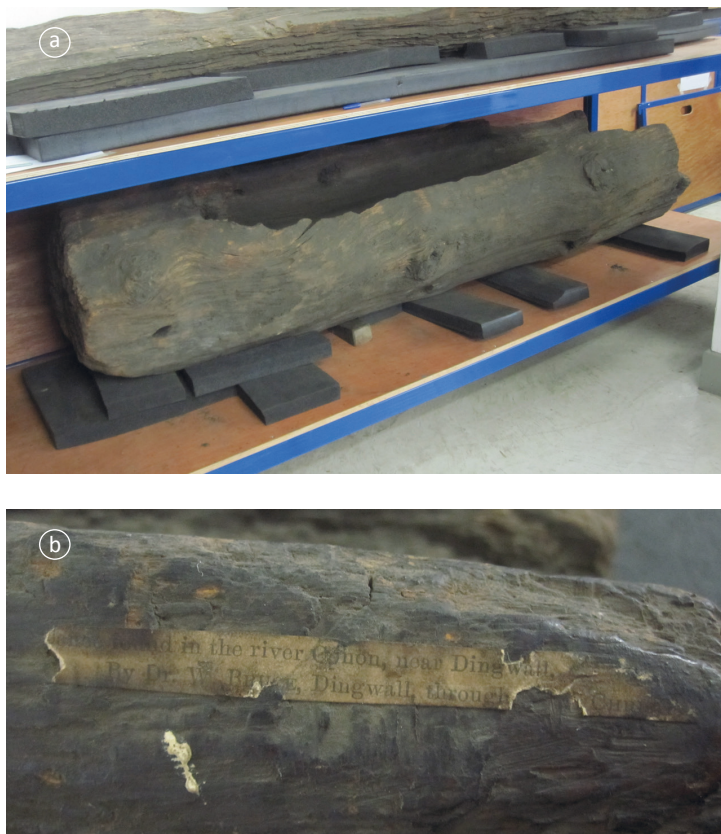
ILLUS 2 (a) View of two of the logboat timbers following rehousing in 2014; the prow section is on the lower tier of the trolley; (b) detail of label on gunwale permitting its conclusive identification as the 'lost' River Conon logboat. The label reads 'Canoe found in the River Conon, near Dingwall. By Dr. W. Bruce, Dingwall, through [] Christison'. © NMS/T Cowie

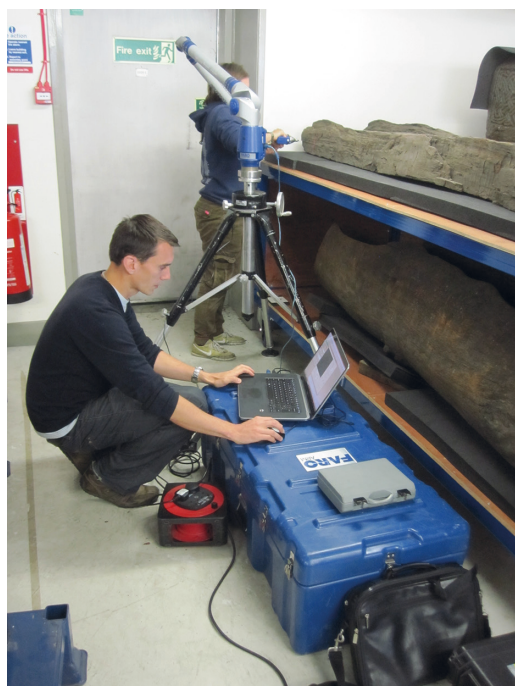
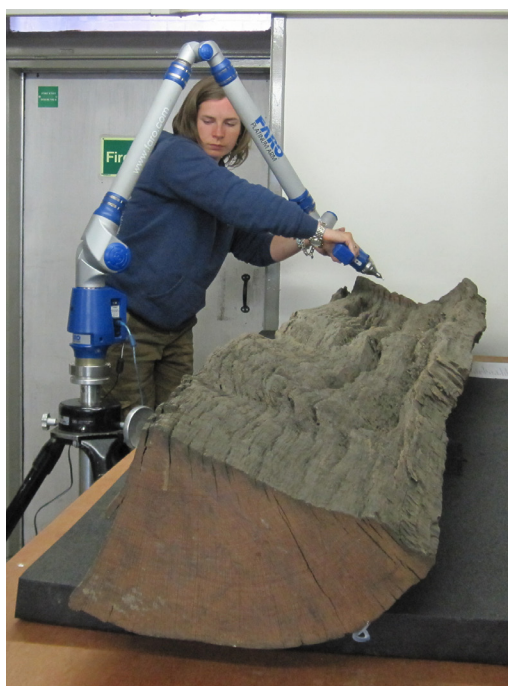
ILLUS 3 River Conon logboat. Laser scanning in progress. © NMS/T Cowie

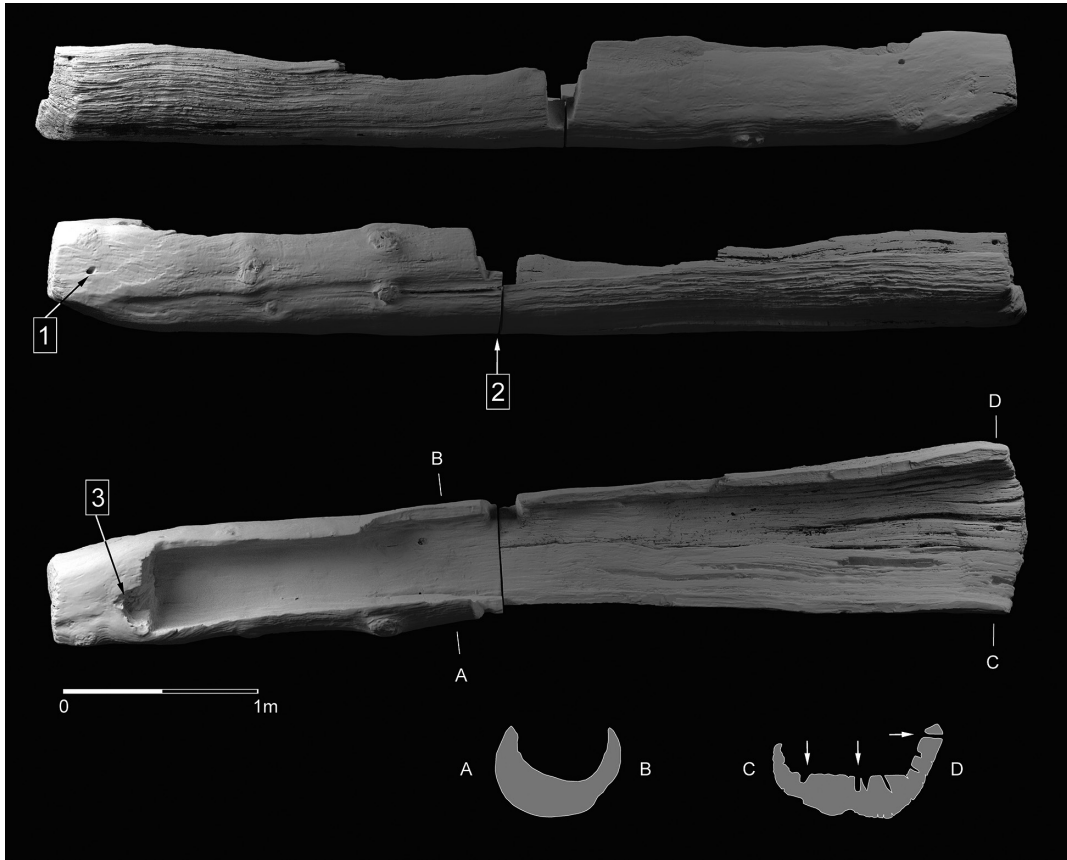
ILLUS 4 Reconstruction of the River Conon logboat following laser scanning of the separate timbers. Features indicated on the image include: (1) artificially worked hole near port bow; (2) approximately amidships, the modern transverse saw cut is clearly visible, coinciding with the ancient notches cut in the sides; (3) irregular cavity, possibly unfinished working. The marked difference in condition between prow and stern is also apparent. © AOC

uncertain significance. The one that is low down on the exterior of the port bow faces forward, is about 130mm deep, and measures about 50mm in maximum diameter, having evidently become elongated in drying (see illus 4). The other was noted within the starboard side of the interior, and penetrates the side of the boat to a depth of about 70mm. The squared form of this hole indicates the use of a metal chisel or similar tool.

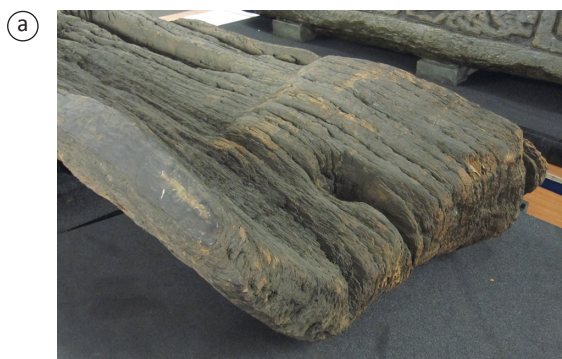
ILLUS 5 River Conon logboat: (a) photo and (b) laser scan of stern, showing pronounced radial splitting of the timber. Features indicated on the scanned image include (1) step-like feature and (2–3) two of the holes for locating the transom.
© NMS/T Cowie and AOC

Both timbers B and C display a slightly raised internal step-like feature and are penetrated by holes, suggesting the former presence of an inserted transom, which was presumably retained by dowels passing through cleats left in the solid timber (illus 5). No transom-groove is apparent in the raised portion of the bottom of the boat. The two holes in the bottom appear to be situated at roughly even intervals across the boat and

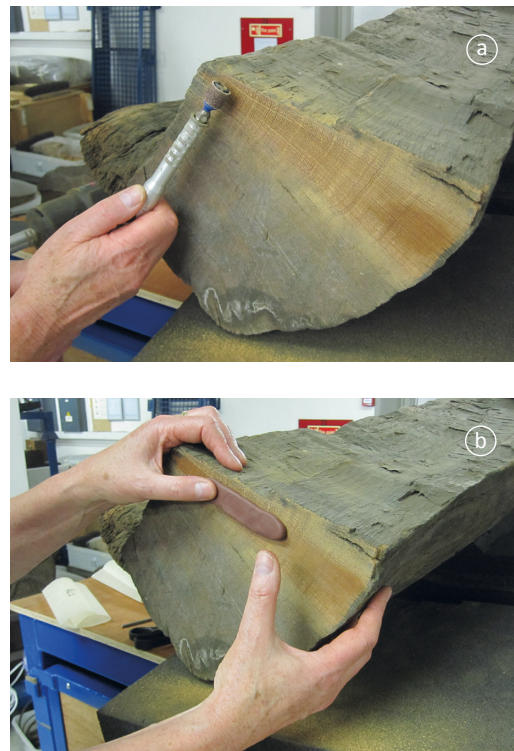
ILLUS 8 River Conon logboat. The sawn ends of the boat timbers provided a convenient cross-section for the purposes of tree-ring dating. Images show (a) the preparation of the surface (b) the use of modelling clay to take a cast of the ring-pattern. © NMS/T Cowie

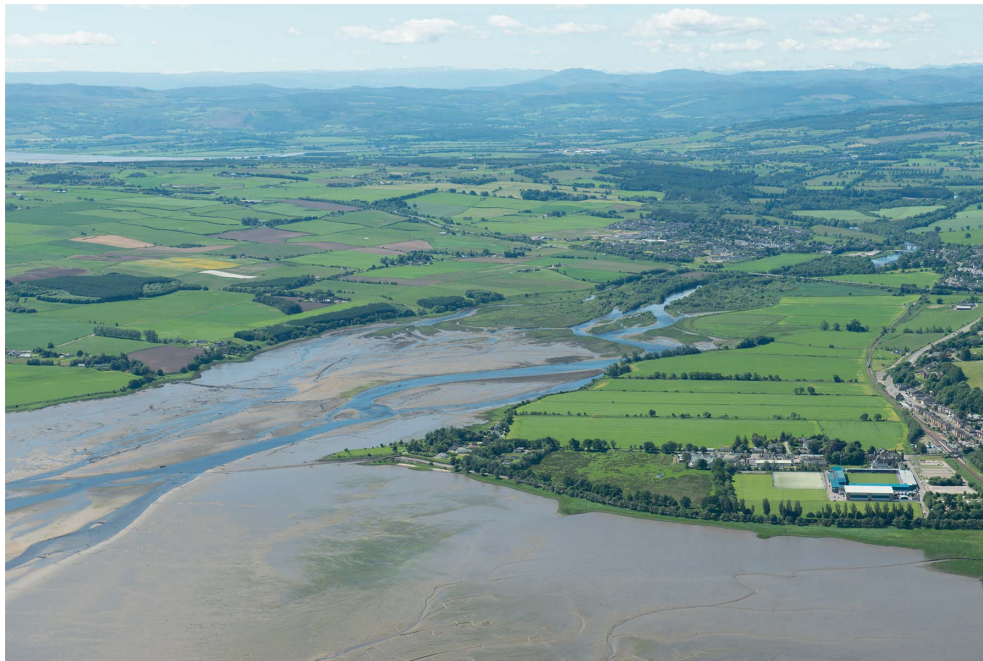
ILLUS 12 An oblique aerial view of the mouth of the River Conon, looking south-west. It is probable that the vessel was washed downstream from a location of use upriver, rather than being used within the more open waters around the location of its discovery. © Historic Environment Scotland. Licensor canmore.org.uk

load-carrying capacity of the river as the flow diminishes rapidly when opposed by the tidal effects (illus 12). It thus appears highly probable that the vessel was washed downstream from a location of use upstream, rather than being used within the more open waters around its location of discovery.

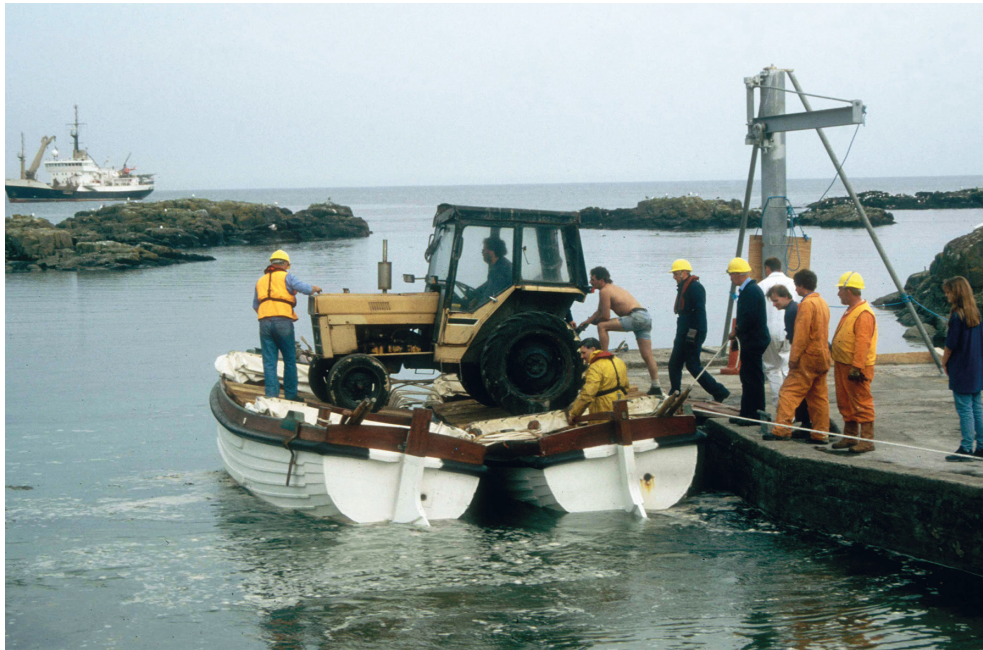
ILLUS 13 Staff of the Northern Lighthouse Board unloading a tractor for use on the Isle of May, with the NLB tender *Pharos* in the background (the date of photograph is uncertain – but *Pharos* was in service between 1993 and 2006). Although from a maritime, rather than a riverine, context, this picture illustrates well the potential value of the use of paired watercraft in calm conditions. If used in multiple, the potential carrying capacity of relatively small vessels could have greatly exceeded that apparent from their remains. © Fife Council/Peter Yeoman
