## FURTHER DISCOVERIES AT HEYDON HALL, SAXLINGHAM

by Edwin J. Rose

A description of the ruins of Heydon Hall or Saxlingham Place, in the village of Saxlingham near Holt (county sites and monuments record number 3167) was given by the present writer in *Norfolk Archaeology* XXXVIII, 336, together with the findings from trial excavations in advance of a proposed restoration (later abandoned) in 1980.

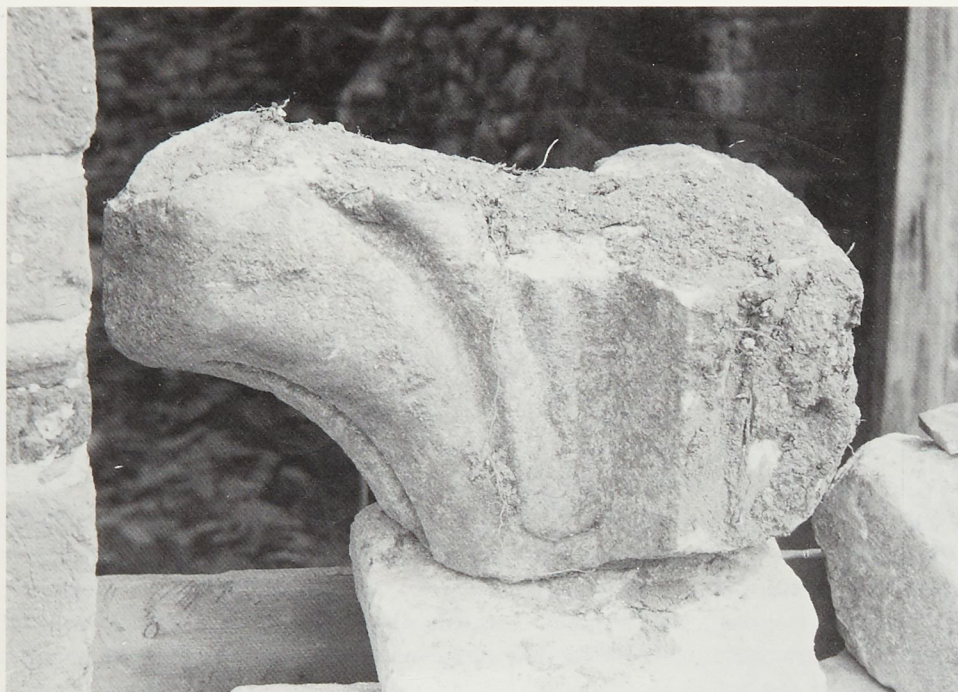
Plate I

Fragment of tracery found in collapsed rubble. *Photograph by E. Rose*

Also from rubble in the building were retrieved a number of fragments of tracery of an unusual form (Plate I), unparalleled in the writer's experience. It is possible that these may be of very late date.

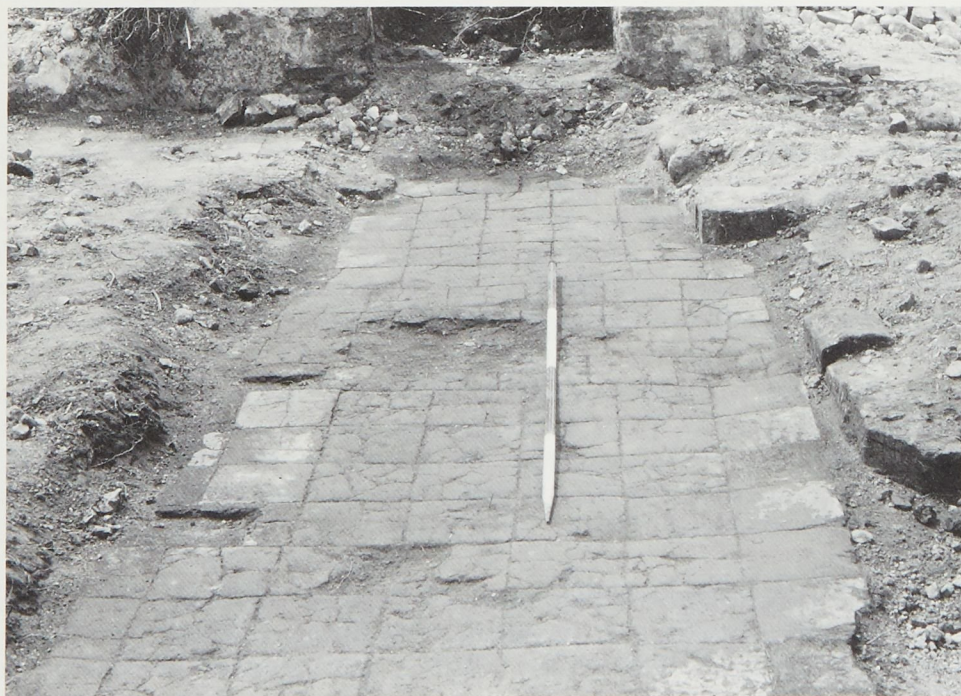
Plate II

The screens pavement after excavation looking south. Scale in 50cm divisions.  
*Photograph by Graham Pooley.*

### **The Screens Passage and its Pavement (Fig. 1 and Plate II)**

Following the demolition of the towering north wall of the New Wing and the subsequent clearance of the area, it became possible to re-expose the tiled pavement and to excavate those sections not accessible before. The results necessitated a revision of the published plan (see Fig. 1). Further traces of coloured glaze, mostly worn away, were located and some glazed tiles were found in the second row from the west, whereas it had before appeared that they were confined to the outer rows. The eleventh row of tiles from the north, level with the slits for the southern doorway in the screen, was found to have been laid out of alignment; a half-tile had been added to compensate. The next three rows south are on the original alignment, but the southernmost six rows are offset. This faulty layout seems partly to be due to the fact that the north and south doorways are not exactly opposite each other; but as well the wall base to the west is slightly thicker at the southern end, the corner of the expansion being chamfered off. It is possible that this may indicate a staircase in this position.

The southernmost row of the pavement contains only three tiles and is set at the base of a short flight of steps, formed of rammed clay, leading up to the south door. The threshold was found to be 0.5 metres below the exterior ground level at the time of excavation. An original iron hinge staple remained in the doorway's east jamb.

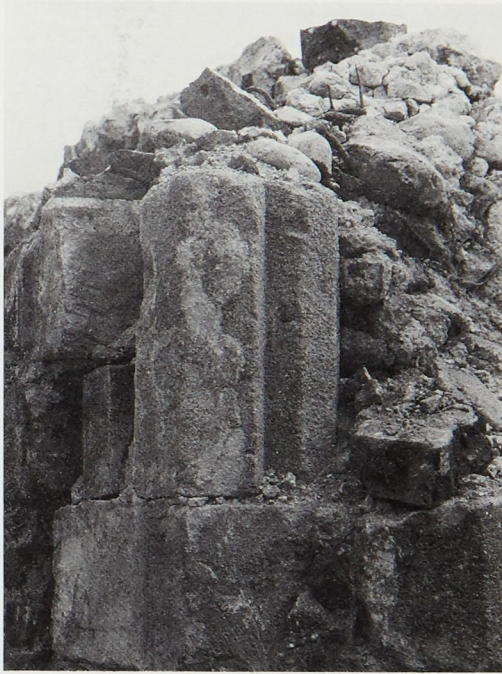
Plate III

Reused stone moulding at the angle of the two wings, formerly wrongly identified as part of a service doorway. *Photograph by E. Rose.*

In this section of the building the previously published account needs substantial alteration. It was suggested that a fragment of a service doorway remained in the core of the section of the east wall of the New Wing that impinged into the area of the Old Wing, covered by 19th century refacing. When this wall was demolished it was clear that this was not the case. Rather than an archway the stone-work consisted of an upright jamb set on a block at a height of 1.75 metres above the level of the tiled pavement, forming an angle in a wall of red brick at the junction of the two wings (Plate III). The brickwork was of 17th/18th century type, very different from some original bricks in the surround to the south doorway of the screens passage. It would therefore appear to be a reuse of stonework at the time when the New Wing was added and part of the wall of the older building demolished.

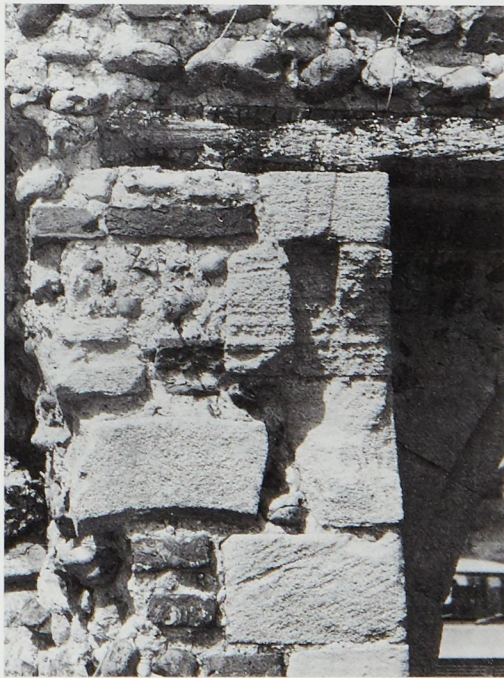
Plate IV

Stone block with groove, above sections of reused stonework, by the north doorway. *Photograph by E. Rose.*

The south face of the north wall of the Old Wing was found to bear no scar where a masonry wall backing the screens passage might have been attached; but a narrow vertical groove remained in the flintwork at the base, and directly above at a height of 2 metres a block of reused stone has a groove on the same alignment (Plate IV). The indications are therefore that the partition wall between passage and service rooms was timber framed, but standing on a masonry plinth.
