# Context Records

Site Code: ~~110010~~ 219970 Site Name: ~~Wilton House~~ BISHOPS MILL, SALISBURY

# Site Notes

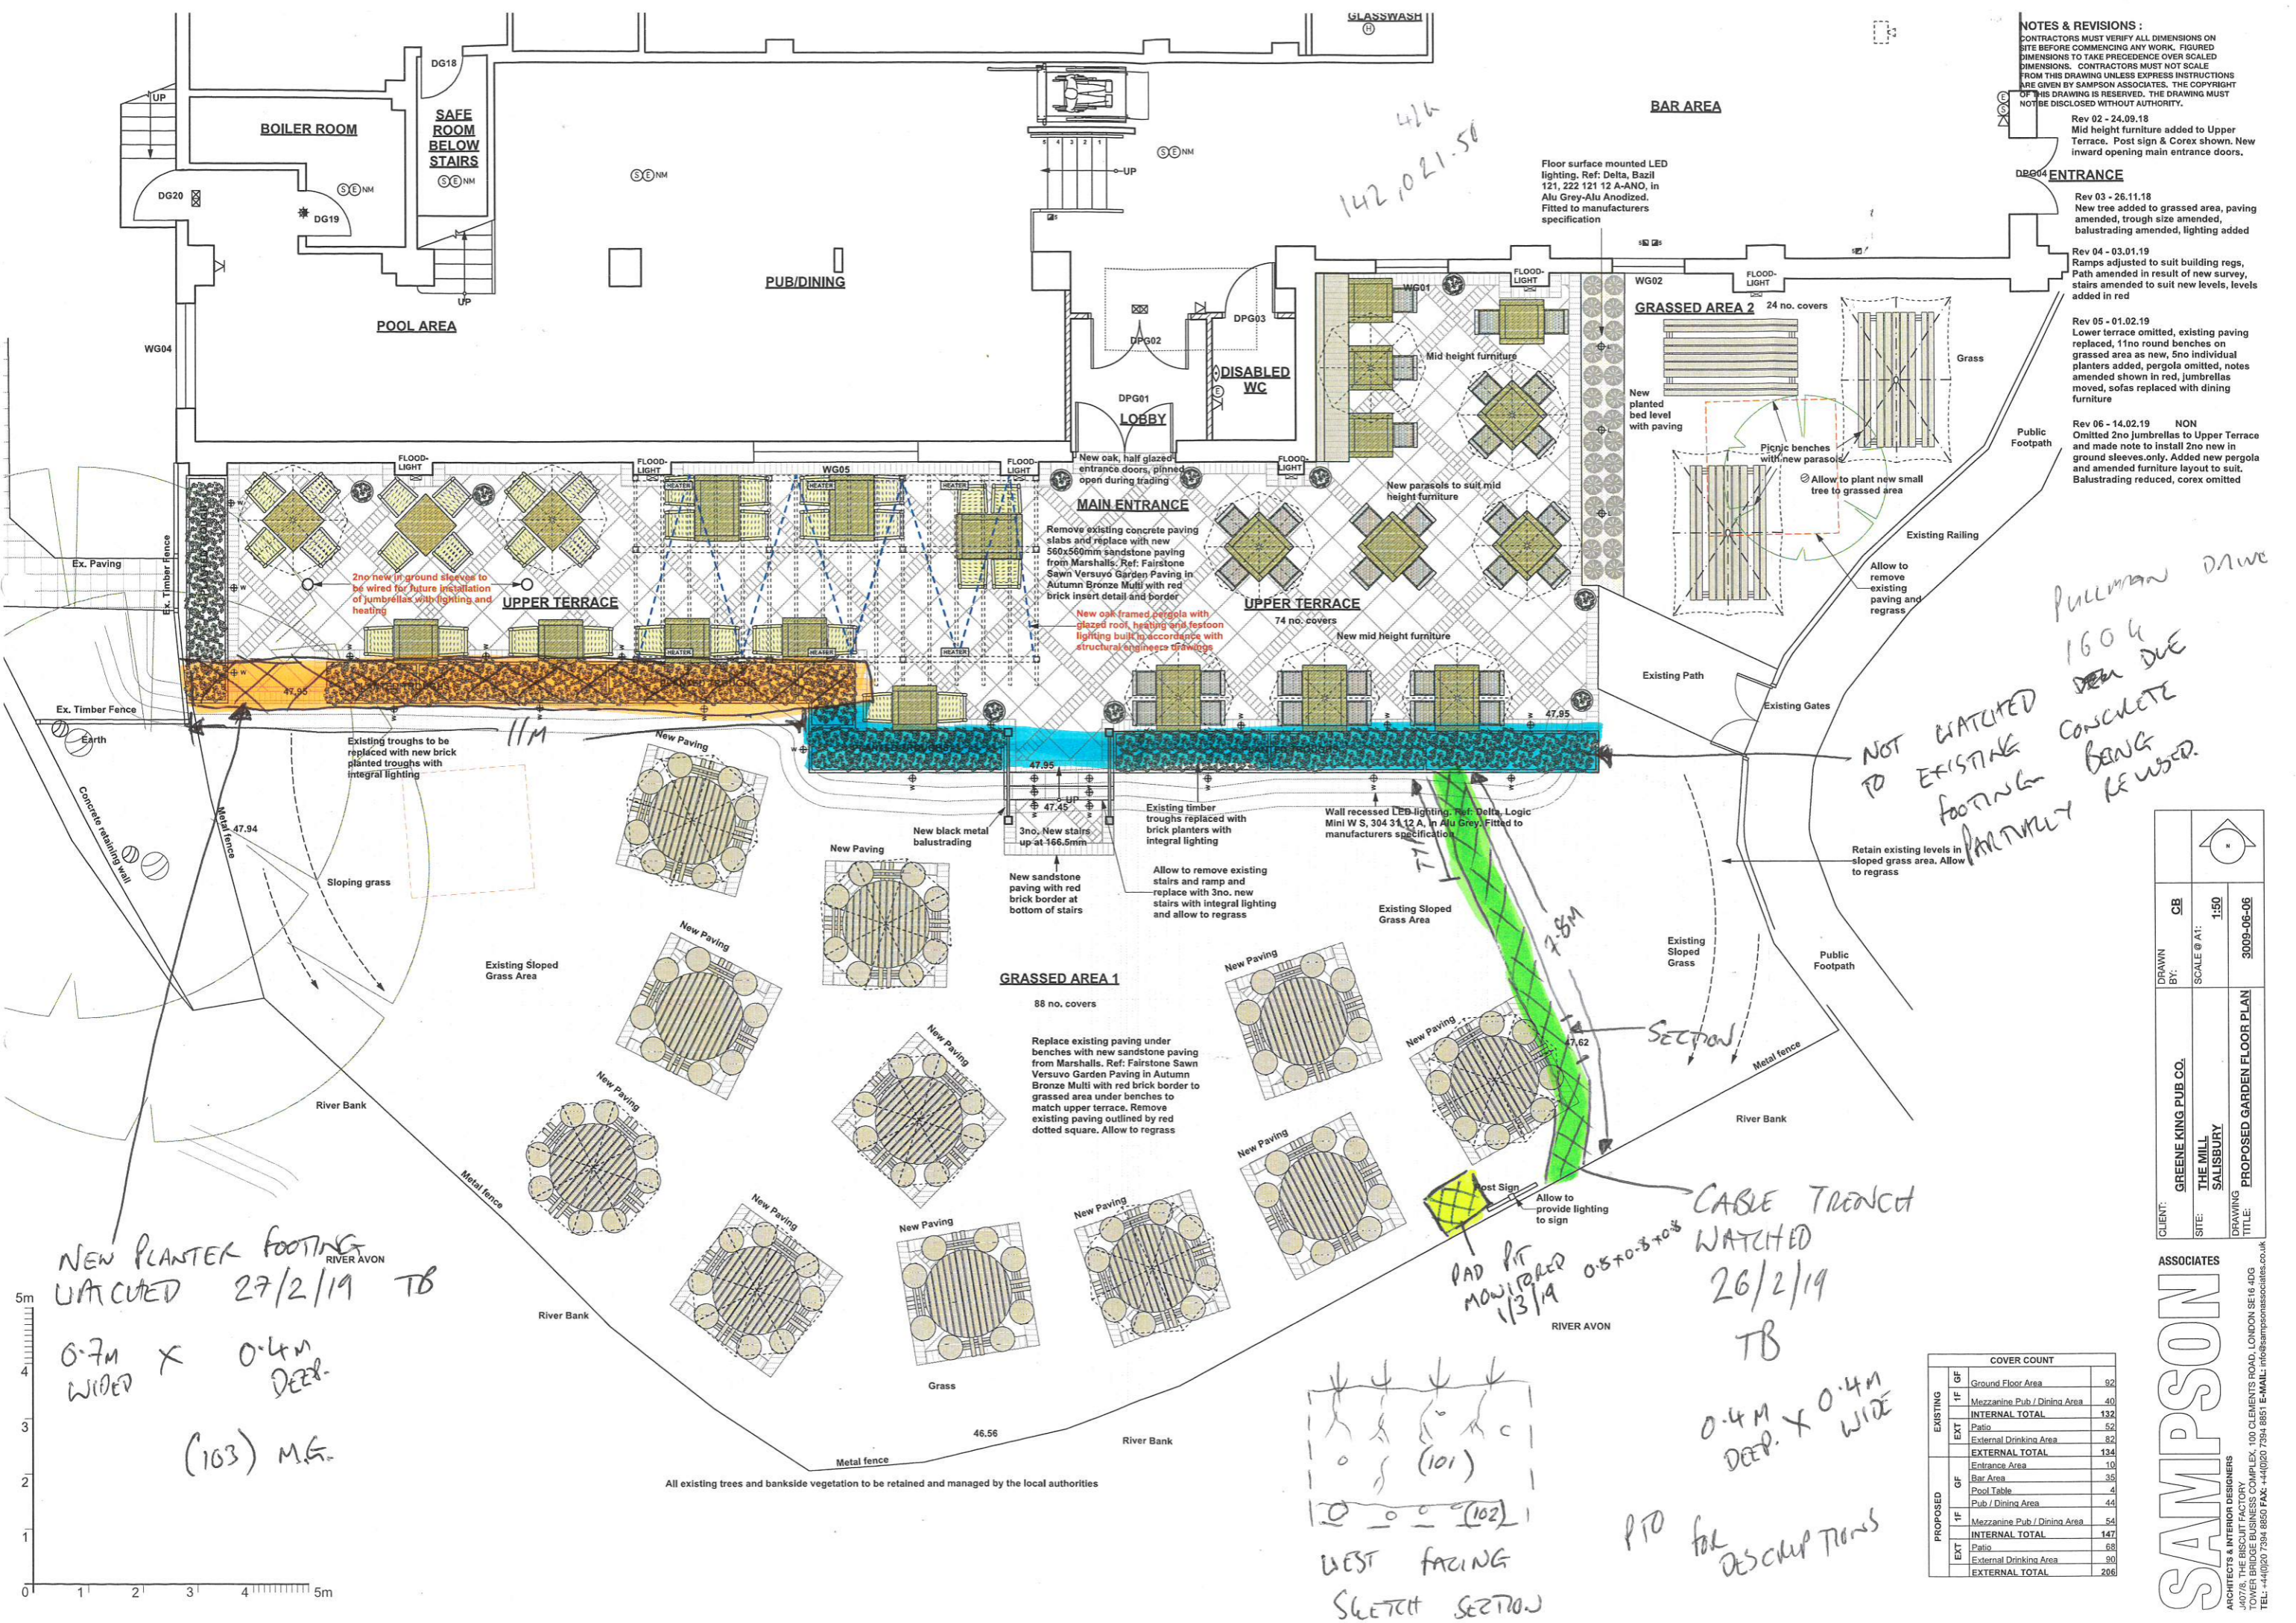
CLIENT:	GREENE KING PUB CO.
SITE:	THE MILL SALISBURY
DRAWING TITLE:	PROPOSED GARDEN FLOOR PLAN
DRAWN BY:	CE
SCALE @ A1:	1:50
DATE:	3009-06-06

NEW PLANTER FOOTING UNCHECKED 27/2/19 TB  
 0.7M X 0.4M DEEP.  
 (103) M.G.

WEST FACING SKETCH SECTION

CABLE TRENCH WATCHED 26/2/19 TB  
 0.4M DEEP. X 0.4M WIDE

PAD PIT MONITORED 1/3/19 0.570-0.870%  
 RIVER AVON

PULLMAN DRIVE  
 1604  
 NOT WATCHED TO EXISTING FOOTING CONCRETE BEING REUSED.  
 PARTIALLY
