# MOLA HEADLAND INFRASTRUCTURE

## CONTEXT SHEET

| Site code<br><b>A14</b> | Area/Field<br><b>TEA 38</b> | Sub-area/Trench<br><b>A</b> | Context number<br><b>383291</b> |

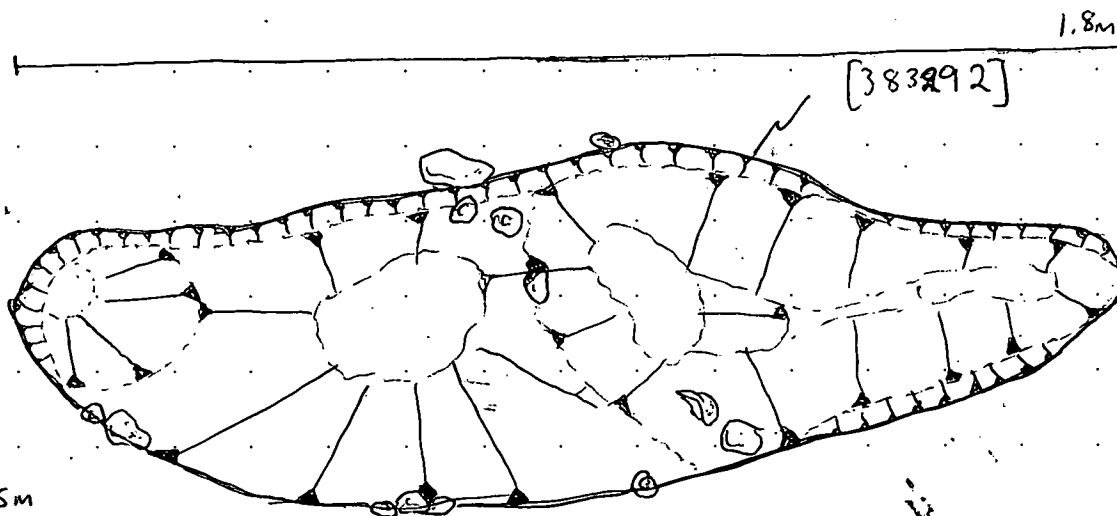
POST/EX PLAN (N.T.S)

FILL OF GRAVE [383292] CONTAINING SKELETON 383290.  
 HEAVILY TRUNCATED BY MACHINE DURING TOPSOIL STRIP,  
 ONLY 3-4 cms REMAINING  
 100% SAMPLED - 6 x 10L Buckets (S 38389 + S38390)  
 NO FINDS, ~~OR~~ INCLUSIONS SMALL SUB-ANGULAR  
 STONES + MED SUB-ANGULAR ROCKS. CHALK  
 + CHARCOAL PRESENT ALSO. NO BONES  
 FOUND IN FILL BELOW SURFACE, LIKELY  
 REMOVED BY MACHINING BUT FILL 100%  
 SAMPLED SO ANY ELEMENTS MISSED  
 DURING EXCAVATION WILL BE RECOVERABLE.
