# MOLA HEADLAND INFRASTRUCTURE

# CONTEXT SHEET

| Site code<br><b>A14</b> | Area/Field<br><b>TEA 10</b> | Sub-area/Trench<br><b>B NORTH</b> | Context number<br><b>602056</b> |

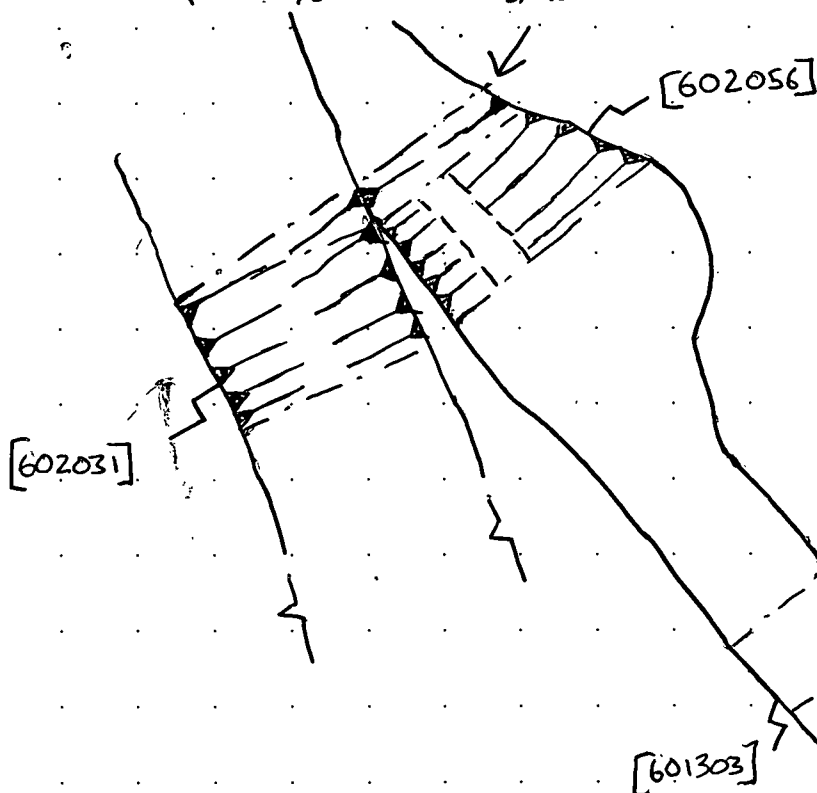
NTS

Cut of ditch. The ditch widens considerably inside the slot. The reason for this is unknown. There doesn't seem to be a second feature in the slot - the soil is homogeneous. This ditch intersects with [602031] just north of this slot.

UPDATE 26/06/17: SLOT EXTENDED TO CLARIFY RELATIONSHIP BETWEEN [602031] and [602056]. THE FORMER TRUNCATES THE LATTER.

For sketch, see (602055)  
26/06/17: For relationship sketch, see (602030) EXTENDED 26/06/17
