# Dairsie Old Parish Church and the Question of Redundancy

*Jonathan Dowling*

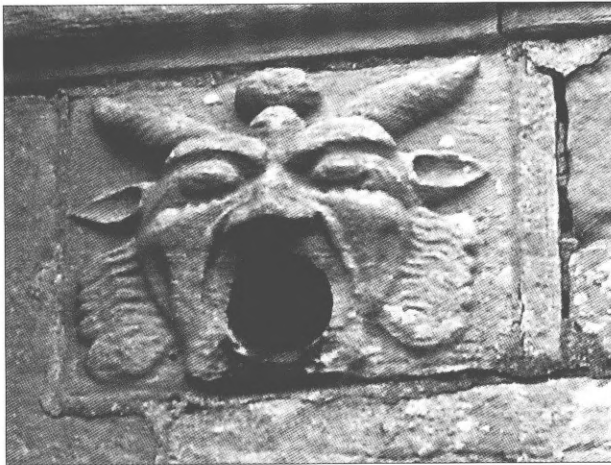
Fig 3 – Dairsie Church, west doorway (photograph, Judy Dowling)

The 'remarkable edifice' (MacGibbon and Ross 1892, 155) is a buttressed, rectangular building, four bays long by two bays wide, with sandstone ashlar walls (Fig 2). The bays are separated by three-stage buttresses which also feature on the corners. The entrance is in the western wall, with an ornate moulded arched doorway framed by classical pilasters (Fig 3). Above this are an inscription panel which states '*Iehovah, dilexi de corem domus tuae*' (Jehovah, I have loved the beauty of thy house) and Spottiswoode's initials and arms, with the date 1621. The tower, to the right of the doorway, juts out unusually, not to say awkwardly, at the south-west corner (there was no gable to support a central
