The Works Chantry Screen in the Great South Transept of Lincoln Cathedral

David Stocker

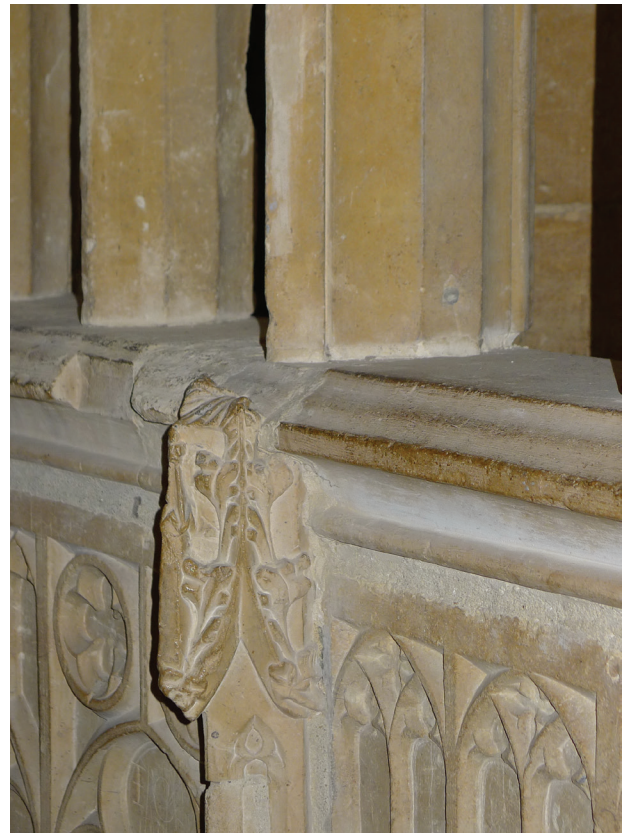
Fig 6
The works chantry screen. Detail of junction between original major mullion and miniature buttress pinnacle rising through dado; dado rail; and later replacement mullion dating from the reconstruction (Photo: author)

The dado is decorated with three bays of blind arcading to either side of the central opening, which are defined by projecting miniature panelled buttresses, rotated through 45 degrees to the plane of the wall. It appears that these buttresses were intended to rise through the dado level and form major divisions in the screen above, but they now terminate at dado level; what was originally a joint with the mullion above has been given a scalloped decoration (Fig 6). This latter detail

Above the dado, the central section of the screen comprises simple square-headed tracery on each side of the doorway. The tracery heads are cut from four pieces of stone to each side of the doorway, which have been selected to fit the space. Although reset, these are also unlikely to represent architectural salvage from elsewhere. The castellated cornice, which the lintels support, however, does not fit the space and there is a nasty bodge in plaster at the south end. The openings in the screen are divided into three groups of three lights by slightly broader mullions but none of them are deeper than the dado rail on which they sit. As has been suggested, the major mullions, incorporating a miniature pinnacle buttress, were clearly intended, originally, to rise through from the dado below, but they are now terminated short of the openwork screen and not picked up in the open lights above (Fig 6). Willson reconstructs such a buttress in this location,

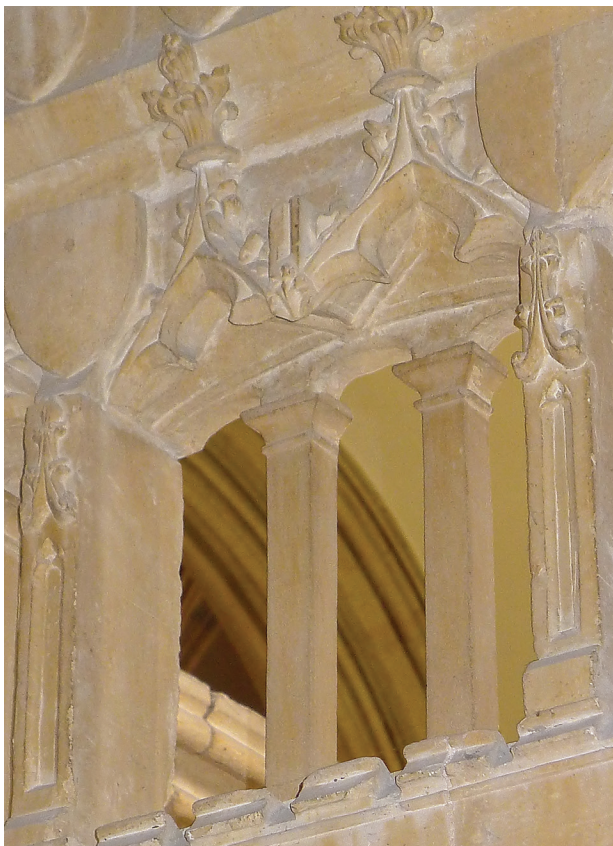
Fig 7
The works chantry screen. Single bay in canopy tier from western side. Note the inserted pillars towards the rear with their 'flared' capitals (Photo: author)

Above the openwork screen the second level of openwork masonry provides an unusual, not to say ungainly, canopy tier, yet it is clear from the responds against the arcade piers that, even if the whole of the present upper screen is a replacement, such an upper tier of openwork screening was a part of the original design. At this level today, however, the masonry simply does not fit the space allotted; it does not correspond to the bay divisions established in the dado and openwork screen below, and neither does it match the fragments of the original screen termination still adhering to the arcade piers to north and south. Each bay within the canopy tier is decorated with two simply cusped ogee canopy heads separated by blank shields supported on the stubs of panelled buttresses, which no longer rise above the shoulders of the arches. Above, the canopies support a heavy, simply moulded cornice decorated with another row of blank shields. In addition each bay within the canopy tier is supported by a pair of

uprights, which sit directly beneath, on the east side. The uprights themselves have a completely different tooling from the tracery in the openwork screen and dado below, and their simple squared section with 'flared' moulded capitals appear neo-classical rather than Gothic (Fig 7). Such deep openings, with straight heads below paired ogee arches look highly unconventional in this context; they are too small-scale for their elevated position and look more like the canopies surrounding niches from a tomb base or another item of furniture. These canopy blocks are probably architectural salvage from elsewhere, although they too are mid- or later 14th-century in date. The run of blank shields supporting the upper cornice is simply moulded compared with the embattled rail above the openwork screen below, and this too might suggest that this whole zone is not original. Similarly, the brattishing is set back from the front face of the cornice in an unusual way: the stalks appear too squat and much of the leaf sculpture itself seems to be of plaster. The simplicity and poor design quality of these cornice components may suggest that they were

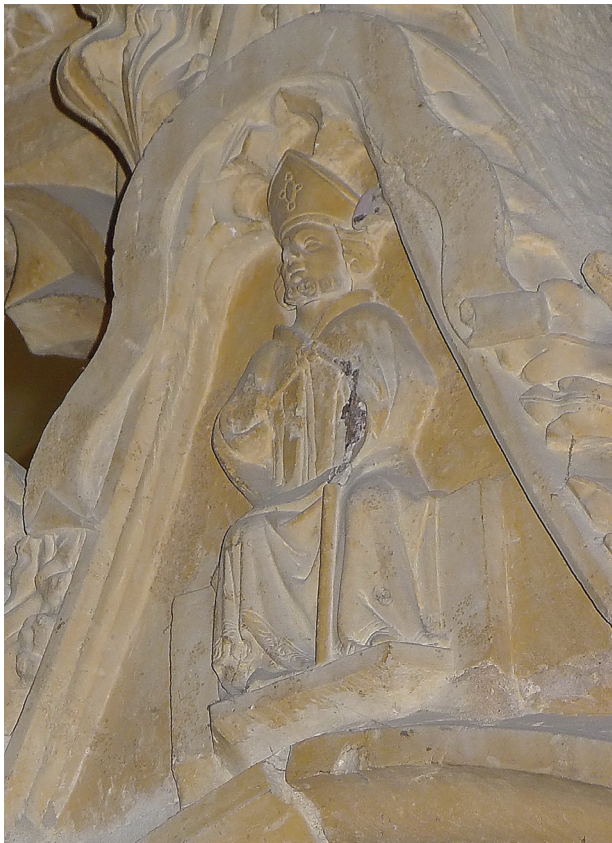
Fig 8
The works chantry screen. The 'blessing bishop' over the central doorway, suggested here to be a sculpture of the later 17th century (Photo: author)

The monolithic decorative gablet above the arch head looks original, however, but the blessing bishop's face and mitre, at least, appear replaced (Fig 8). By contrast with the bedesmen in the imposts below, the bishop's head and mitre is present in Willson's studies and here, once again, the features and the shape of the mitre look later 17th-century in date. The bishop sits beneath a blank scroll on the gablet, which may have originally been decorated with a painted prayer. The pierced panels to either side and the cornice with square-flowers above, appear convincing medieval work, and they are decorated towards the east as well as towards the west. They have clearly been reset in their current location as packing is visible on the east face, and their flanking buttresses are missing finials. The stone carrying the principal, central, statue niche, and carved with the arms of England 'ancient', is also apparently of medieval workmanship, although it too has been relocated. It no longer sits comfortably on the finial below and is supported by two lateral fillets of stone, clearly later insertions. These insertions are seen in Willson's studies, however, and so may have been made during the initial reconstruction. The uppermost tabernacle along with its spire also seems to be of medieval workmanship. Like the smaller openwork tabernacles to either side, it is also decorated on its east face as well as towards the west. The two subsidiary tabernacles also appear to be largely original medieval
