Northbrook School, Taunton Road, Lee Green, London Borough of Lewisham Historic Building Recording

Planning Application Number: DC/07/67730/X

AOC Project no: 30260

October 2008

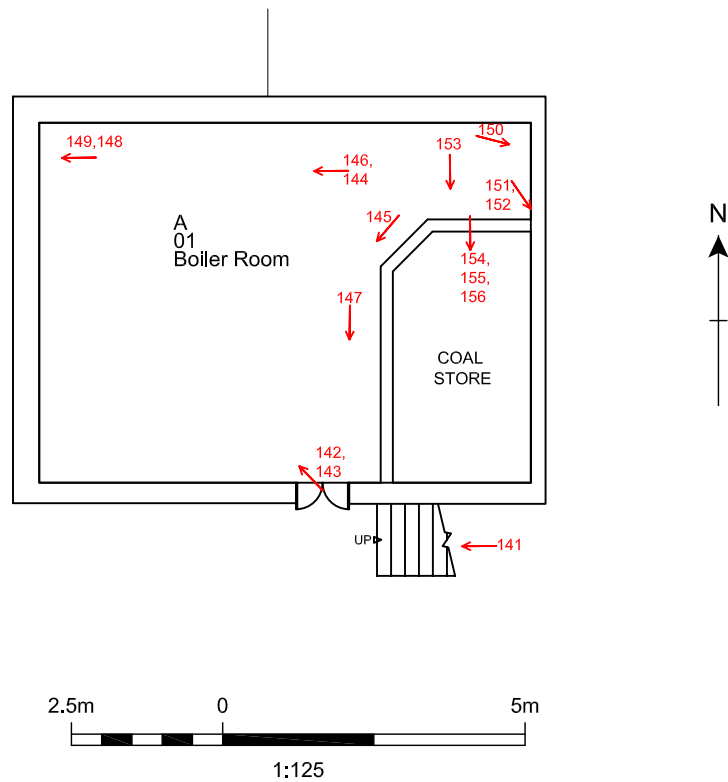
Figure 4: Photographic Locations: Basement

- 3.2.1 The basement lies beneath the eastern part of the single story section of Block A, and is accessed down a narrow set of concrete stairs along the south side; the doorway is in the south side of the basement. The stairway is enclosed by a concrete-rendered wall to the south and west. The basement is separated into two areas, the **Boiler Room** (A01) being the principal room, providing the majority of the services for the school buildings. At the time of recording, the floor was beneath several inches of water.

- 3.2.2 The plant in the boiler room is concentrated along the western part of the room, and consists of a 'Sanigaz' gas-fired water heater, manufactured by Guillot-Yngis Heating Ltd, a Buderus condensing boiler and a Clyde CG condensing boiler. Independent pressure dials are located on the south walls, and electric fuses on the east wall. A Fire-extinguisher is also located in this room.

- 3.2.3 The **Coal Store** is located in the southeastern part of the basement, and can be accessed through a pair of iron doors. There was no coal remaining, and it is assumed that the use of coal to heat the boilers was abandoned after the Clean Air Acts of 1968 or 1993. The chimney which is part of the heating system is built of rings of reinforced concrete and stands higher than the roof of Block A.

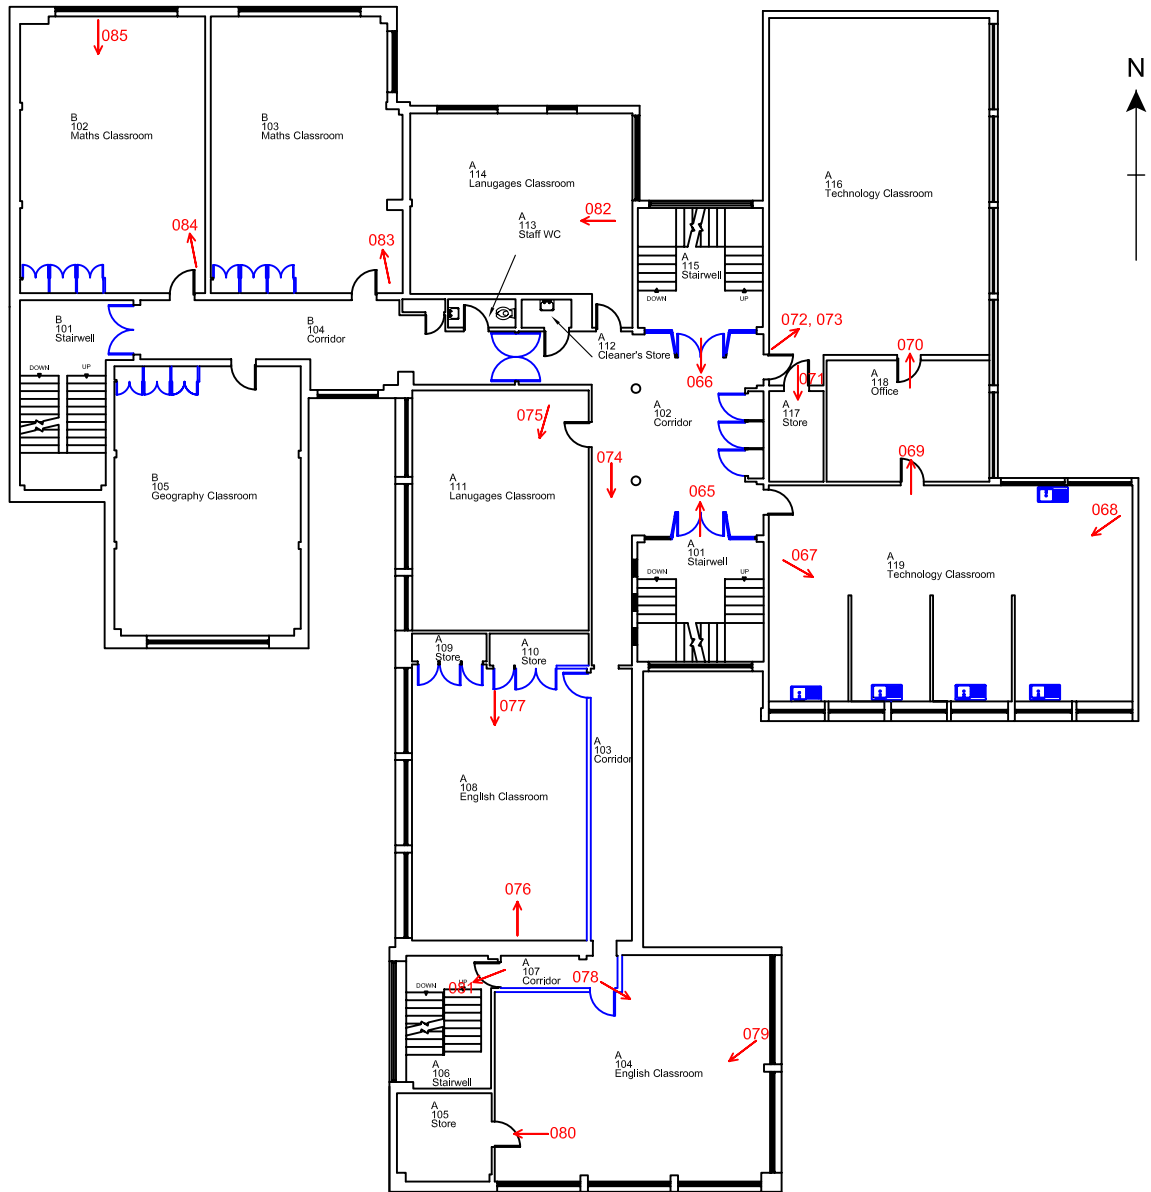
Figure 6: Photographic Locations: First Floor
 Not Present at Time of Photographic Recording

- 3.4.1 The principal circulation area of the first floor is the central **Corridor** (A102), which can be accessed by either the northern or the southern stairs. Between the corridor and both sets of stairs were pairs of glazed doors. These would protect against sudden falls and prevent inappropriate running. These were removed prior to recording. The corridor is wide, and features circular columns that support the floor above. At the northern end of the corridor, a branch runs west, towards Block B. At the southern end of the corridor, another **Corridor** (A103) runs south towards the southern extension.

- 3.4.2 A large classroom lies to the southeast of the corridor. This is a **Technology Classroom** (119), and is well-lit by windows on both long sides. Three low walls divided the room into partial cubicles, each with a sink, and probably contained workbenches. A door in the north wall leads to an **Office** (A118), which retains its flooring: pale linoleum. The walls are pale green. A second door in the north wall of the office opens into the classroom in the northeast corner of Block A. This northeast classroom is primarily accessed from the principal corridor, and is also a **Technology Classroom** (A116), of equal size to that to the south. No fittings survive. In the south wall of the classroom are two doors: one leads to the Office, the other to a small **Store** (A117).

- 3.4.3 Two rooms lie to the west of the corridors of Block A, the nearest to the main corridor is a **Languages Classroom** (A111), the blackboard or whiteboard was mounted on the south wall. South of here is an **English Classroom** (A108), the blackboard also mounted on the south wall. This is a practical location for the boards: this avoids sunlight shining upon them. One notice was present in the room, an instruction: 'Please do not write on this board'. In the northern end of the room were two small **Stores** formed by partitions removed prior to recording (109 and 110).

- 3.4.4 The western branch of the main corridor that leads to Block B has two small rooms on its northern side: a **Cleaners Store** (A112) which contains a small low-level sink, and a Staff WC (A113) with a lavatory and basin. Both small rooms are breeze-block partitions of the corridor. North of the corridor

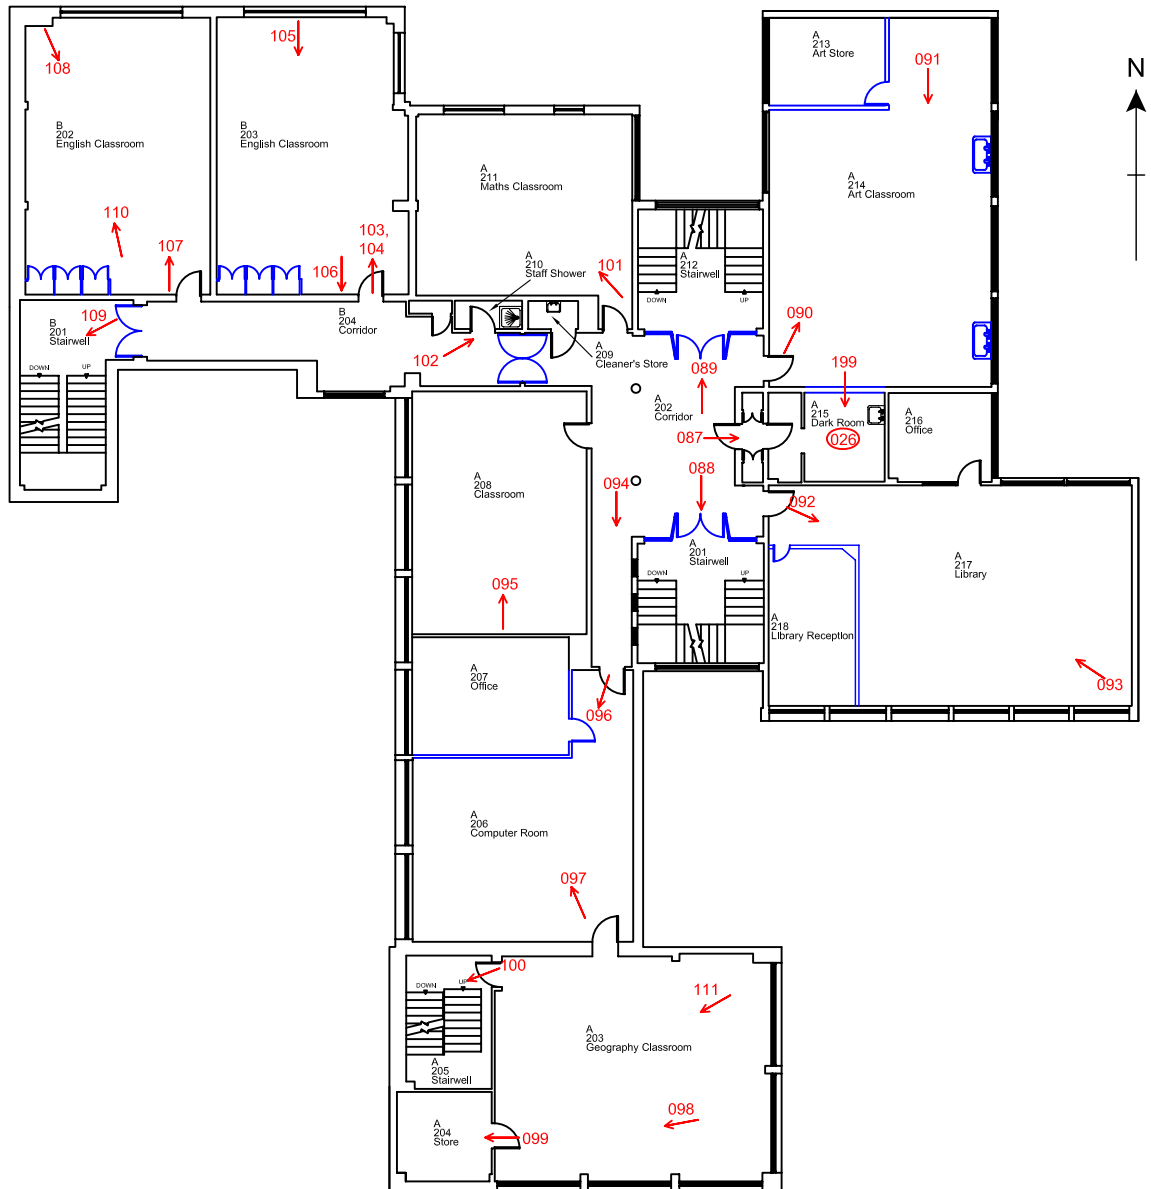
Figure 7: Photographic Locations: Second Floor

- 3.5.1 The second floor is accessed by the **Stairwells** (A201 and A212), which both accessed the **Corridor** (A202) via pairs of glazed doors. The layout is largely identical to the First Floor, the corridor having a short branch southwards and westwards to Block A. To the southwest of the corridor is a large room which was used as a **Library** (217). There is evidence of a low partition on the west wall, and this is the scar left following the removal of a counter that bound the **Library Reception** area (A218). A door in the northern wall leads to a small **Office** (A216) that was formed of breeze blocks.

- 3.5.2 In the northeast of the Second floor is a second large room, this an **Art Classroom** (A214), which had an **Art Store** (A213) beyond a small partition at the north end. Little evidence remains of the room's use, but a large rectangular sink attached to the east wall resting on a brick.

- 3.5.3 South of the Art Classroom is a small room accessed from the main corridor. This is a **Dark Room** (A215), largely painted black, and containing a sink against the eastern wall. The entry from the corridor is through sets of doors with a small vestibule between. This is clearly to prevent light spillage into the dark room.

- 3.5.4 At the south end of the main corridor's southern branch is a **Computer Room** (A206). The board had been mounted on the southern wall. A door in the southern wall leads south into the southern extension of Block A. In the northern end of the room, a demolished partition once enclosed an **Office** (A207), upon the wall was remnants of IT equipment, possibly once a server. Directly north of this room and also accessed from the main corridor is another classroom. The subject taught was not clear from any evidence in the room. The board was situated on the south wall.

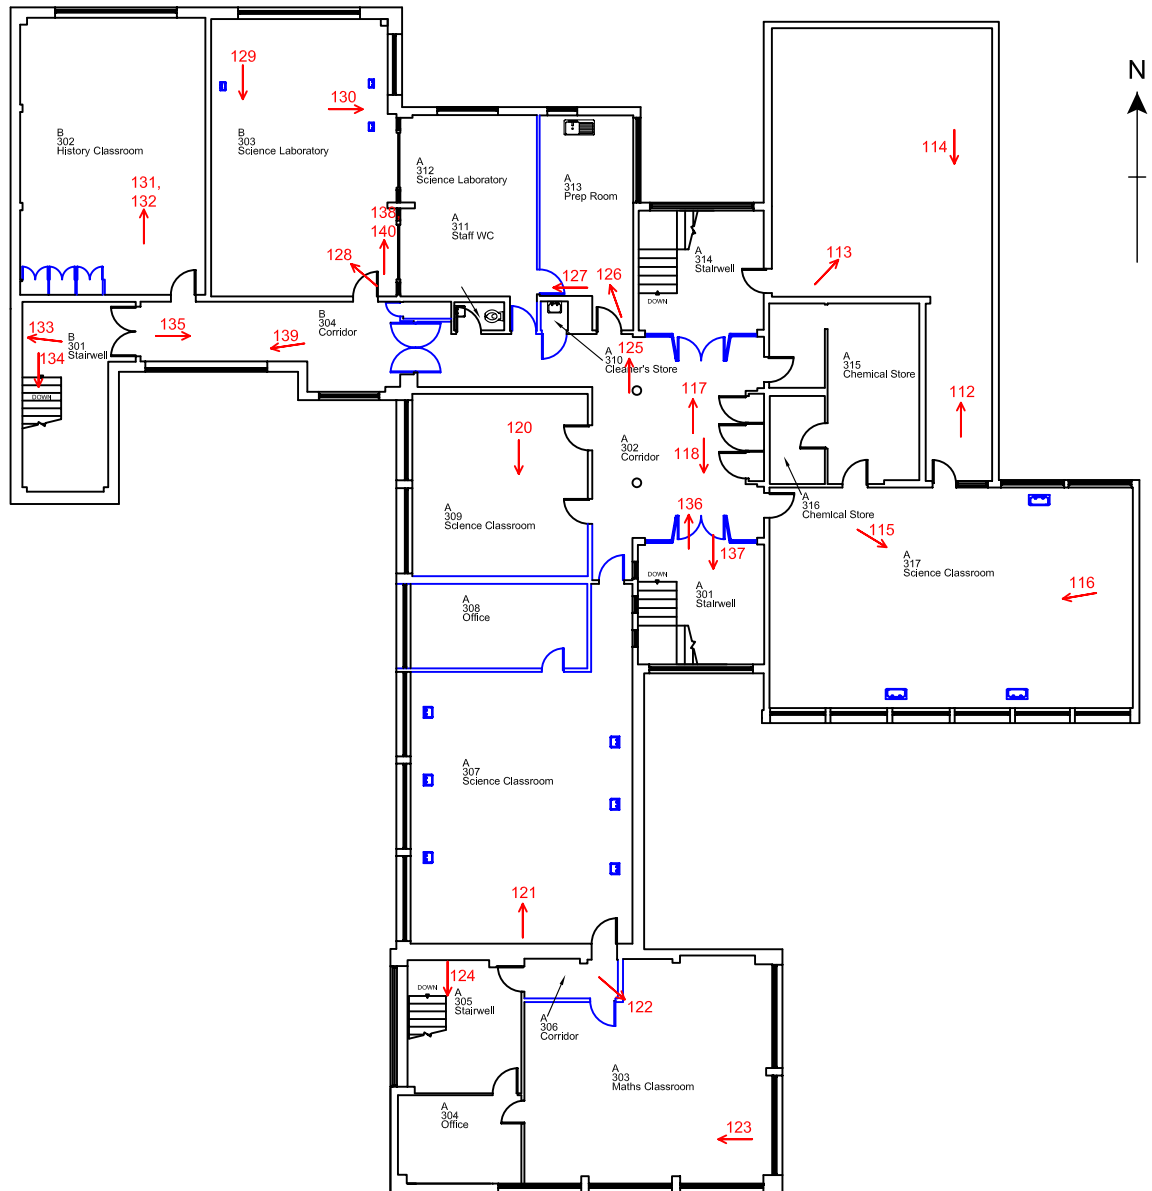
Figure 8: Photographic Locations: Third Floor
 Not Present at Time of Photographic Recording

- 3.6.1 The third floor is accessed by the **Stairwells** (A301 and A314), which both accessed the **Corridor** (A302) via pairs of glazed doors. The layout is largely identical to the lower floors; the corridor having a short branch southwards, and also westwards to Block A. The corridor has a series of alphabetical science posters, and names of eminent scientists have been painted on supporting pillars. To the southwest of the corridor is a large room which was used as a **Science Classroom** (A317). Gas pipes rise from the floor, indicating the former location of work benches. There was no evidence to prove or disprove whether the benches were an original feature of the room, but it seems very probable. The gas pipes would have lead to gas taps for Bunsen burners for use in science lessons. Two doors in the north wall of the room lead to two different areas; the western of the two doors leads to a **Chemical Store** (A315) with an ante-room from the main corridor and a smaller stall to its south west (A316).

- 3.6.2 The second northern door in the room opens onto a flat roof with a low parapet wall surmounted by a waist-high railing that was used as a **Roof Garden**. This area is also accessed from the northern stairwell (A314). Two plant pots with long dead plants were on the roof space. This is the roof of the Art Classroom (A214 below).

- 3.6.3 In the west of Block A were once three rooms formed by partitions: these partitions had been removed prior to recording, leaving one large open space almost 18m long. This area once held two **Science Classrooms** (A307 and A309) with an **Office** between (A308). The only surviving features in the room are radiators on the western wall.

- 3.6.5 The roof of Block A is formed of steel beams and timber. Wall plates that are steel I-beams surmount the walls, and further steel beams are bolted horizontally to these to form the basic roof structures. Timber beams 0.25m wide are bracketed to the horizontal steels; these form roof joists, atop which boards are laid. The whole is covered in roofing felt.

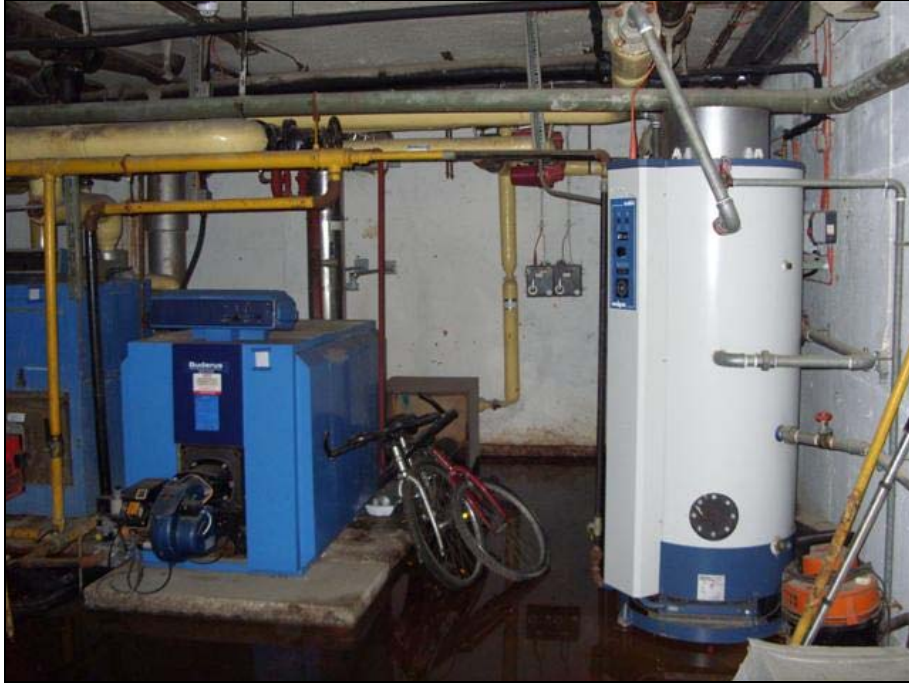
Plate 3: Boiler Room, basement

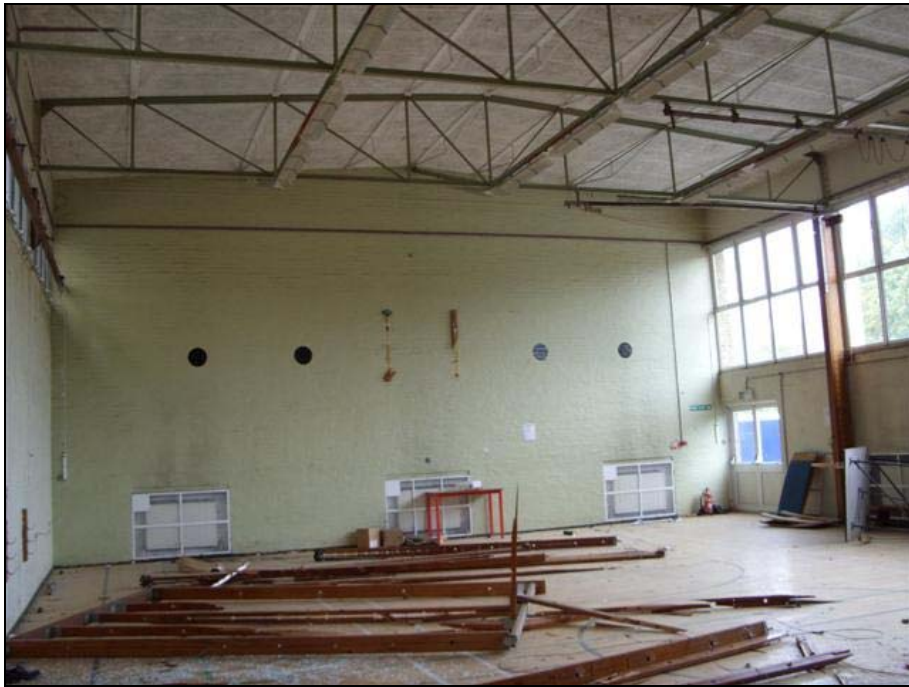
- 3.8.2 The **Gymnasium** (A026) occupies the western end of the Main Hall. It is open to the roof, with the steel frame showing. The roof of this section has four low profile roof trusses, each of eight sections with cross braces. Each truss is strengthened by tie-beams. The room is lit by high level top-hung casement windows, which are operated by a winding mechanism at shoulder-height. The floor is probably sprung, and finished with highly polished wooden boards, forming the gymnasium space, marked out with a basketball court. It is also furnished with climbing frames and ropes. The gymnasium is accessible from the school playground and from a corridor to the south. The eastern wall of the room is formed of a lightweight steel foldable shutter.

Plate 4: Gymnasium, looking west

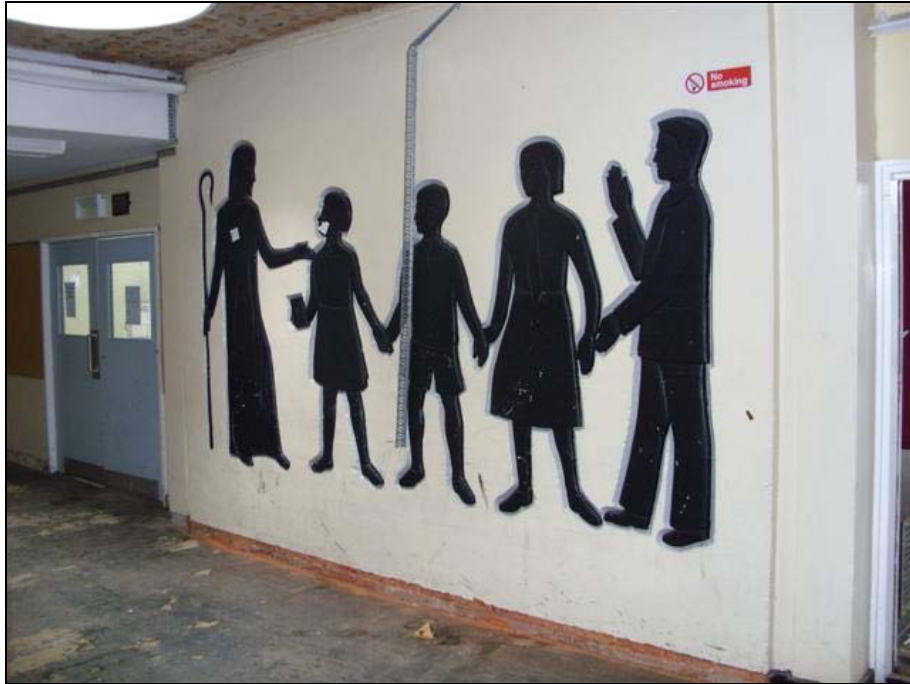
- 3.3.9 The principal corridor of the Ground floor is decorated with a religious motif in relief. This is on the south wall of the Main Hall and depicts a family of two parents and two children approaching Jesus as a shepherd. The carving is black against the white wall of the corridor. This part of the corridor is single storey and is lit by circular skylights, and connects to the boys changing rooms in Block B. opposite the carving is a door which leads to the **Girls Changing Room** (A023).

Plate 5: Ground Floor Christian mural, looking northwest

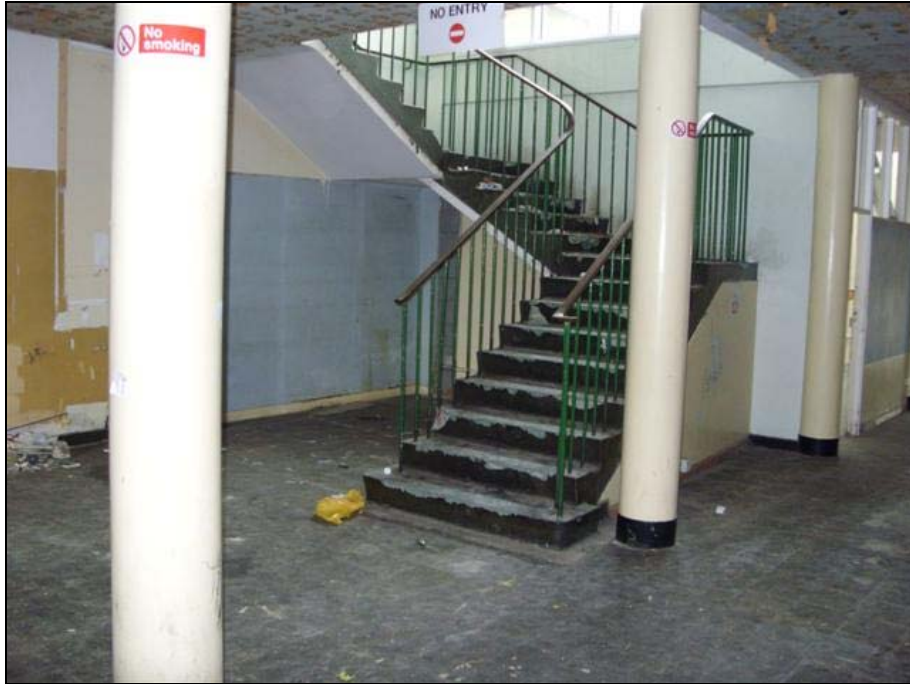
- glazed doors. The lobby also provides access to the main southern stair of Block A and to two Careers Offices to the south.
- 3.3.5 The two principal stairs are built identically, being half-turn stairs with landings, three flights between each floor. However, that to the north rises anti-clockwise and that to the south rises clockwise. The stairwells are lit by full-length windows from floor to ceiling on all floors, except for the ground floor northern flight, which is within the principal corridor. The balusters are thin with a square profile and the banister flat. On the upper floors, the **Stairwells** are separated from the main Corridors by pairs of glazed doors.

Plate 7: Ground Floor Northern stairwell, looking northwest

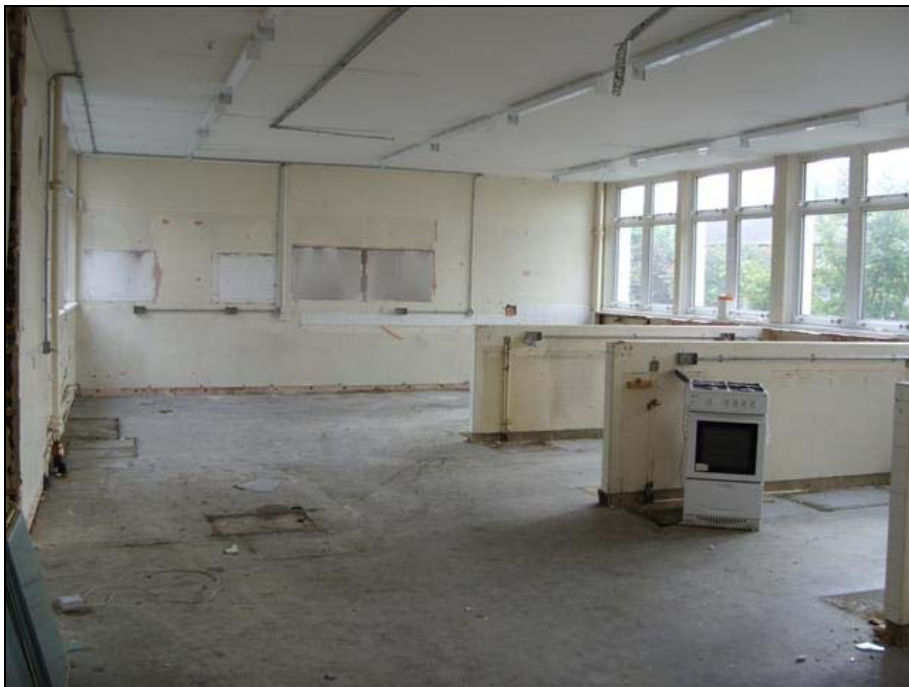
Plate 10: First Floor Technology Classroom, looking southeast

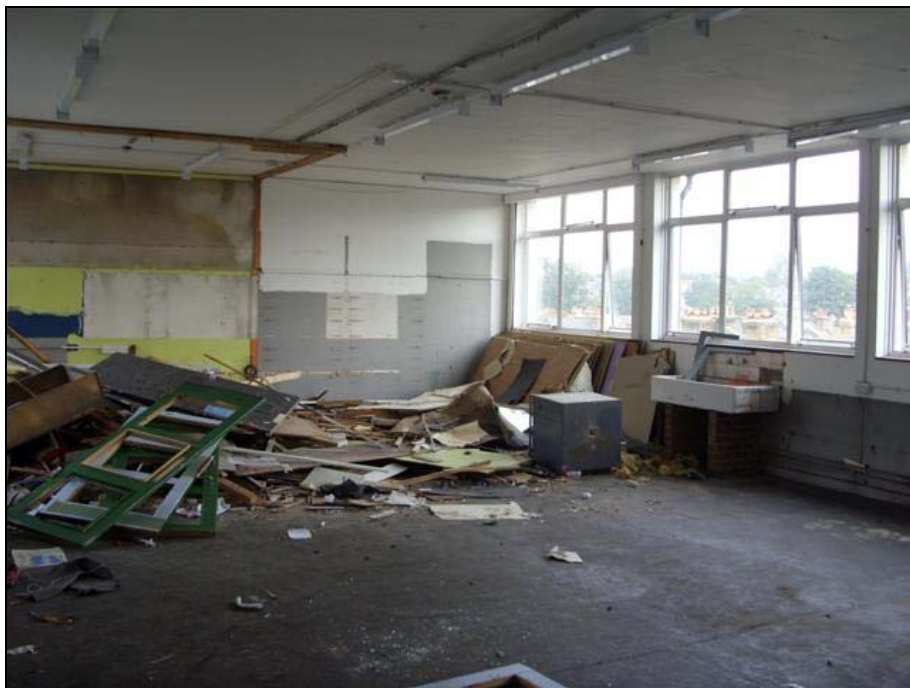
Plate 12: Second Floor Art Classroom looking north

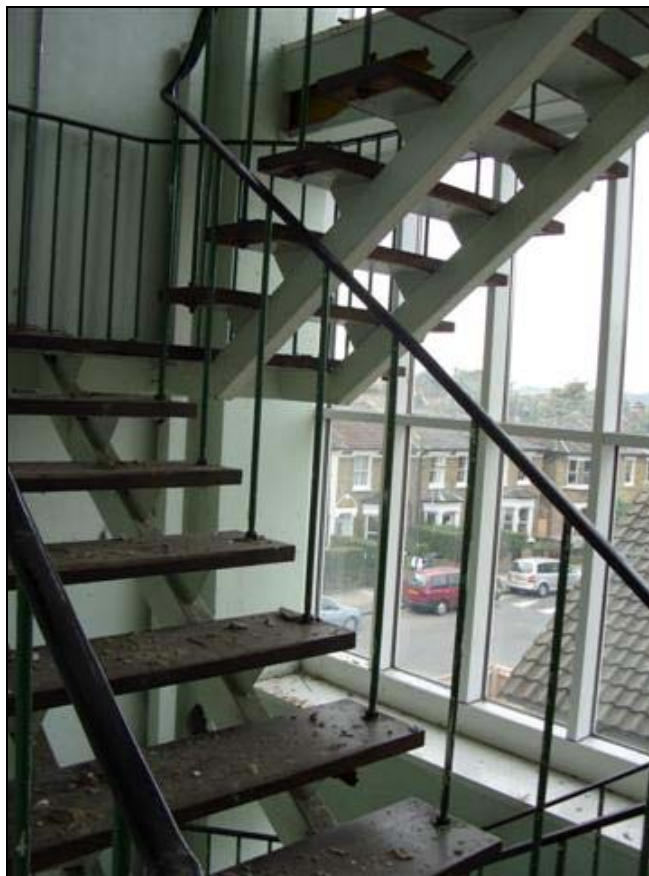
- 3.9.3 A flying dog-leg stair without risers in a glazed stairwell rises up the northwest corner of the extension. The treads are wooden and the balusters have a round profile. The handrail is metal.

Plate 14: Second Floor Extension Stairwell, looking southwest

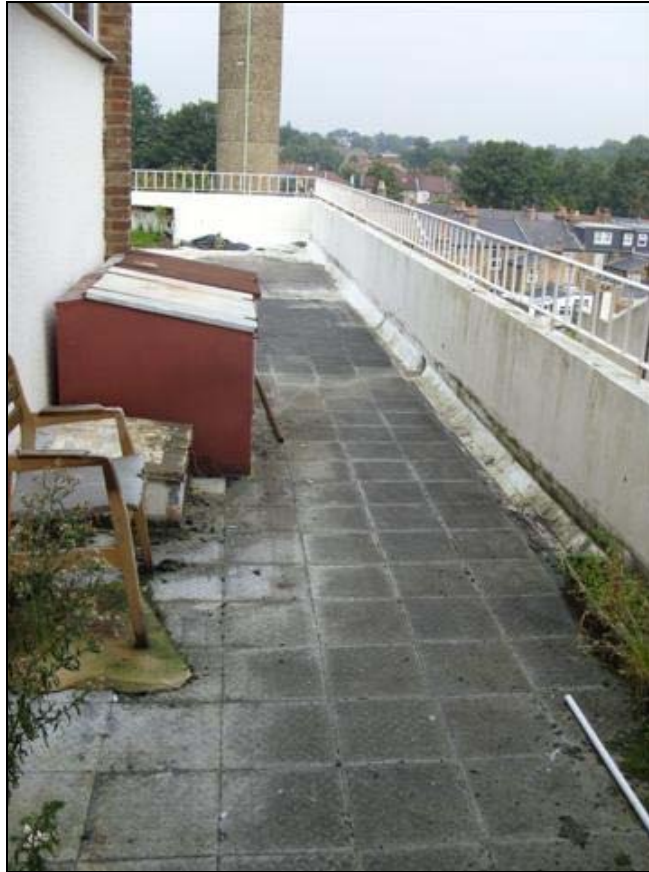
Plate 17: Roof Garden looking north
