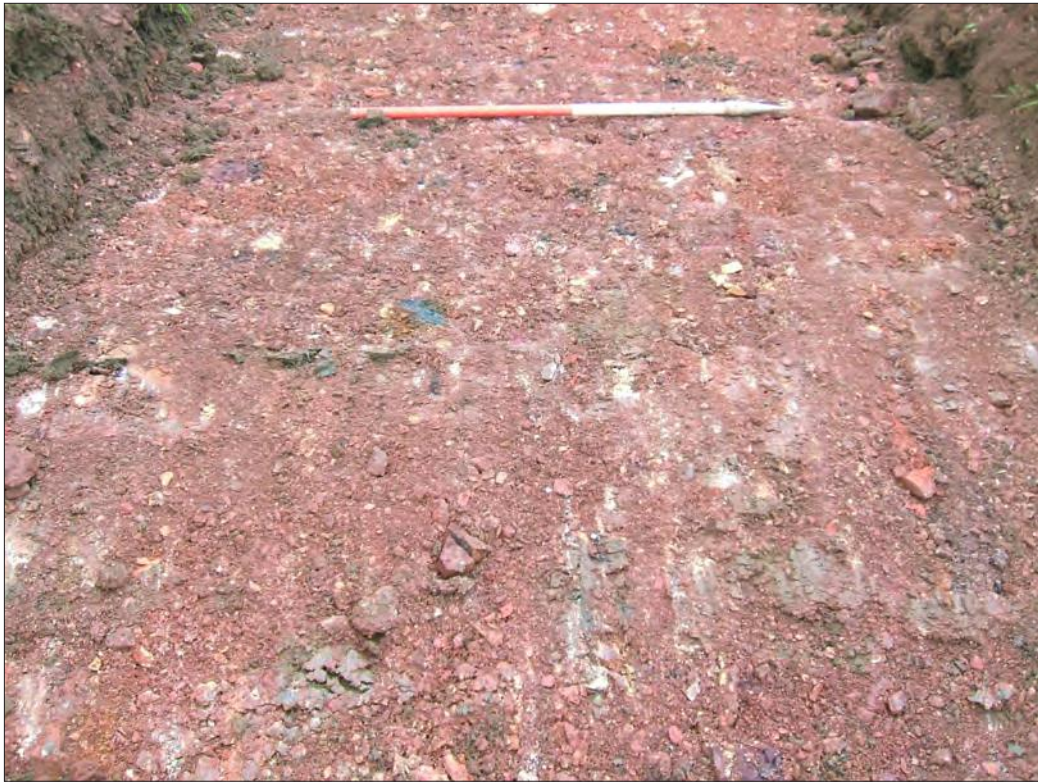
Plate 7: General view of red blaes surface 805 in Trench 8 from the east. Typical of blaes surfaces found elsewhere across the site.

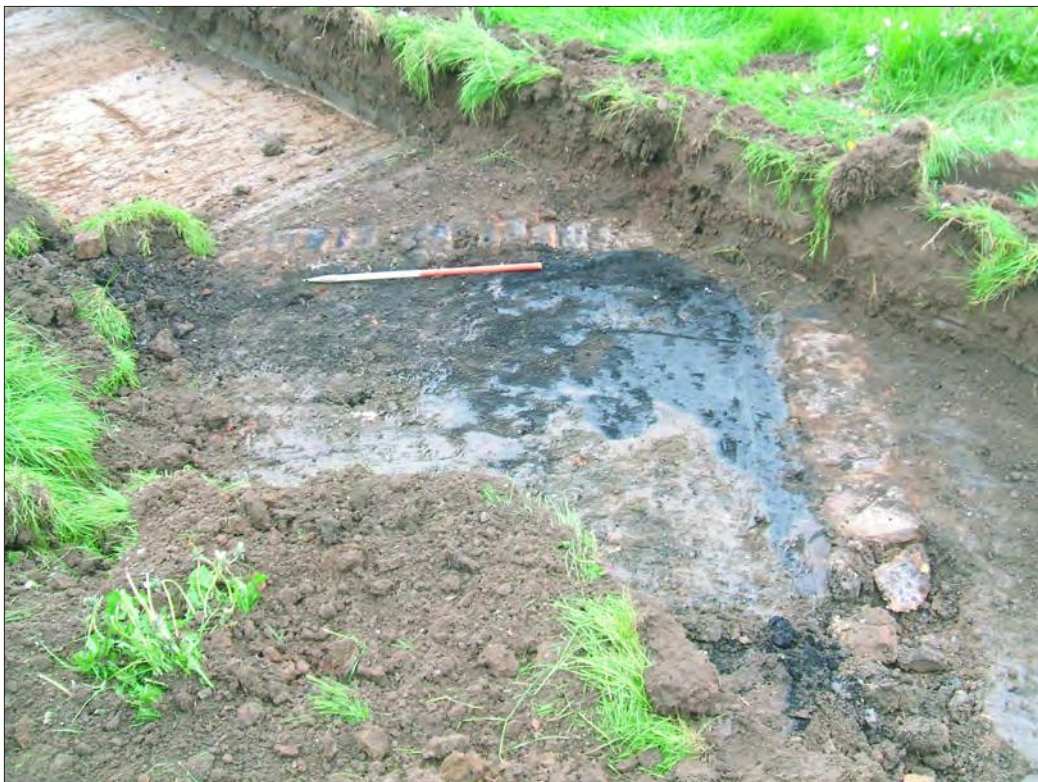
Plate 8: Brick structure 901 and coal dust deposit 902 in Trench 9, from the north-west
