ARCHAEOLOGICAL MONITORING REPORT

20010 3750375	T= = ··
SCCAS REPORT No. 2013/092	Parish: Southwold
Clyde Cottage	Planning Application No.:
Clyde Cottage	DC/12/1115
15 CONSTITUTION HILL	HER Event No.: SWD 068
SOUTHWOLD	OASIS ref: suffolkc1-154069
Address:	Grid Reference: TM 5071 7586
15, Constitution Hill	Number of Site visits: 2
Southwold	
	Date of visits: 23rd April and
	14th May 2013
Nature of the work: excavation of footings for extensions to an existing property.	
Reason for condition: site is located in the medieval historic core of Southwold,	
within the area of archaeological interest defined on the County HER (SWD 051). It	
is also in the vicinity of a documented medieval castle site (SWD 009).	
% of total seen: 80% of footing trenches	
Location Map:	
GARDNER ROAD garden room Clyde Cottage Constitution tilling	
garage ©Crown Copyright, All Rights Reserved, Suffolk County Council Licence No. 10002	e and extension OUREN'S ROAD

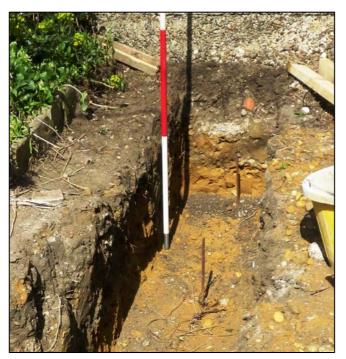
The rear extension was on a strip foundation that revealed a deposit of clean sand and gravel at a depth of 0.2m below the present ground surface (plate 1). No features or artefacts were identified.

Plate 1. view of the footing trench for the rear extension

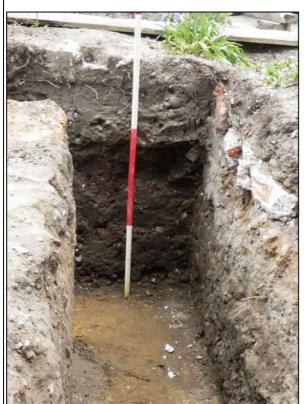
The second area monitored was more complex due to the sloping nature of the site which had been previously formed into two terraces. The footings on the lower terrace were 1.35m deep at which depth a deposit of sand and gravel was encountered (plate 2); again, no features or artefacts were revealed.

Plate 2. footing on the lower terrace

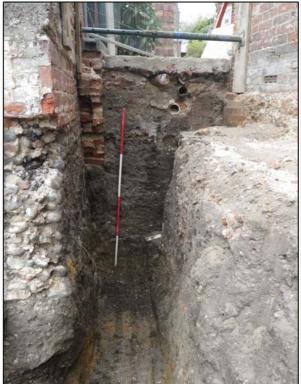
Excavation along the boundary between the two terraces revealed over 2.5m of made ground, from the level of the upper terrace (plate 3), indicating that much of this upper terrace was formed by dumping imported material against a wall. The upper section of the wall was built of brick whilst the lower portion, presumably an earlier phase, was built of large flint pebbles and mortar. No dating evidence was recovered for this lower section of wall although it was not thought to be of any great antiquity.

plate 3. trench between terraces
