ARCHAEOLOGICAL EVALUATION REPORT

NEW MUSEUM BUILDING, WEST STOW ANGLO SAXON VILLAGE WSW 076

A REPORT ON THE ARCHAEOLOGICAL EVALUATION, 2007
(Planning app. no. SE/07/0481)

Suffolk County Council
Archaeological Service

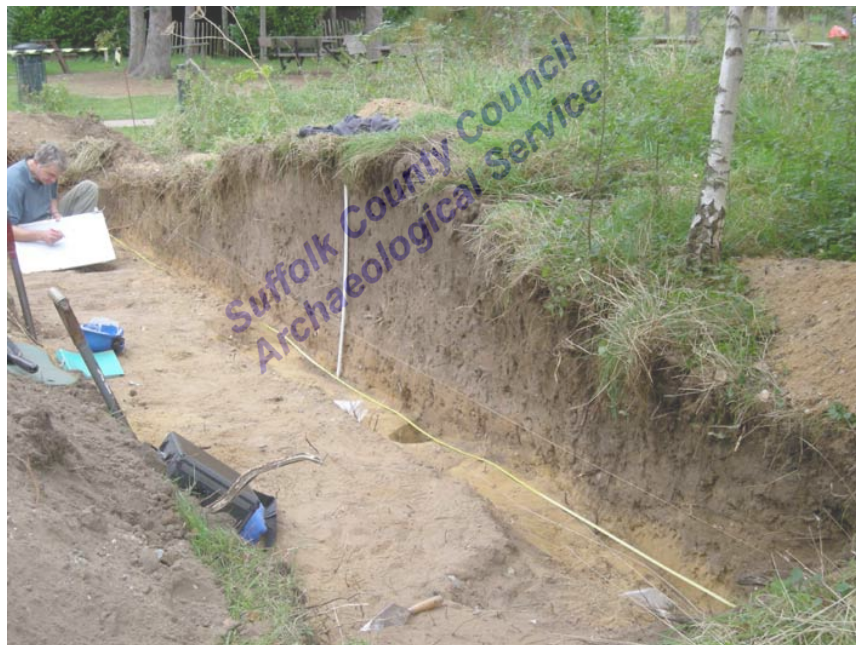
Figure 5. Section through the bank

Trench 2 was 9.5m long and positioned to section the bank that ran across the north end of development area. Access was restricted and the length of the trench limited by the position of trees. The machine cut through the bank to the surface of a pale sand (0016) where a single feature 0023 was identified. The bank was made up of a deposit of dark sand (0019) which had buried an earlier topsoil layer (0020). The construction of the bank had occurred long enough ago for the bank soil and the topsoil to have become almost homogenous, but the line of the old ground surface was still just discernible (Fig. 5). The bank supported trees older than the

The bank is thought not to be archaeological and follows the line of an earlier forest track that is now part followed by the path to the visitor centre. The bank is probably associated with the planting of the tree belts in the early part of the 20th century and similar banks have been recorded on the edges of rides and tree compartments elsewhere during the forest earthwork surveys (Craven 2003).

The bank although relatively recent is a detail that relates to the land use as a managed forest and therefore forms part of the historic landscape. It is therefore recommended that the extent of the bank is recorded and is plotted against the Ordnance Survey.
