ARCHAEOLOGICAL MONITORING REPORT

2, CHEQUER SQUARE, BURY ST EDMUNDS BSE 254

Planning Application No.:SE/04/1687/P

SCCAS Report no. 2005/98

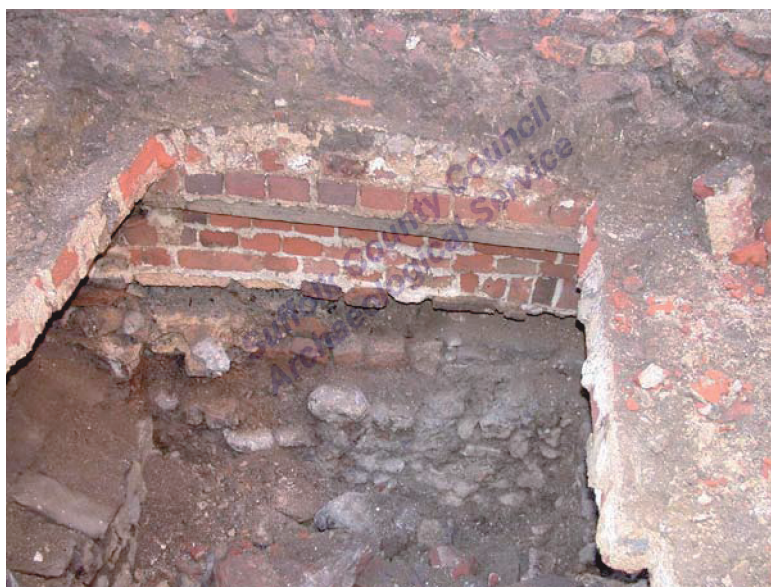
A concrete slab was removed within the garden, which exposed the arch over a rectangular brick and flint lined chamber (Fig. 2 below). This was built up to the boundary wall with 3, Chequer Square to the west where it was 1.6m long and projected out 1.1m. The pit was filled with brick rubble and general building debris but was at least 1.5m deep. On the south side a series of overlapping slate tiles angled into the chamber. This feature is thought to be late 18th or 19th century in origin. No research has been carried out but it seems likely that this was a well-built garden cesspit. The pit was consolidated before building.

Figure 2 Brick and stone built cesspit (?)

The construction of the conservatory work did not disturb any archaeological features with the exception of a probable cesspit thought to be late 18th or early 19th century in origin. The site of the cellar was probably occupied by buildings from the early medieval period and therefore not subject to pit excavations, which might have appeared below the cellar in backyard areas.
