**An Archaeological Watching Brief at 7-9
Castle View, LE1 5WH, Leicester**

NGR: SK 5827 0415

ULAS Report No. 2018-106
©2018

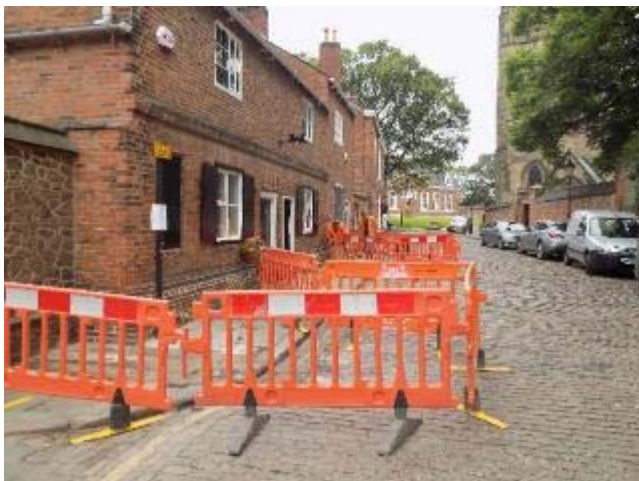
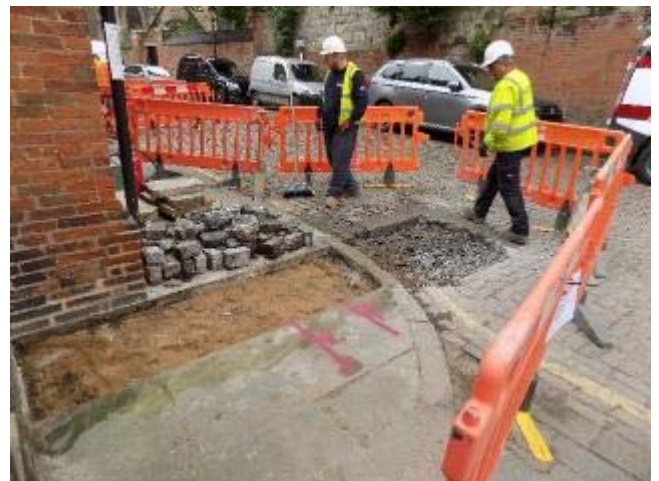
Figure 3. Location of Nos.7-9 Castle View (provided by Client)

a. Location of groundworks (facing N)

b. Slot in No. 9 after removal of stone slabs
