# M11 JUNCTION 7A, HARLOW, ESSEX

## ADDITIONAL GEOPHYSICAL SURVEY

commissioned by Ringway Jacobs  
on behalf of Essex County Council (ECC)

November 2016

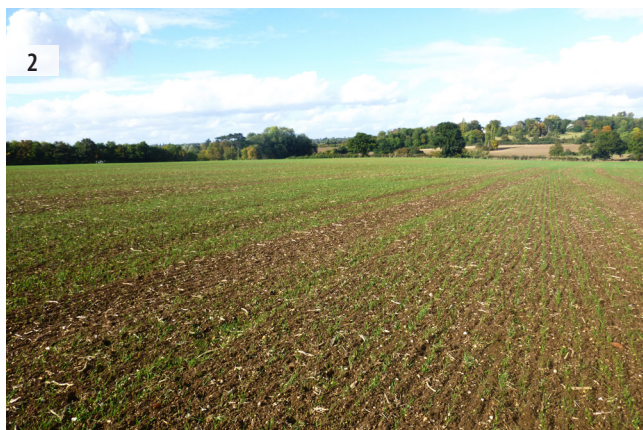
**ILLUS 2** Area 13 and Area 10, looking north-west    **ILLUS 3** Area 11 and Area 14, looking south    **ILLUS 4** Area 17, looking east    **ILLUS 5** Area 12, Area 16 and Area 15, looking south-east

A general site location plan is shown in Illus 1 at a scale of 1:10,000. Illus 2 to Illus 5 are site condition photographs. A large scale (1:5,000) survey location plan showing the processed greyscale magnetometer data is presented in Illus 6. An overall interpretative plot is shown at the same scale in Illus 7.
