Snake Woodlands, Dr Talbotes Gate

Archaeological Evaluation: Statement of Results

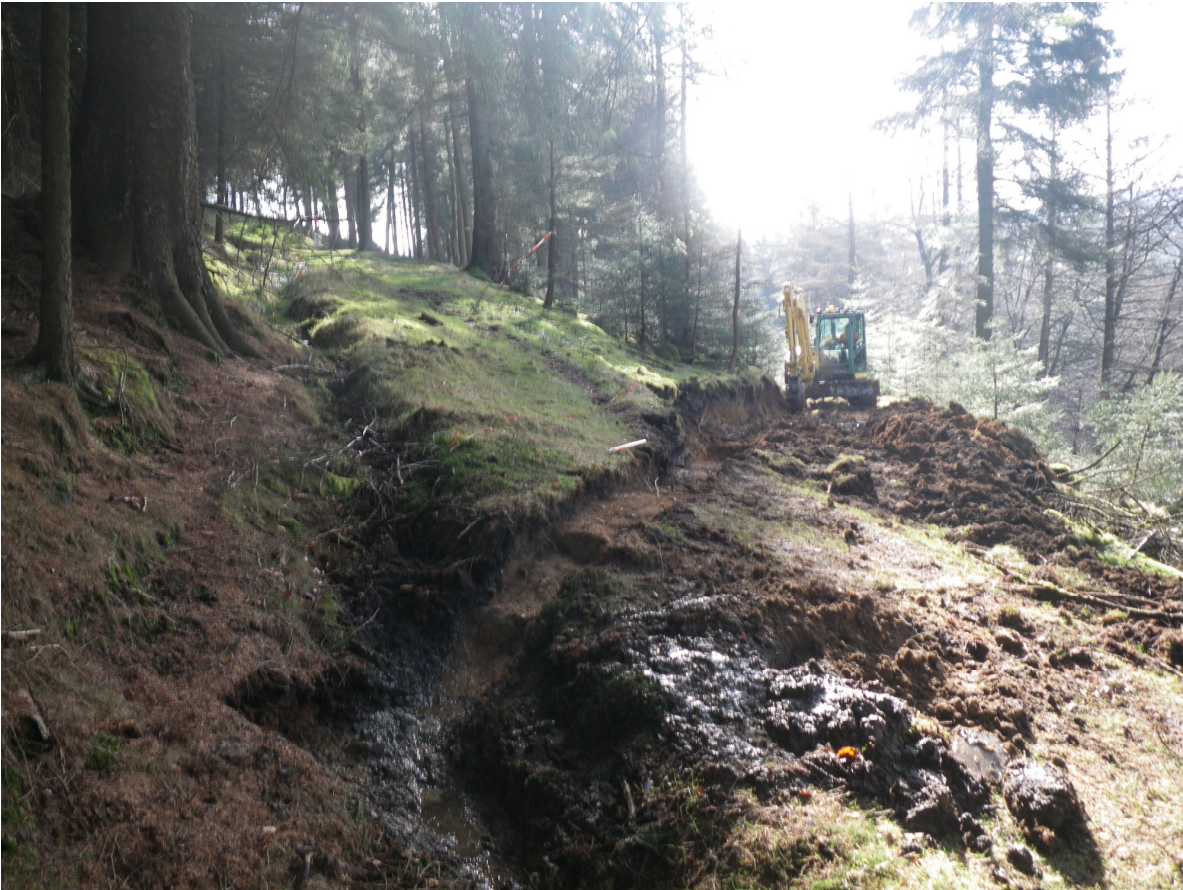
Plate 1: Working shot

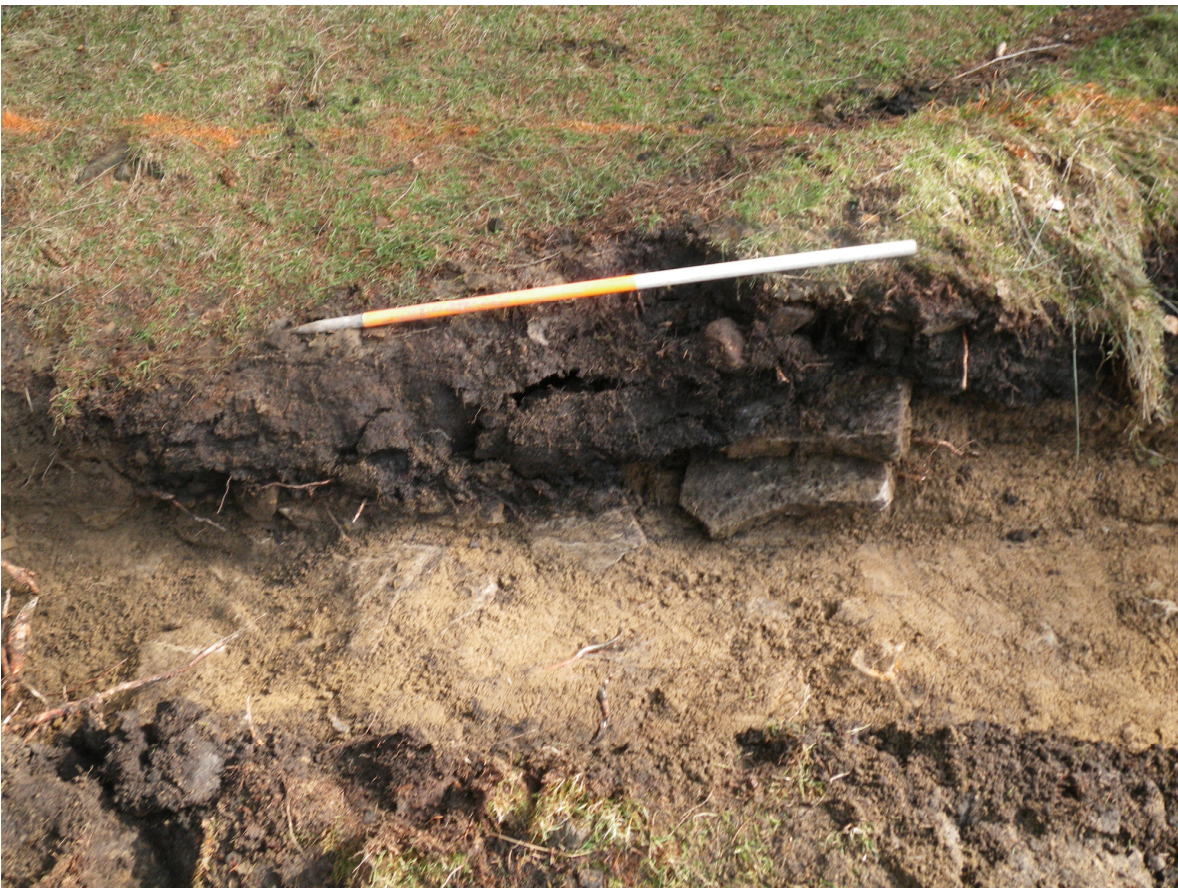
Plate 2: Stones on line of 'Dr Talbotes Gate'

The path in this area comprises rounded gritstone slabs set into the ground on end and bordered by narrower, sharp-cornered slabs standing slightly proud of the path itself. The paved path continues to the north-west, into Charlesworth parish. To the south-east the paving disappears as the path approaches a boggy confluence of gullies above a clough. The line of the trackway cannot be traced further east, but stone revetment and wall footings may have been built to support the route as it approached a clough. The projected line of the trackway would join it with the present Snake Pass. It is possible that the projected section was destroyed by the
