**ST PETER'S CHURCH  
GOLDHANGER  
ESSEX**

**ARCHAEOLOGICAL MONITORING OF  
GROUNDWORKS FOR A NORTH EXTENSION**

**December 2010**

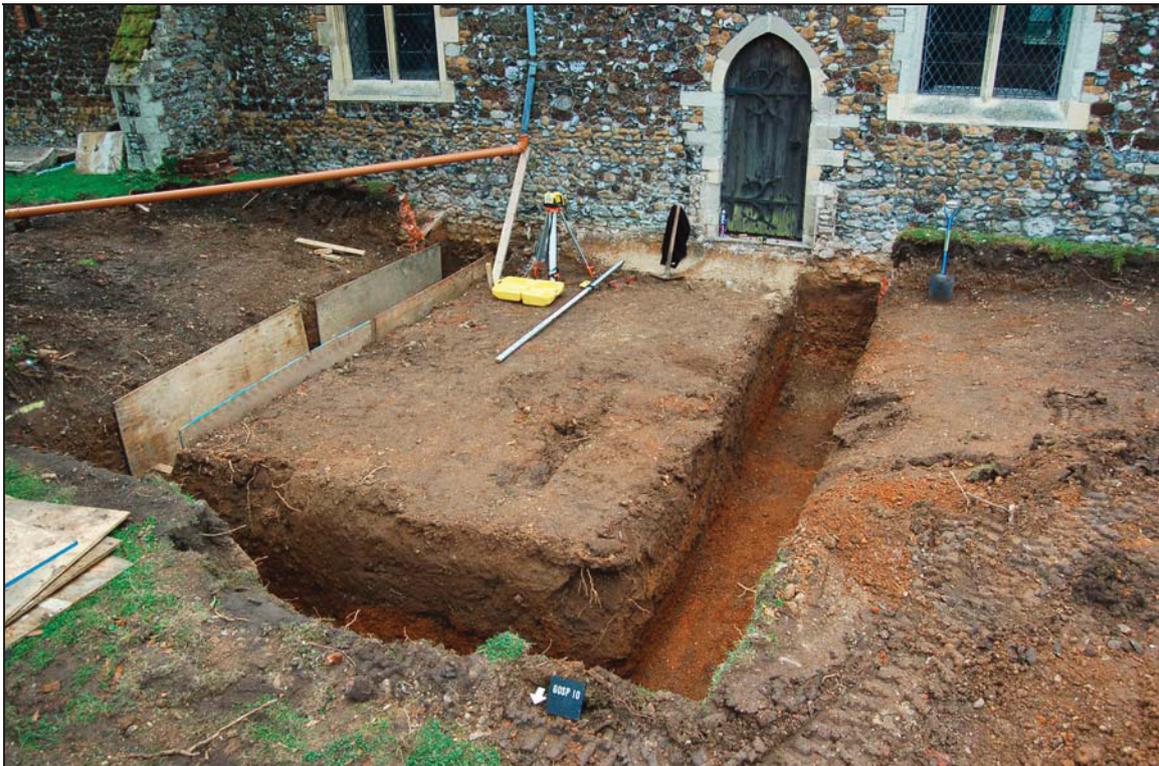
The area of the extension (5.8m x 6.8m) was initially reduced by 1m to form a flat working area. 1m-wide wall foundation trenches were then dug around the edges to a maximum depth of 2m from ground level (plate 1). The trench revealed a thin (0.2m) layer of brownish-grey sandy silt topsoil (context 1) over a deep (0.66m) dark brown gravelly silty sand soil layer containing fragments of mortar and tile (context 2) likely to date from a church refurbishment in 1853. Below this was an earlier graveyard soil (context 3) of similar depth. It was in this layer that the graves were found, between 1.1m below ground level and the top of the hard orange gravel natural at 1.6m (i.e. between 3½ and 5½ ft). The graves were neatly laid-out in rows on a west to east alignment, as would be expected (fig. 1). Most were adults (plate 2), buried with their spouses, but there were also many adolescents and children and some babies, who were always buried closest to the church. The positions of the graves were marked on a plan and those bones within the trench were lifted and bagged individually for re-burial at a later date. Where possible, graves were left undisturbed.

Plate 1 Foundation trench for north extension viewed to south

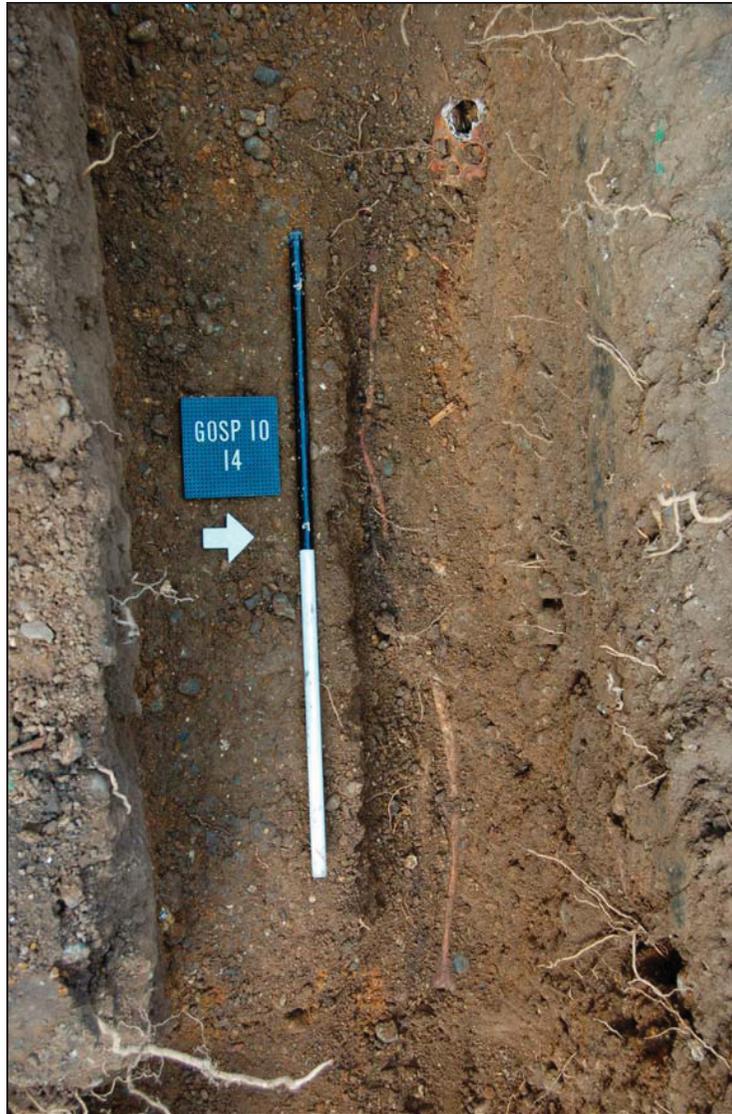
Plate 2 Skeleton in grave 14 in north part of foundation trench

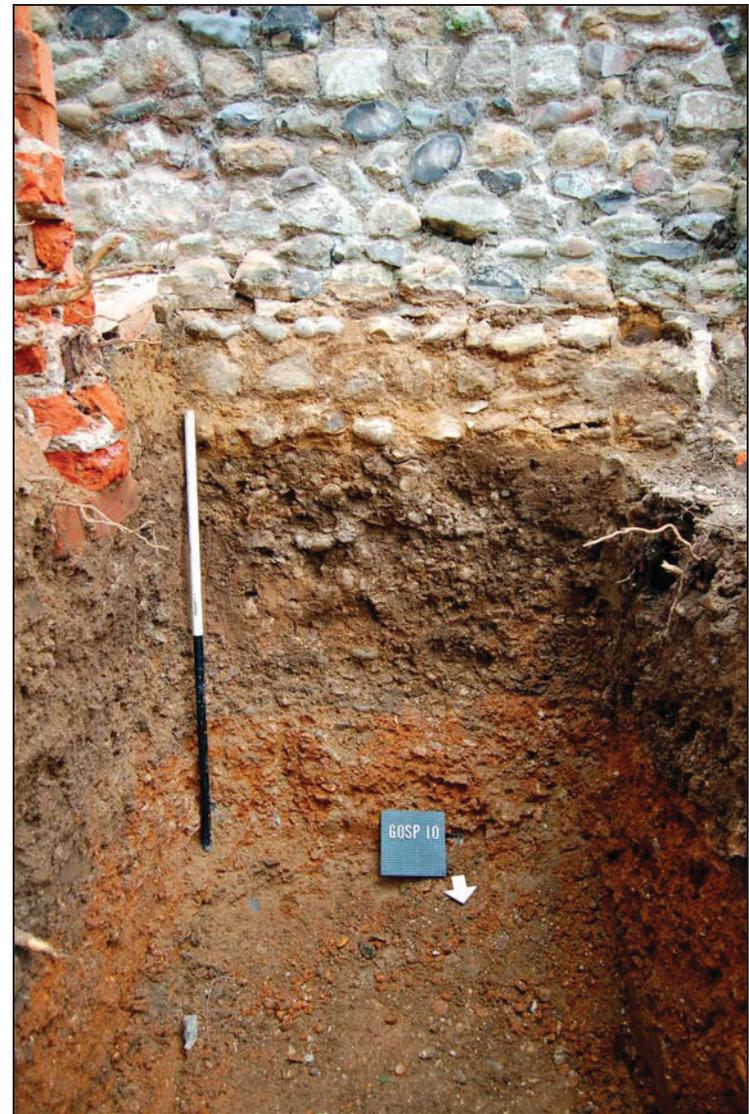
The church footings were examined during the course of the monitoring works and found to be quite shallow. They were slightly stepped out from the church and comprised three courses of flint and squared limestone bonded in a light yellow lime mortar (plate 3).

Plate 3 Church footings
