THE FOX INN Willian, Herts

Archaeological Monitoring Report

Prepared on behalf of Anglia County Inns Ltd

Report no. 293

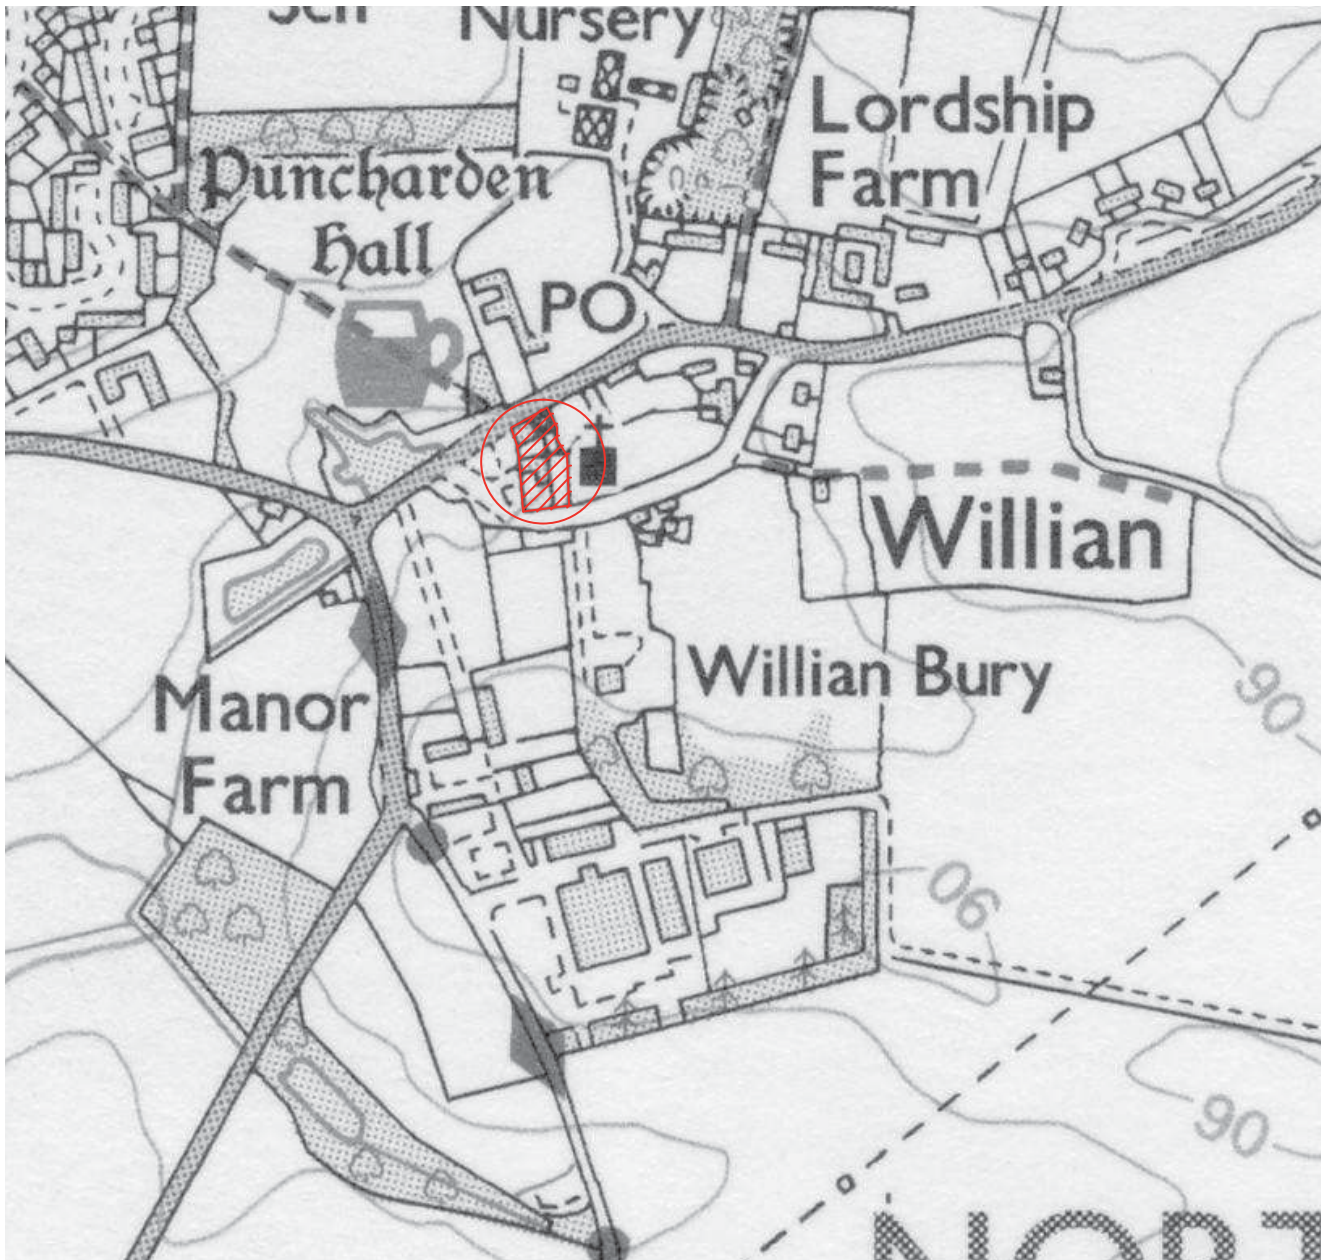
Figure 2

2.6 The footings trenches for the new extension measured approximately 0.45m in width and varied from 1.0m in depth to approximately 1.9m in the eastern corner where some subsidence had taken place (Figure 2).

2.9 A single soakaway, measuring approximately 2.5m square by 2.5m deep, was excavated on the south-east of the new extension (Figure 2).

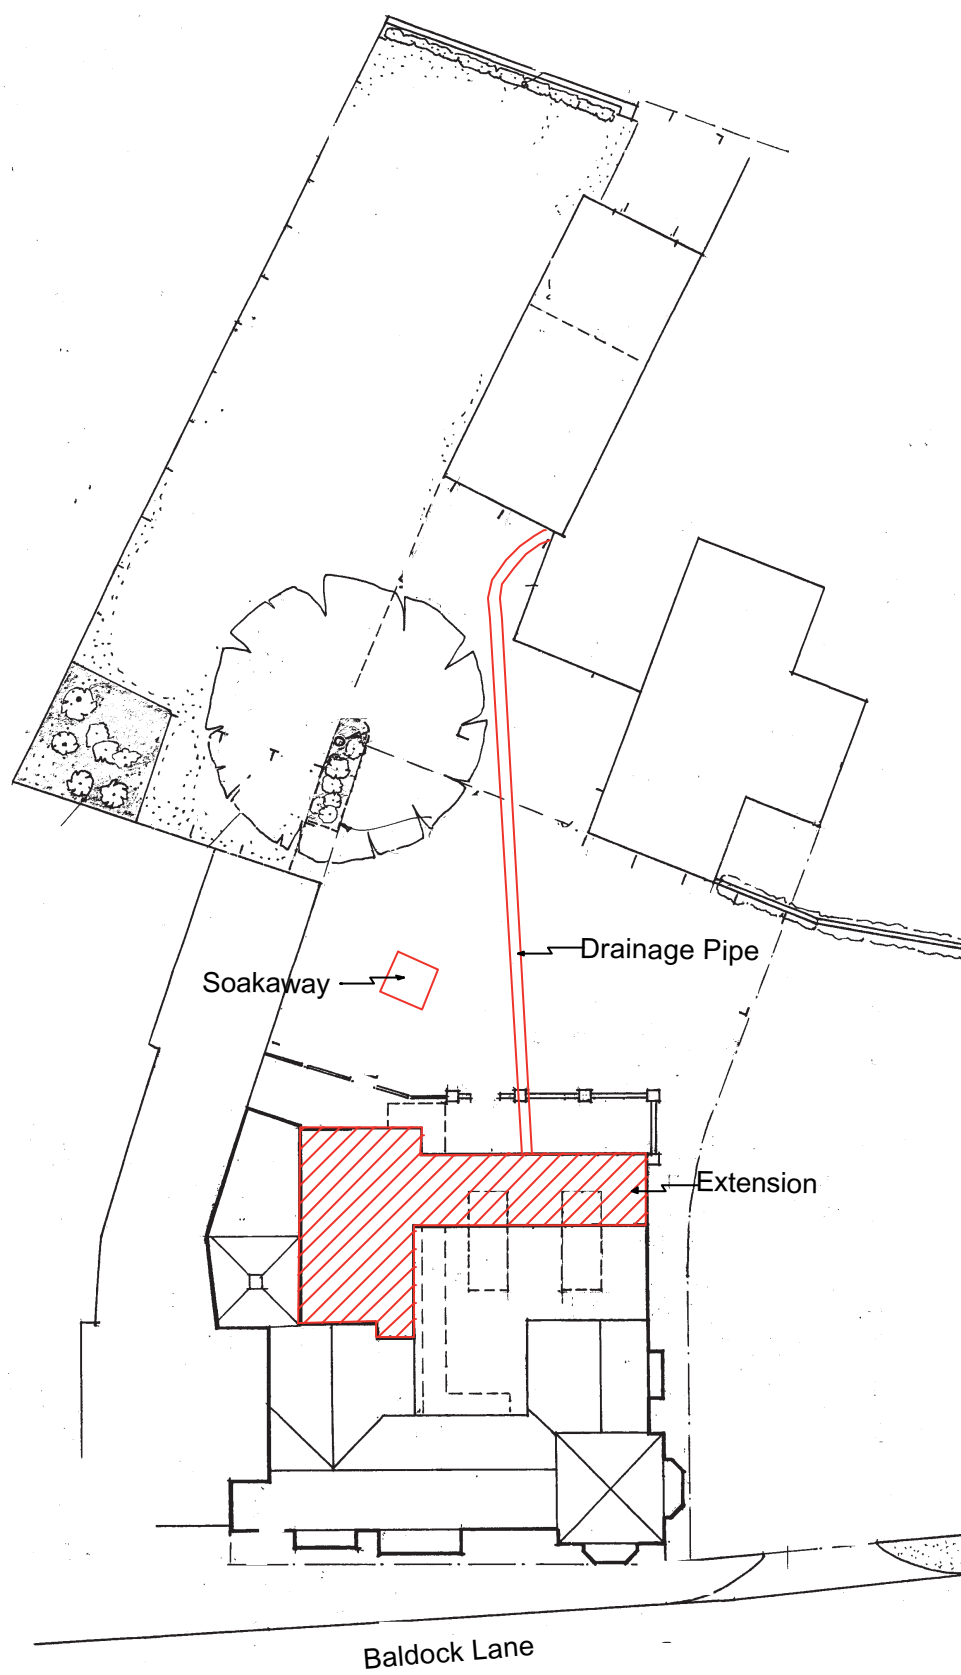
2.10 At a depth of approximately 1.1m in the north-west facing section of the soakaway 4 brick courses were observed indicating the base of a wall of post medieval date.

Site Layout
