ST. COLUMBA'S COLLEGE, ST. ALBANS, HERTS.

Report No. 376

Synopsis: In response to a condition on the planning permission for the construction of a car park extension at St. Columba's College, St. Albans, the Heritage Network was commissioned by F T Gearing Landscape Services Ltd., to undertake the archaeological monitoring of the development groundworks.

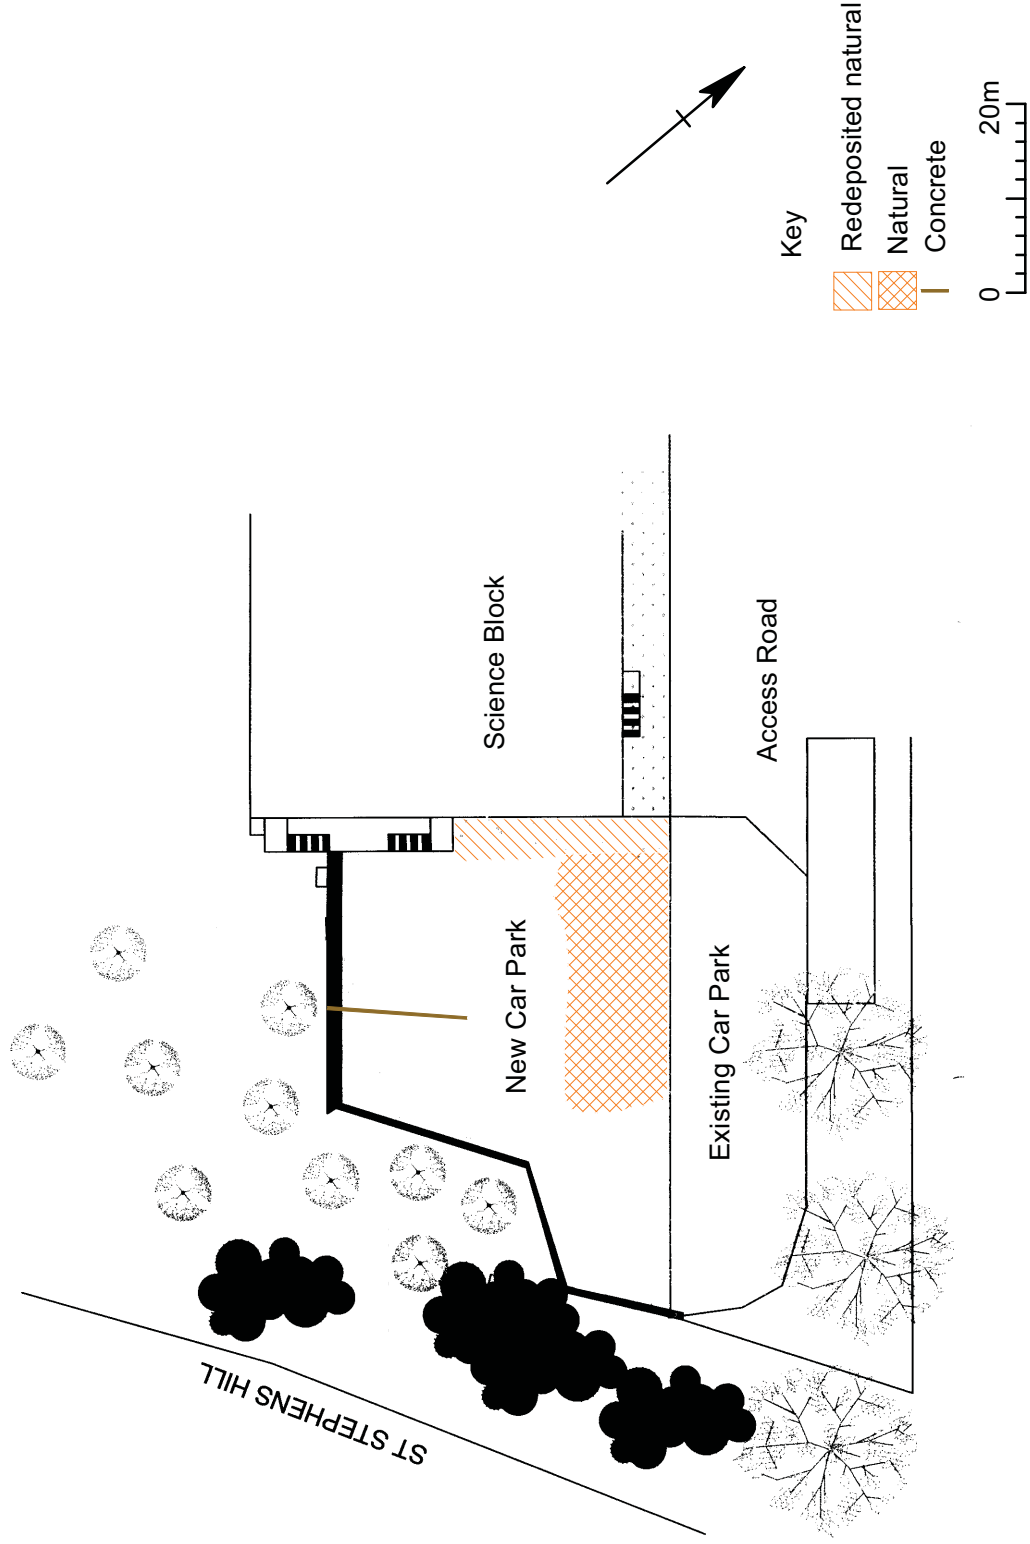
Site Layout

The natural geology was exposed in approximately 20% of the stripped area and was confined to a single patch on the steepest part of the gradient between the study area and the existing car park (Plate 1a). The redeposited clay was located in an area immediately adjacent to the science block (Plate 1b), (Figure 2).

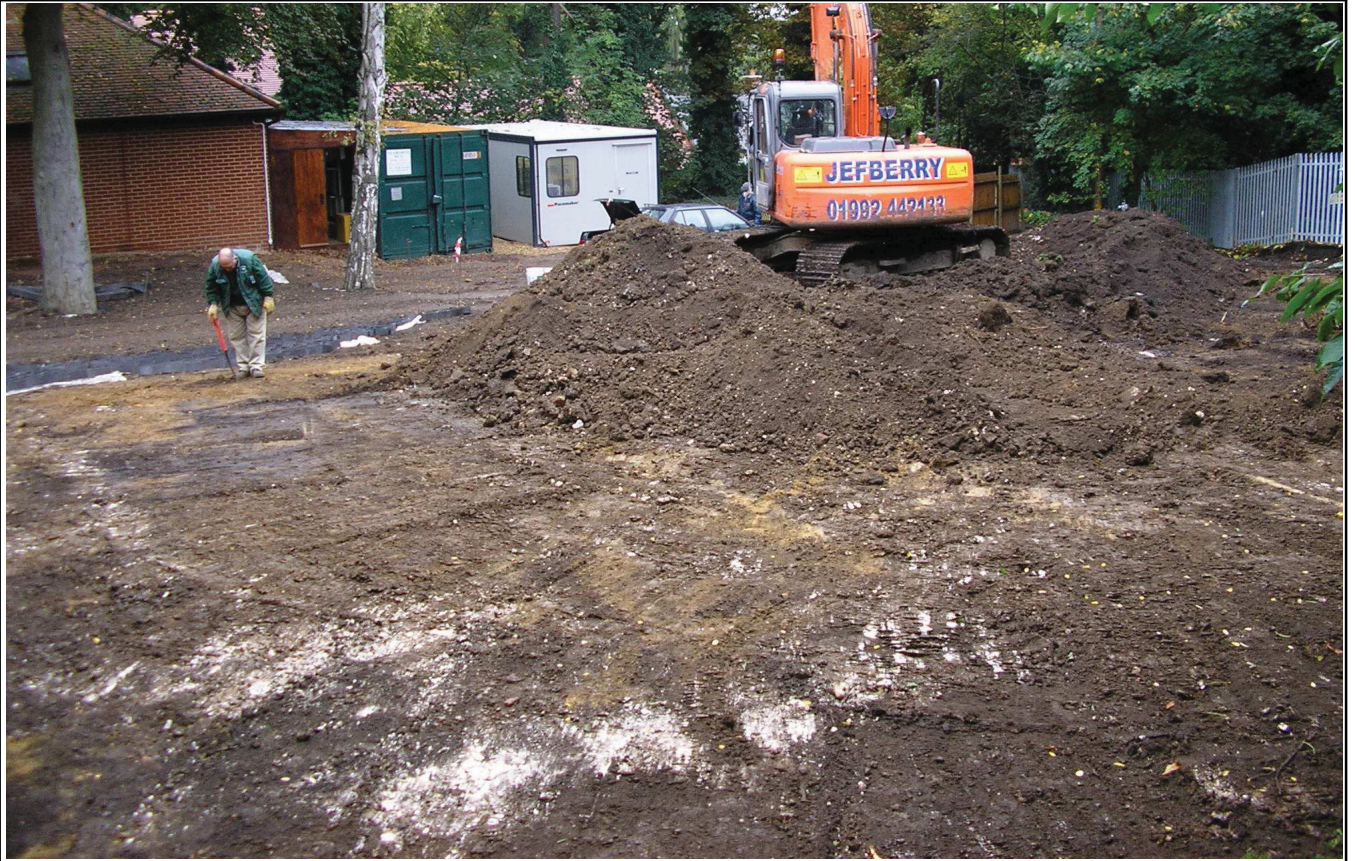
Plate 1a: Ground reduction looking east

The observed stratigraphy of the site consisted of 0.1m of very dark grey (10YR 3/1) silty clay topsoil overlying 0.45 – 0.5m of made ground. The natural geology is strong brown (7.5YR 4/6) clay with frequent flints.

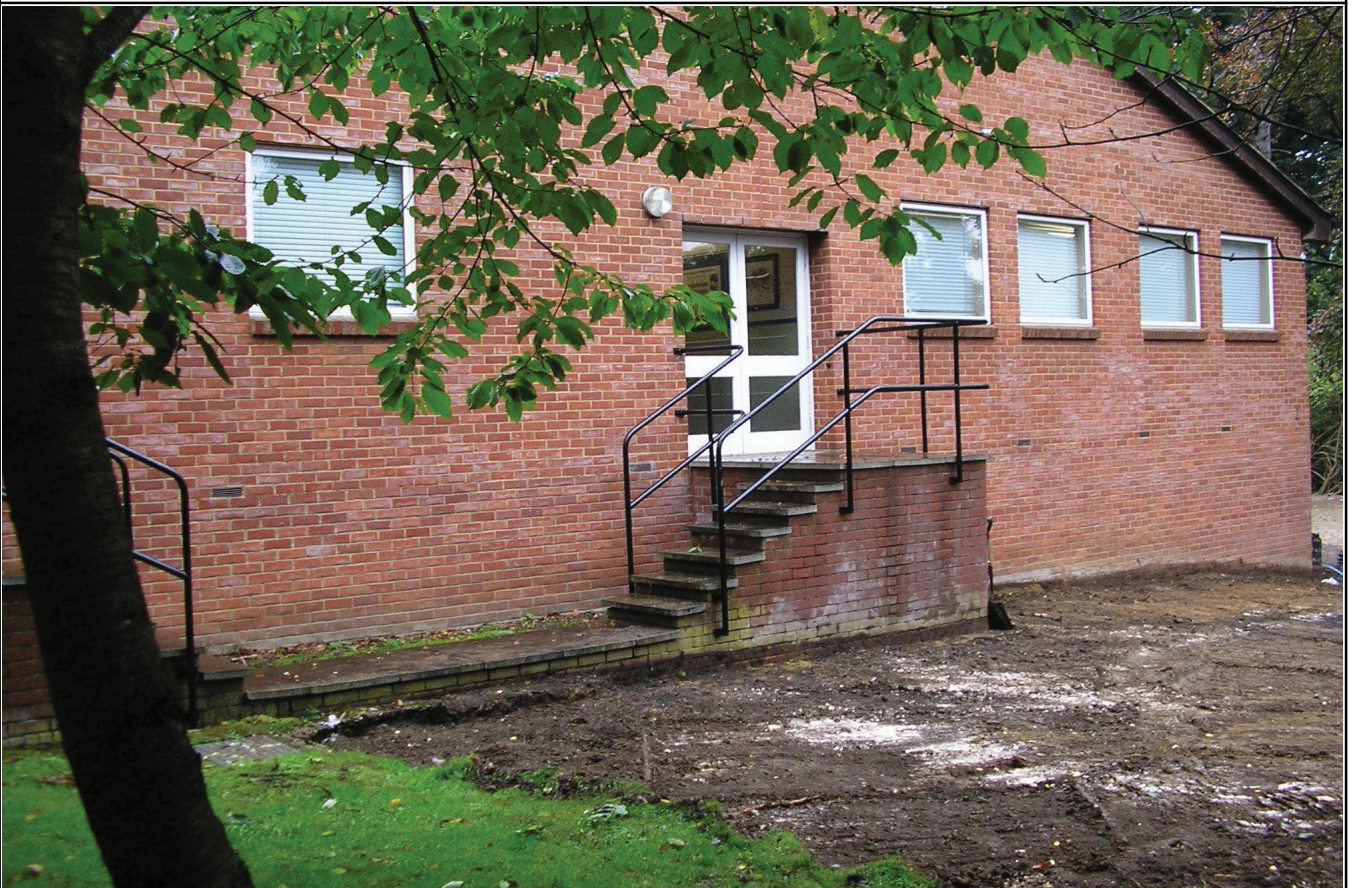
Plate 1b: Ground reduction looking north

The topography of the site appears to have been formed partly by the redeposition of the natural clay removed during the construction of the adjacent science block and partly by the addition of imported material.
