# Kentish ragstone ashlar masonry in London

# Tim Tatton-Brown

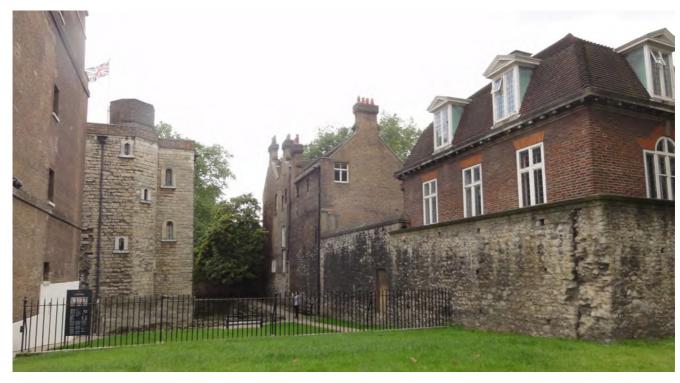
Fig. 1: the Jewel Tower, all the stone is Kentish ragstone, except the Portland stone window and door openings. View from the east (left); details of plinth and tower external face (centre) and details of the ragstone ashlar quoin and face on the north-west side (right).

Alas, the clock tower was demolished in 1698, but we know that it was about 25 feet (7.6m) square and 60 feet (18.3m) high, and there are several fine drawings (the most famous by Hollar) of it, before it was pulled down. On the other hand, the Jewel Tower still survives intact with its surrounding stone-lined moat. It is now a fine monument looked after by English Heritage, even if rather overshadowed by the new 1850s Palace of Westminster (Fig. 1).

beautiful ashlar masonry plinth of the tower, and the masonry walls of the moat, show the quality of masonry that Thomas Hardegrey could produce in the mid-1360s.

One can also see very good external masonry on the tower itself, while on the 'inside' faces behind (and only facing the King's garden), roughcoursed rubble is used.

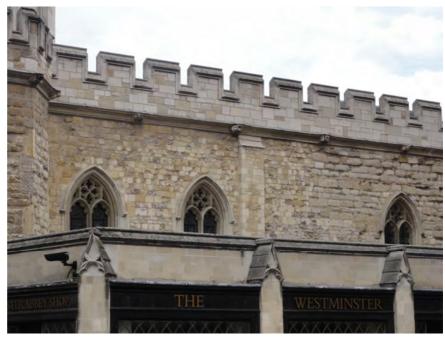
Fig. 3: west front of abbot's house showing the break in masonry between the Jerusalem Chamber and College Hall; the Kentish ragstone is visible (right)

If one goes round to the west front of Westminster Abbey, now faced almost entirely in post-medieval Portland stone, though with a little original Reigate stone still visible, it is possible to see the upper walls of the abbot's house on your right, above the modern Abbey Book and Gift shop<sup>11</sup> (Fig. 3). Remarkably this was built from c. 1365-70 for Abbot Nicholas Litlyngton at exactly the same time as the Jewel Tower. The construction of the grand house for the abbot probably started with the abbot's great chamber (now called the Jerusalem Chamber) on the north. Its west wall (and windows) can be seen above the low modern shop roof, and the facing is done with rather rough masonry using Caen stone and rubble (perhaps reused). However, immediately to the south of this, one can see that the continuing and neighbouring wall of the abbot's great

hall (now College Hall) is made with Kentish ragstone ashlar masonry, so the abbot was using the services of Thomas Hardegrey, or one of his competitors, as well.

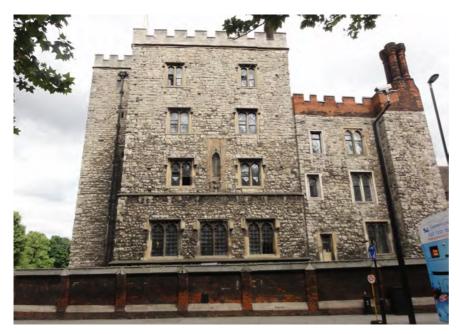
Fig. 4: west side of the Lollards Tower at Lambeth Palace

During the 15th century, the quarrying and carving of Kentish ragstone reached a new high point, and there are several places in London where one can still see fine examples of this. On the other side of the Thames at Lambeth Palace, for example, it is possible to see (over the wall from the very busy Lambeth Palace Road) the west side of the fivestoreyed Lollards' Tower, also faced in Kentish ragstone (Fig. 4). The lower three storeys were built by Archbishop Chichele in 1435, and then the tower was heightened in c. 1490 by Archbishop Morton. The break between the two phases of masonry (and the use of red brick in the side walls of the later phase of work) is still visible. 14 Another fine early 15th-century building with high quality ragstone masonry is the Guildhall in the City (Fig. 5). 15 Though heavily restored, one can still see this from the courtyard to the left of George Dance's 1788 porch.

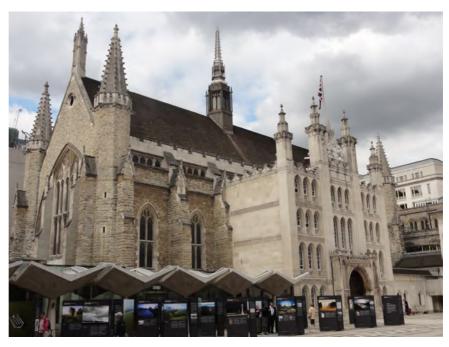
Fig. 5: the London Guildhall with Kentish ragstone to the left of the 18th-century porch

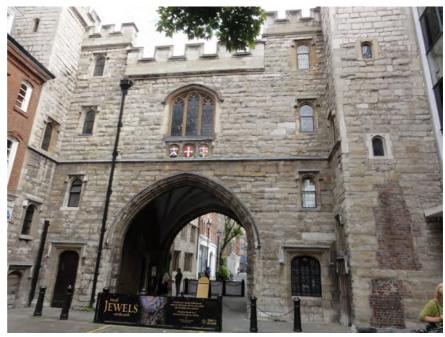
Fig. 6: gatehouse of St John's Priory, Clerkenwell

reached in the reign of King Henry VII. In London, perhaps the best example of this to be seen easily, is the wonderful 1504 gatehouse to St. John's Priory in Clerkenwell (Fig. 6). 16 However, if one returns to Westminster Abbey, and goes to the extreme eastern end of the Abbev opposite the main entrance to Parliament, one can peer through the railings at the plinth (really a Romantype podium!) of the Henry VII Chapel (Fig. 7). This was built in 1503, and where the faces of the ragstone blocks, with their very fine mortar joints, are not eroded, one can still see the beautifully cut original faces of the blocks with a 'drafted margin' around the end of each stone.

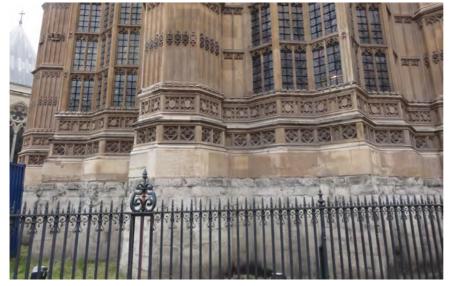
Fig. 7: plinth of the Henry VII Chapel, Westminster Abbey (left) with the detail of the ragstone masonry (right)
