**Baydon Valley Farm, Manor Lane,  
Baydon, Wiltshire**

**Archaeological Evaluation**

**Site Code: BVF14/258**

**January 2015**

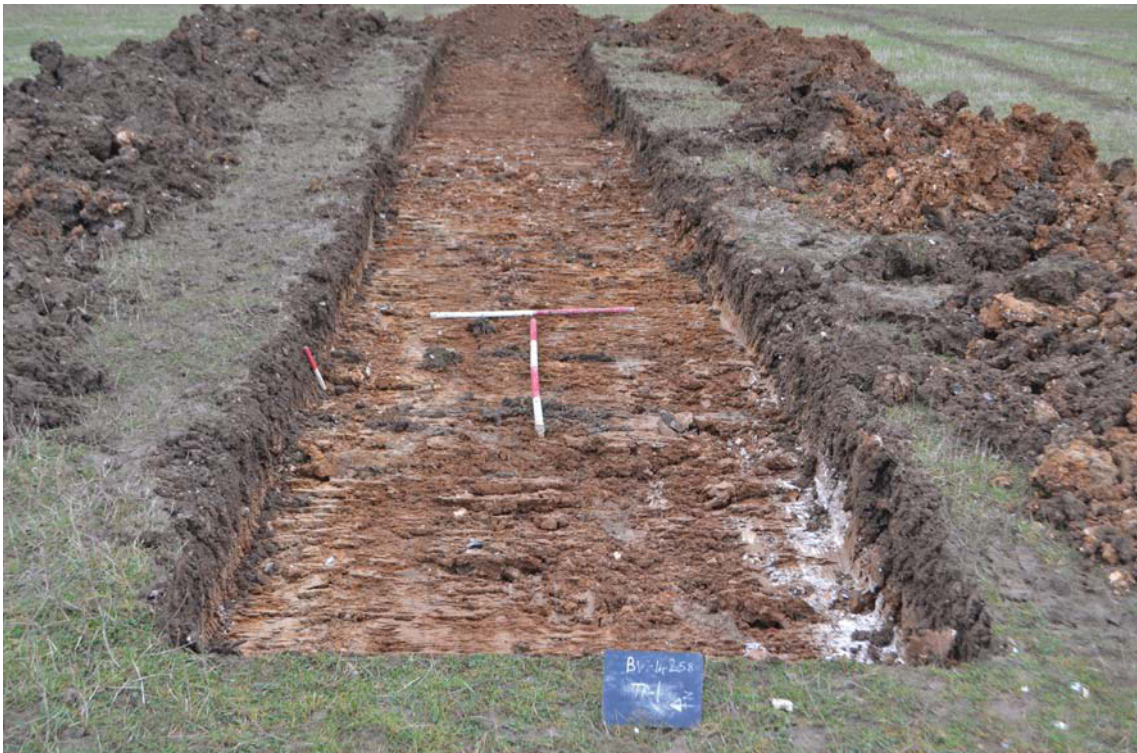
Trench 1 was aligned WSW - ENE and was 19.60m long and 0.30m deep. The stratigraphy consisted of 0.27m of topsoil overlying natural geology comprised of clay with flints. No finds were recovered.

Plate 1. Trench 1, looking east, Scales: horizontal 2m and 1m, vertical 0.1m.

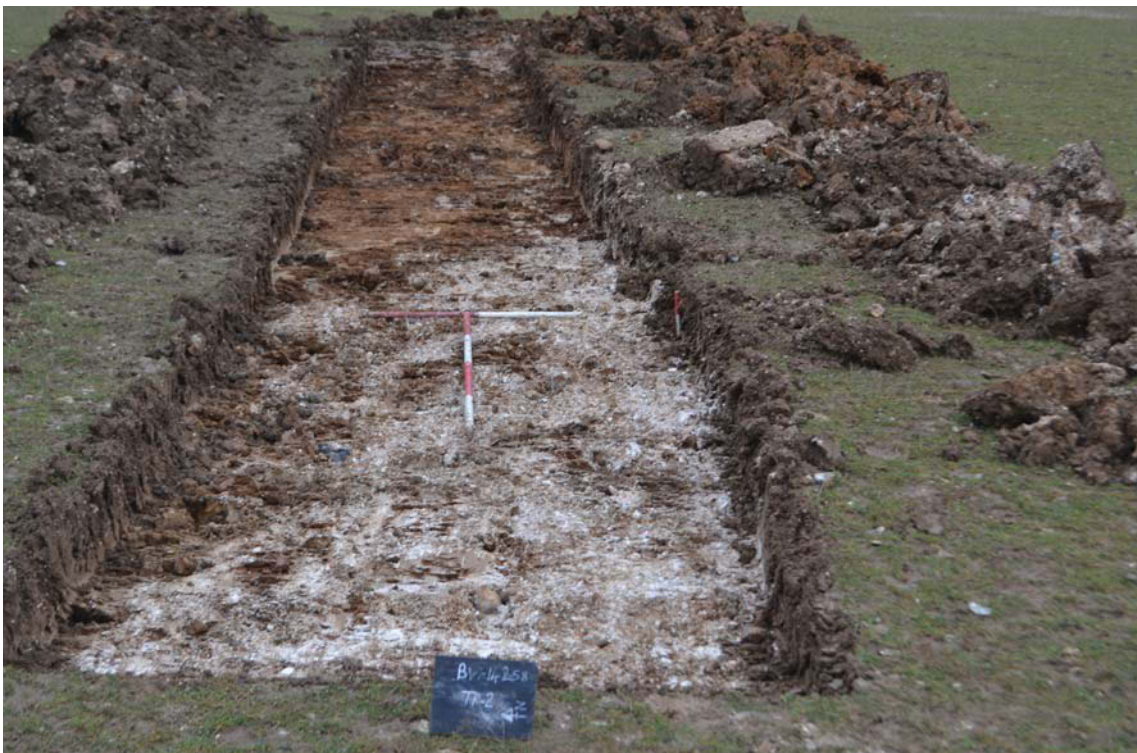
Trench 2 was aligned WSW - ENE and was 19.70m long and 0.29m deep. The stratigraphy consisted of 0.29m of topsoil overlying natural geology comprised of chalk and clay. No finds were recovered.

Plate 2. Trench 2, looking east, Scales: horizontal 2m and 1m, vertical 0.1m.

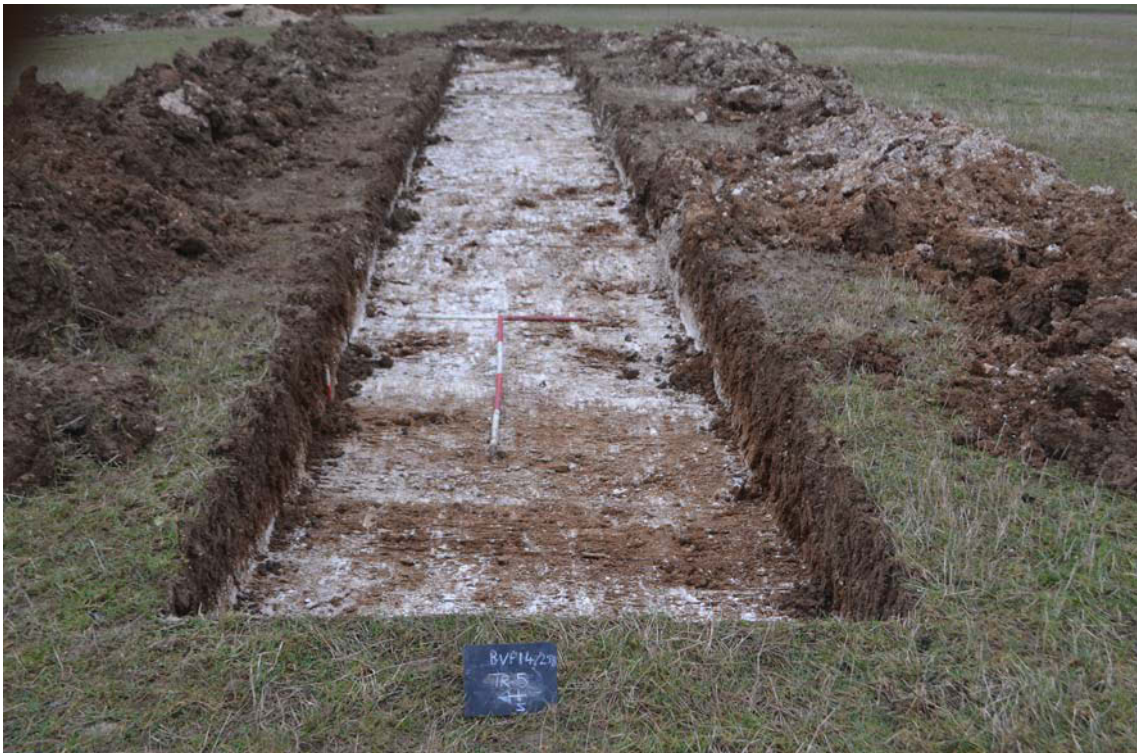
Trench 5 was aligned WSW - ENE and was 19.50m long and 0.24m deep. The stratigraphy consisted of 0.24m of topsoil overlying natural chalk geology. A possible posthole was located at the western end of the trench but upon investigation it was considered to be a natural patch of clay in the chalk. No finds were recovered.

Plate 3. Trench 5, looking east, Scales: horizontal 2m and 1m, vertical 0.1m.

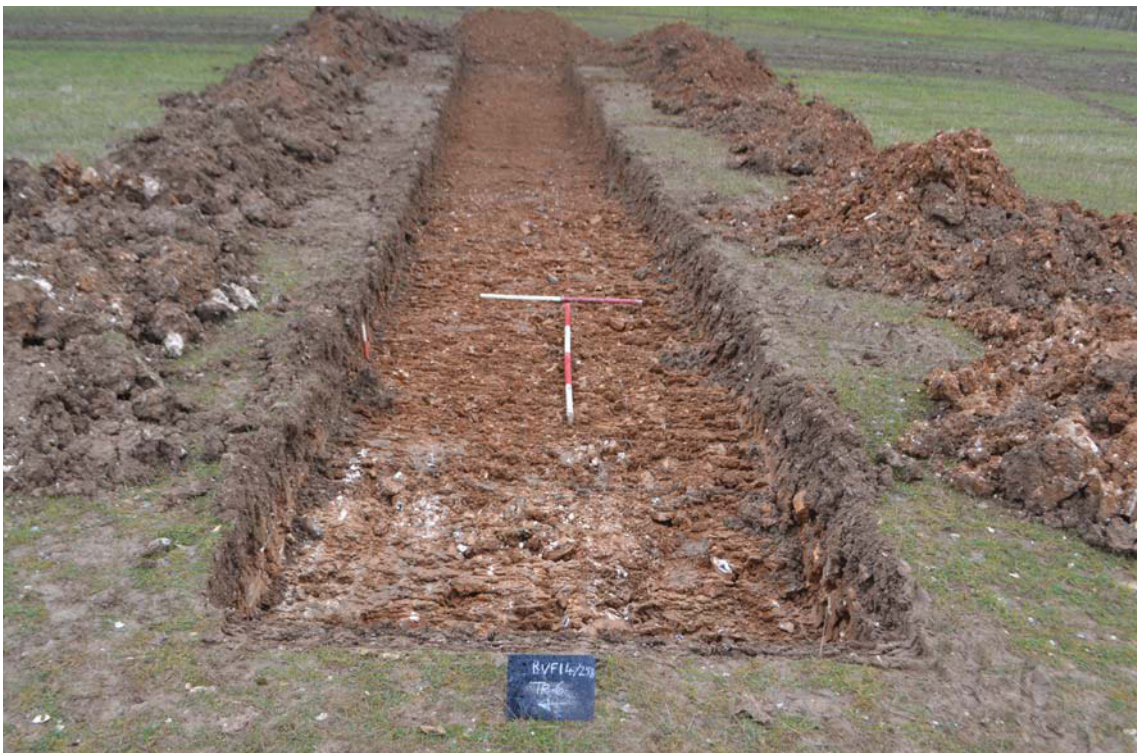
Trench 6 was aligned WSW - ENE and was 19.65m long and 0.24m deep. The stratigraphy consisted of 0.24m of topsoil overlying natural clay with flints geology. No finds were recovered.

Plate 4. Trench 6, looking east, Scales: horizontal 2m and 1m, vertical 0.1m.
