**Heywood Farm, Waltham Road,  
Maidenhead, Berkshire**

**Archaeological Watching Brief**

**Site Code: HFM21/29**

**June 2021**

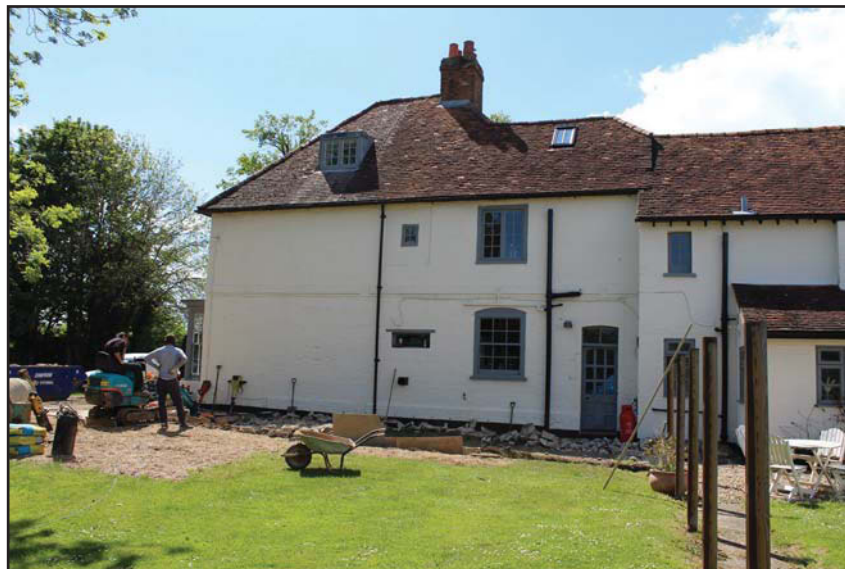
Plate 1. Footing trenches under excavation on the east side of the building, looking west.

The watching brief comprised the observation of the excavation of footing trenches for a new conservatory and extension to the existing listed building on its south-east corner (Fig. 3; Pl. 1). The groundworks affected an area of approximately 10.5m by 4m with two footing trenches, the first from the eastern wall of the building towards the east with a length of 4m and the second trench from the eastern end the first trench towards the north with a length of 10.3m. Both trenches had a width of approximately 0.60m reaching a depth between 0.95m and 1m (Figs 3 and 4).

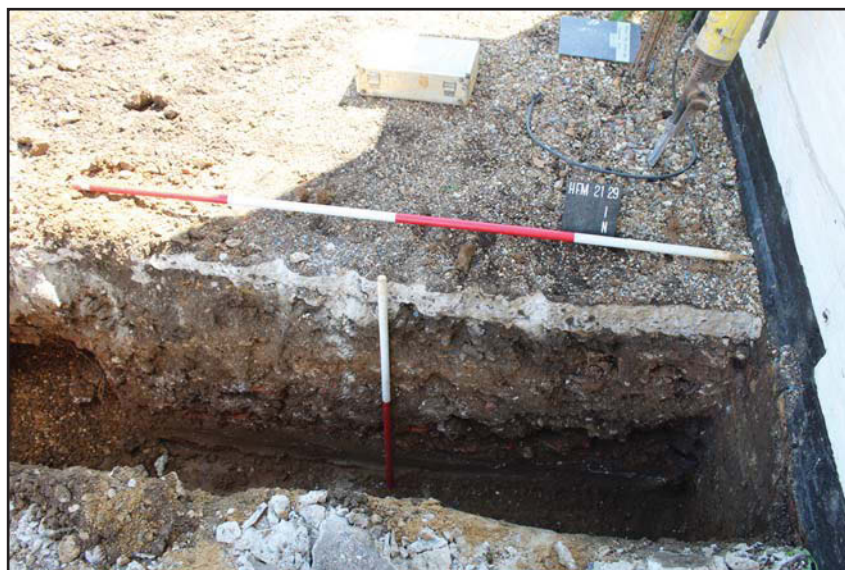
Plate 2. Representative section of footing trenches, looking south,  
Scales: 2m and 1m.

The stratigraphy observed in both trenches consisted of 0.12m of concrete slab, 0.23m of dark greyish brown clay silt with occasional small chalk and gravel inclusions (buried garden soil), above 0.25m of mid yellowish brown clay silty with frequent chalk and gravel inclusions (made ground), and between 0.20m and 0.25m of mixed made ground consisting of sand, silty clay and frequent modern brick and tile fragments with moderate chalk inclusions, overlying mid reddish brown silty clay natural geology (Fig. 4; Pl. 2). Frequent fragments of modern brick and tile were recorded in both made ground deposits along with two sherds of 'china' pottery from the bottom deposit. This stratigraphy was truncated by three service trenches, one in the southern footing trench and two in the eastern trench, all of them comprised live services of the existing building.
