Mullions, 11 Market Hill, Whitchurch, Buckinghamshire

An Archaeological Watching Brief

Site Code MMW 08/77

April 2009

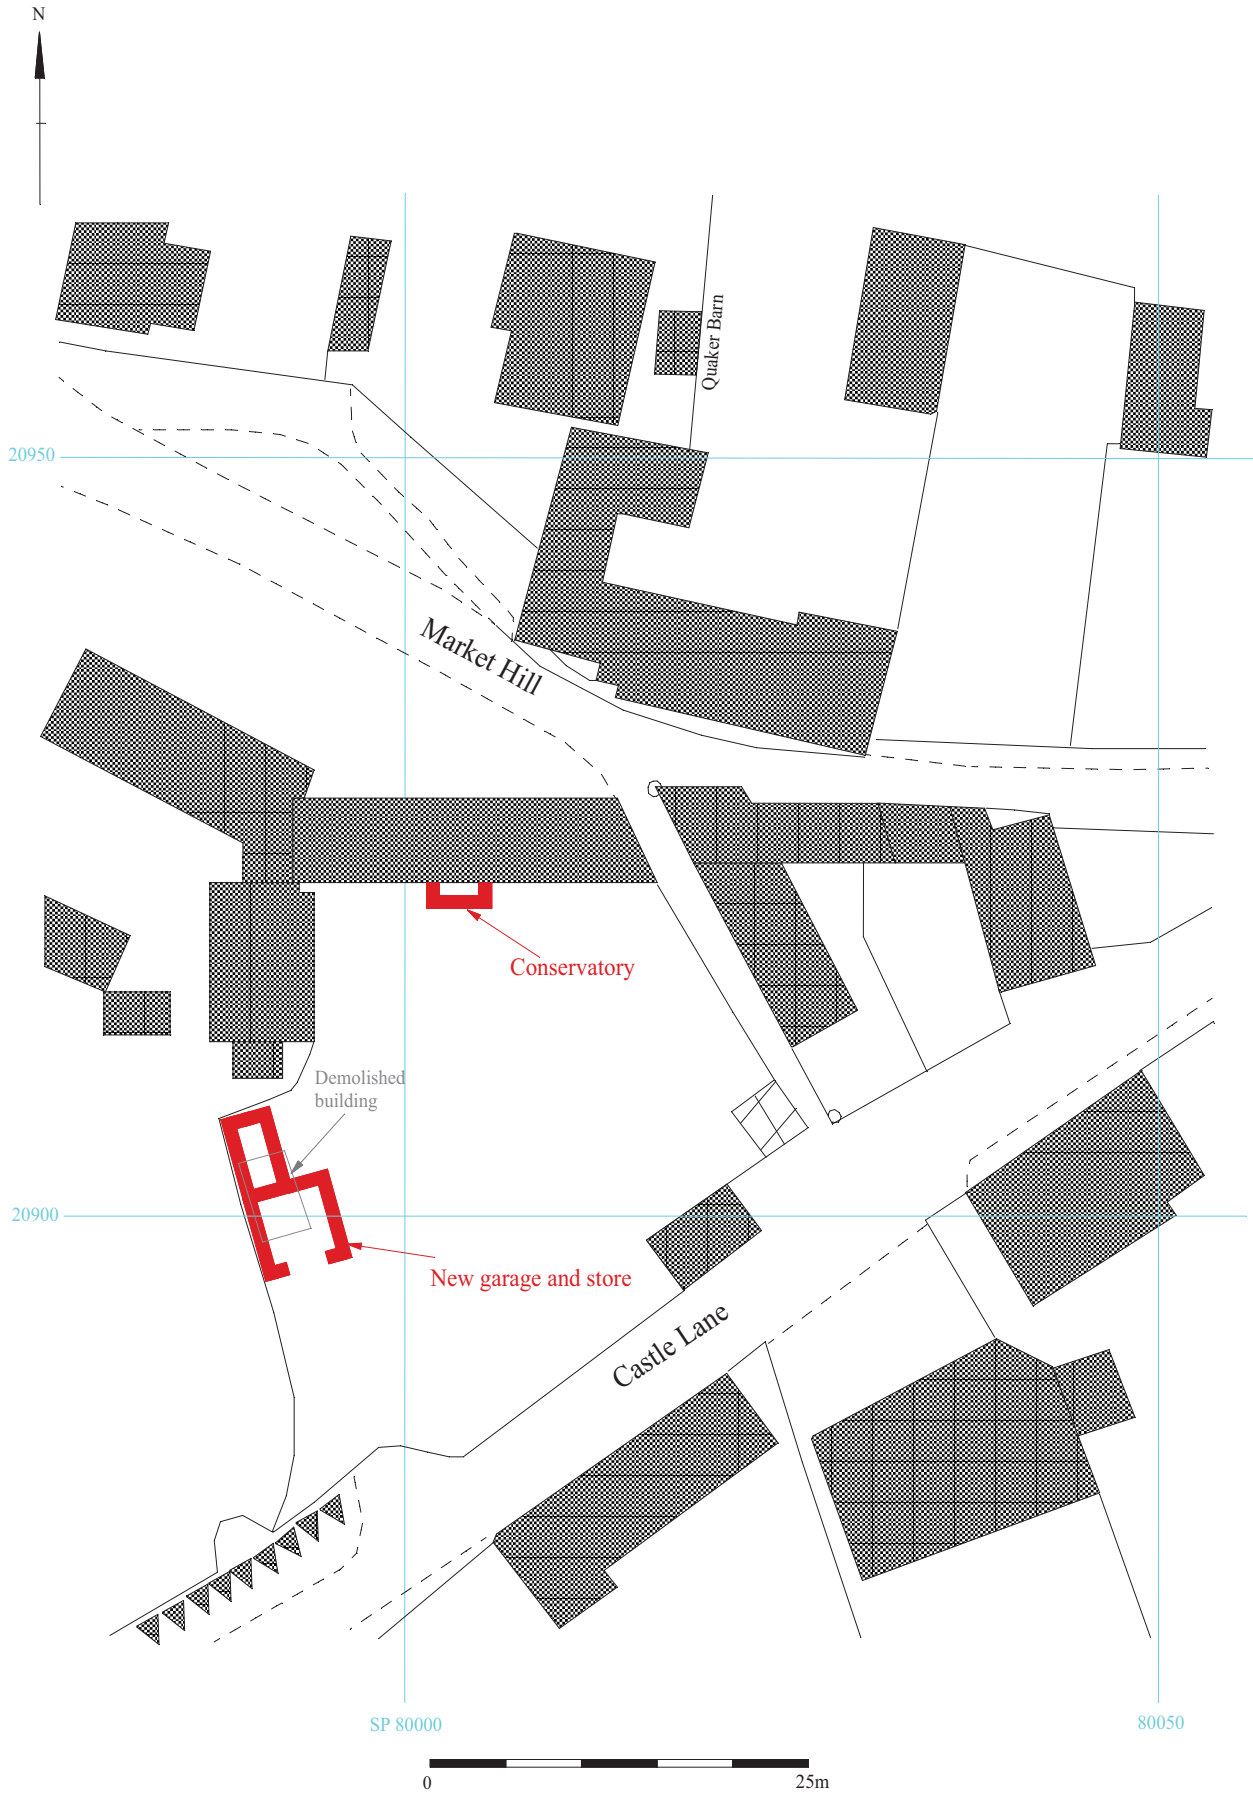
Figure 3. Location of groundworks

The trenches for the garage extended for an area of 10.6m by 6.0m, mainly over the position of the demolished garage (Fig. 3) and were 0.70m wide and 1.0m deep. The stratigraphy comprised 0.05m of concrete above 0.45m of made ground consisting of brick and tile, over natural geology which varied between limestone and grey-green sand (Fig. 4).

The foundation trenches for the new conservatory were located adjacent to the present conservatory and were 0.70m wide and 0.30m deep. The stratigraphy here comprised 0.22m of topsoil directly overlying limestone.

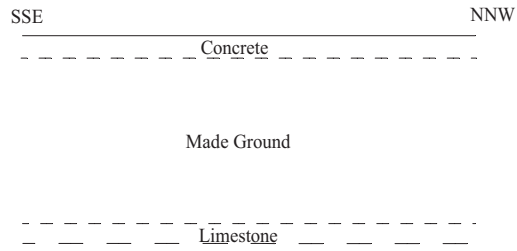
West footing of storage area

Figure 4. Representative Sections
