**18 Sherifoot Lane,
Four Oaks, Birmingham**

**An Archaeological Watching
Brief 2002**

Birmingham University Field Archaeology Unit
Project No. 1022
February 2003

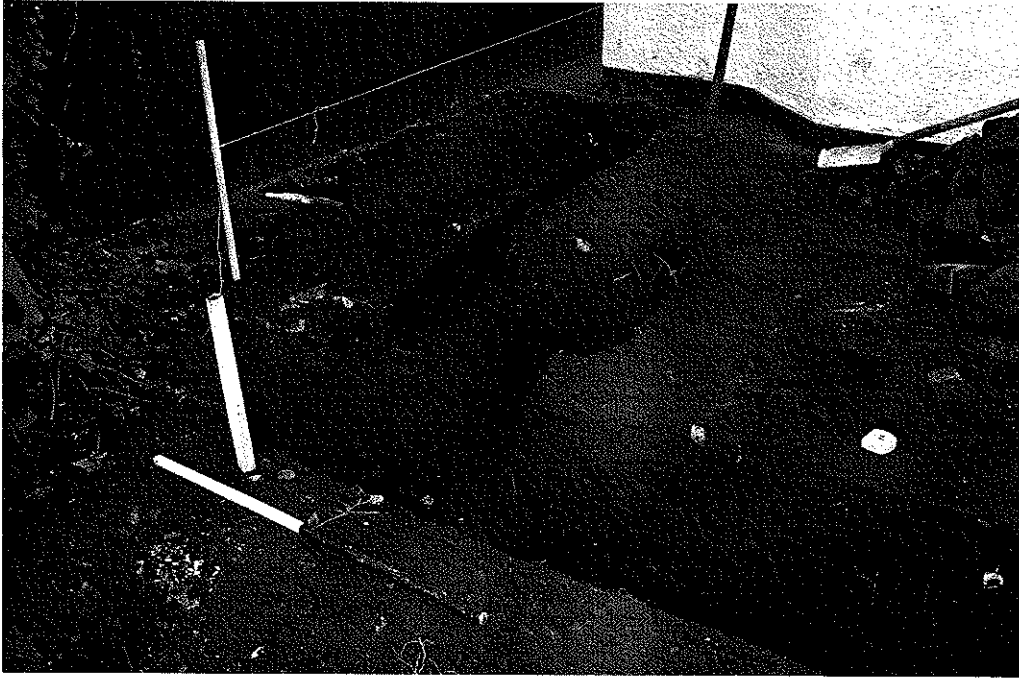
Plate 1
Western Foundation Trench (with Drain)

The natural subsoil horizon (1002) exposed by the excavation of foundation trenches was a friable red-brown sand and gravel, recorded at a depth of 0.7m below the modern ground surface. Above was a deposit of made ground (1001), comprising friable dark brown sand and silt with rounded pebbles throughout. A modern soakaway and several north-south aligned drainpipes were encountered cutting through this layer. Sealing layer 1001 was a concrete flag stoned patio over the majority of the site (1003, not illustrated). Along the southern foundation trench layer 1001 was sealed by garden topsoil (1000).
