SITE NAME
CORN EXCHANGE EXTENSION,
NORTH SQUARE DORCHESTER

SITE CODE
53552

FIELD
NOTES

Project Name:
Corn Exchange
Dorchester
Dorset

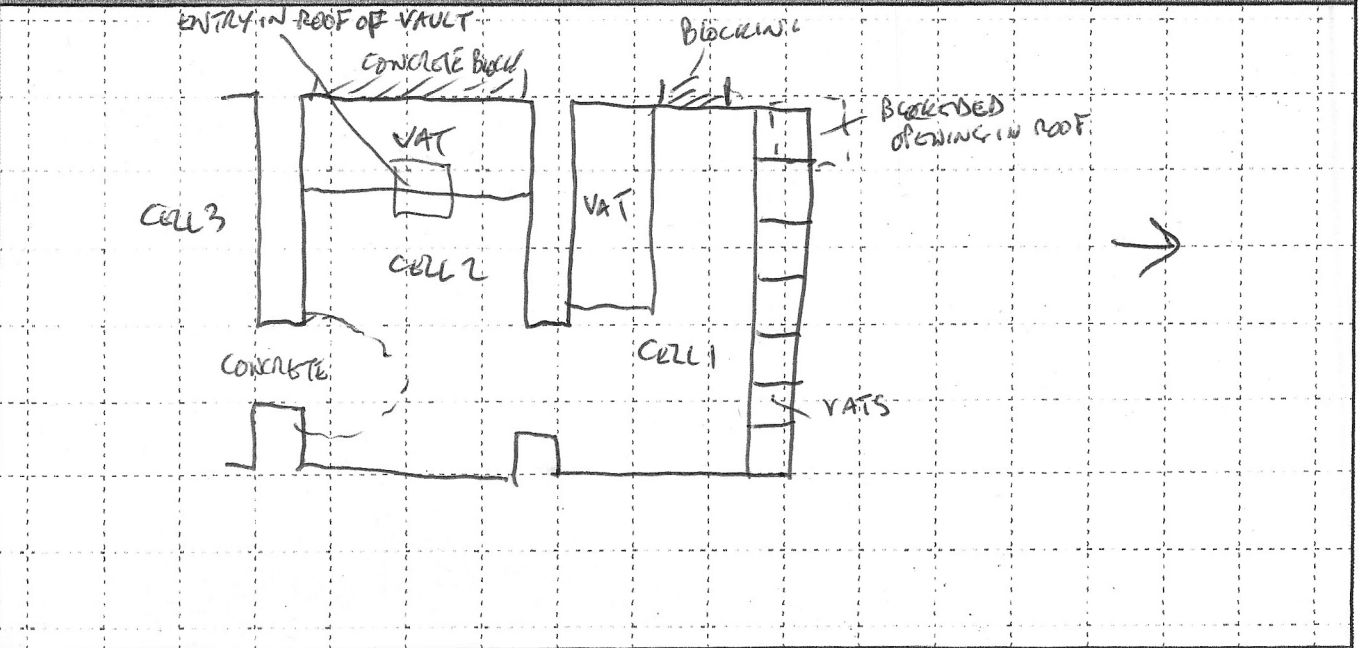
SKETCH

THE CELLARS CONSISTED OF A ROW OF BRICK-VAULTED ROOMS OF WHICH ONLY TWO NORTHERN CELLS ARE ACCESSIBLE. THE CELLS ARE NUMBERED 1-3 FROM N. CELL 3 IS BLOCKED BY CONCRETE INFILL. CELL 1 HAS A WINDOW OR WATCH IN W END BLOCKED BY CONCRETE BLOCKWORK. IN NW CORNER IS A BLOCKED OPENING IN TOP OF VAULT. ALONG N WALL IS A ROW OF 7 VATS BUILT OF BRICK WITH CEMENT RENDER. ANOTHER LARGE VAT ALONG S WALL. ALONG E WALL IS LOW TIMBER SHELF. A MODERN BRICK & CONCRETE PIER SUPPORTING VAULT IN NW PART. ROOM FULL OF RUBBLE & RUBBISH. OPENING IN E END OF S WALL LEADS TO CELL 2. MUCH OF CELL 2 IS FILLED WITH CONCRETE SPILLING OUT OF CELL 3 & A PILE OF ~~ASPHALT~~ ASPHALT & CONCRETE BENEATH MANHOLE ENTRY INTO CELLAR. ALSO PILES OF RUBBLE THROUGHOUT ROOM. THE W END OF CELL 2 HAS BEEN REBUILT IN CONCRETE BLOCKWORK. VAT ACROSS W END OF CELL 2

PLANNED LOCATION OF MANHOLE ENTRY TO CELLAR IN RELATION TO GATE PIERS.

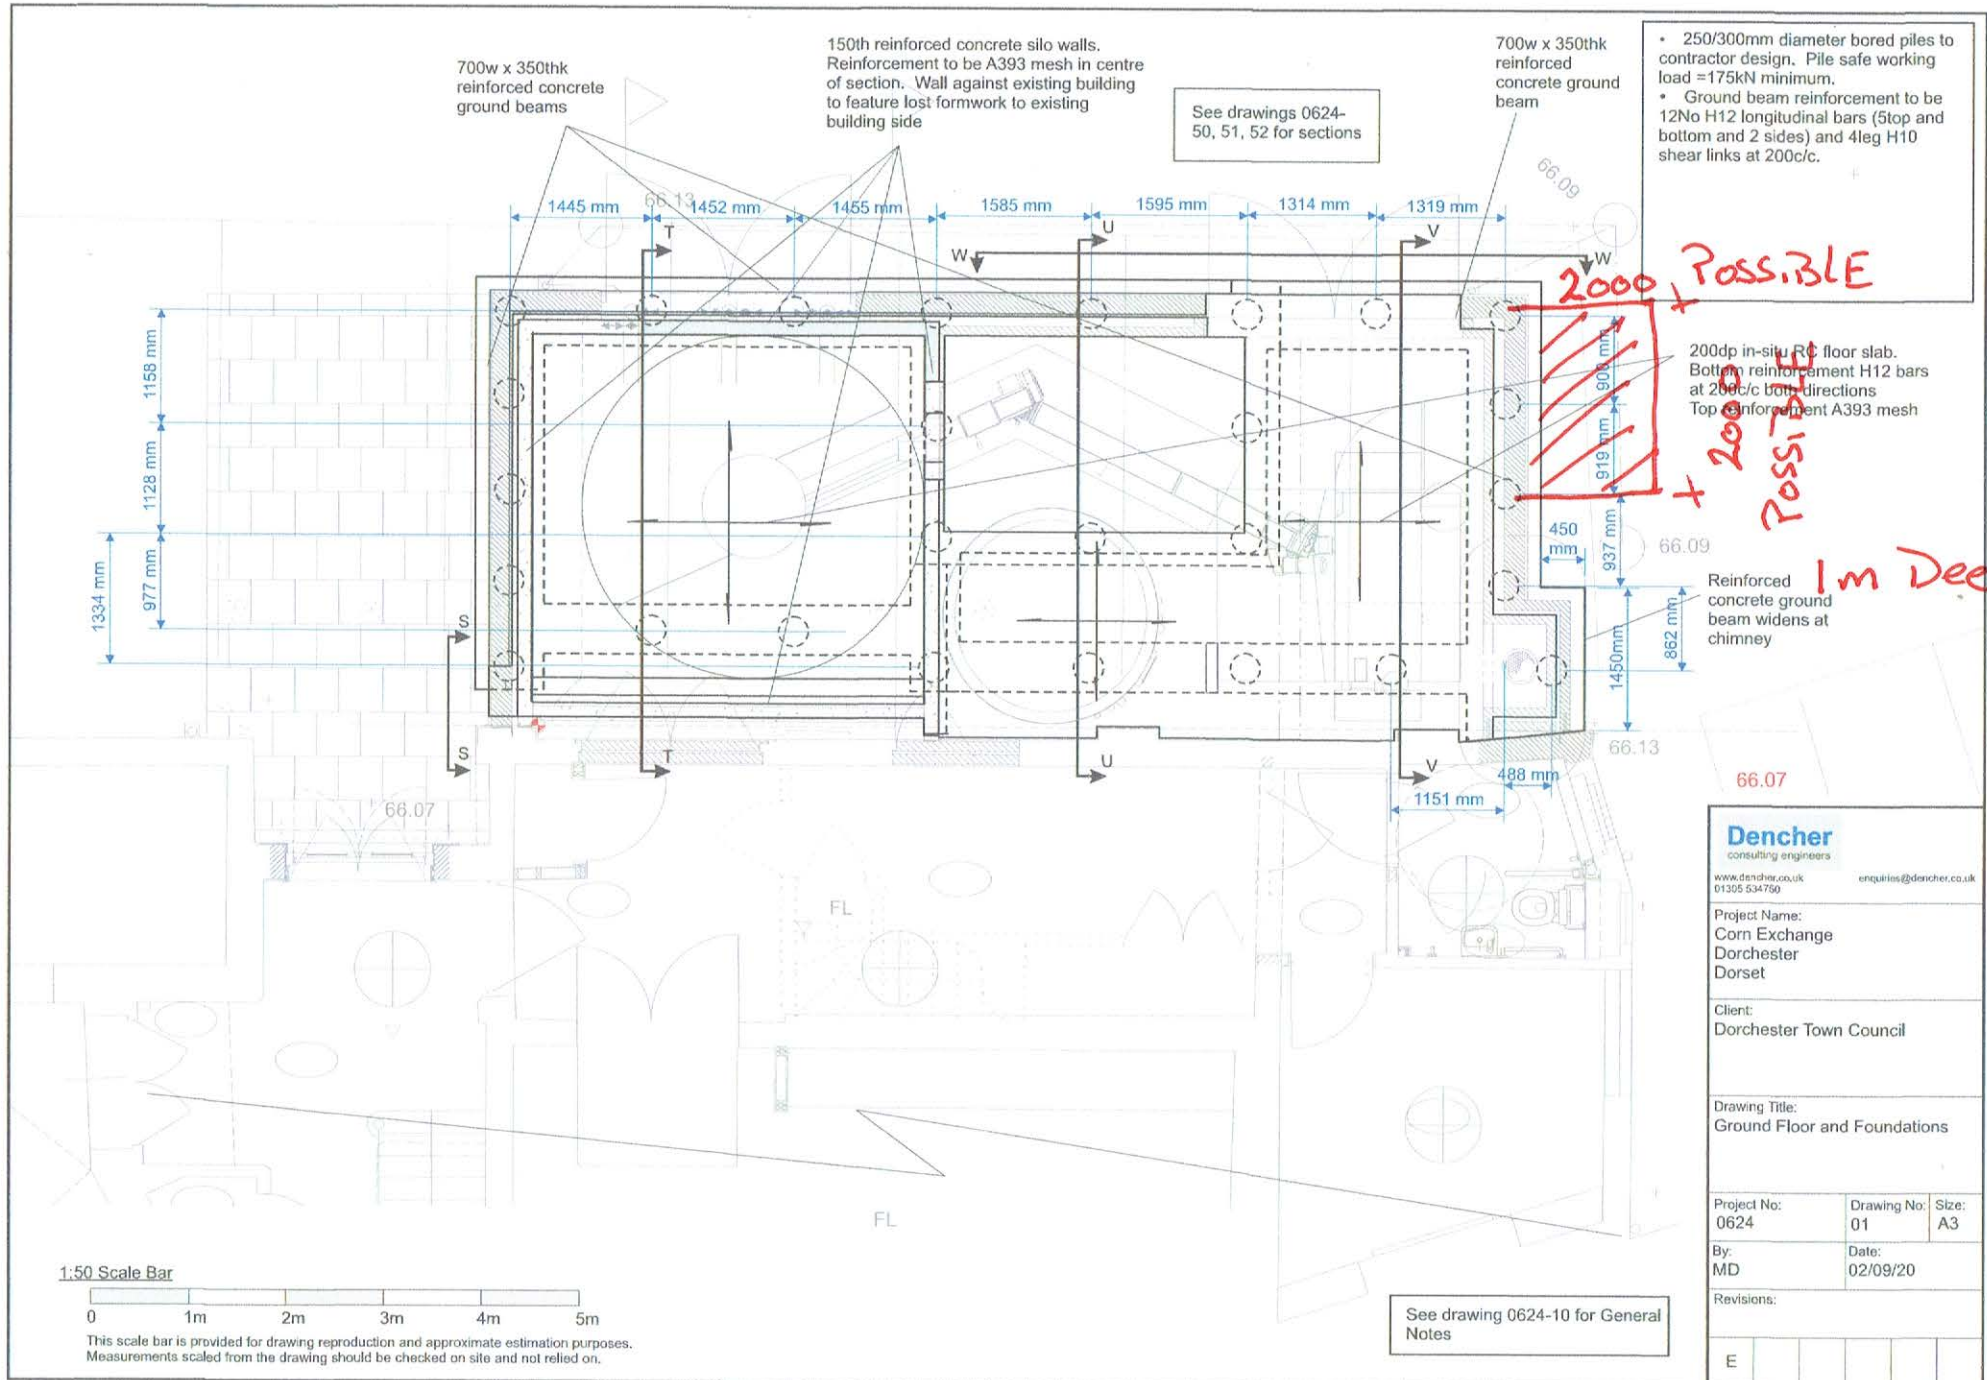
Drawing Title:
Ground Floor and Foundations

700w x 350thk reinforced concrete ground beams

150th reinforced concrete silo walls. Reinforcement to be A393 mesh in centre of section. Wall against existing building to feature lost formwork to existing building side

- 250/300mm diameter bored piles to contractor design. Pile safe working load = 175kN minimum.
- Ground beam reinforcement to be 12No H12 longitudinal bars (5top and bottom and 2 sides) and 4leg H10 shear links at 200c/c.

200dp in-situ RC floor slab. Bottom reinforcement H12 bars at 200c/c both directions. Top reinforcement A393 mesh

Reinforced concrete ground beam widens at chimney
