Two Unusual Timber-Framed Buildings in South-West Bedfordshire

J.M. BAILEY

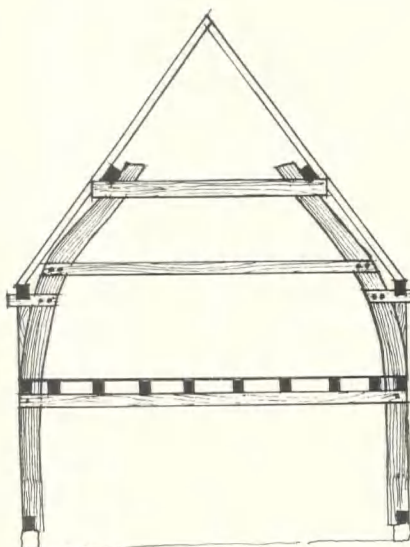
Fig 1 Ivy Farm, Stanbridge: the cruck blades.

Figure 1 shows a section through the surviving cruck frame. The cruck blades stop above the collar and it would appear from inspection that they terminated at this height originally. The tie beam mortices over tenons on the top of the posts and the wall plate site over the ends of the tie beam. The termination of the cruck blades above the collar is not uncommon in the region as there are examples at 13 Castle Street, Aylesbury, Bucks and Dragon Farm, Long Crendon, Bucks.

During the writer's investigation of the apparently seventeenth-century Ivy Farm at Stanbridge, a surviving pair of cruck blades were discovered within the frame work of the modified buildings, only fragments of one end bay survive. The end bay was floored and the original joists survive.
