**BLACKHORSE ROAD  
ANGLO-SAXON CEMETERY**

**RAVENS DEN CHURCH**

**ELSTOW ABBEY**

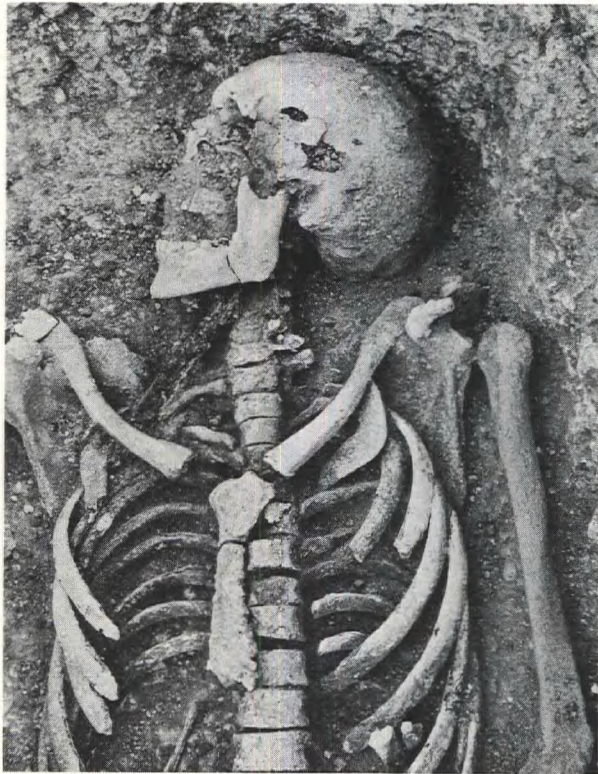
Plate 1 Burial 6 at Blackhorse Road, with spear in chest cavity.

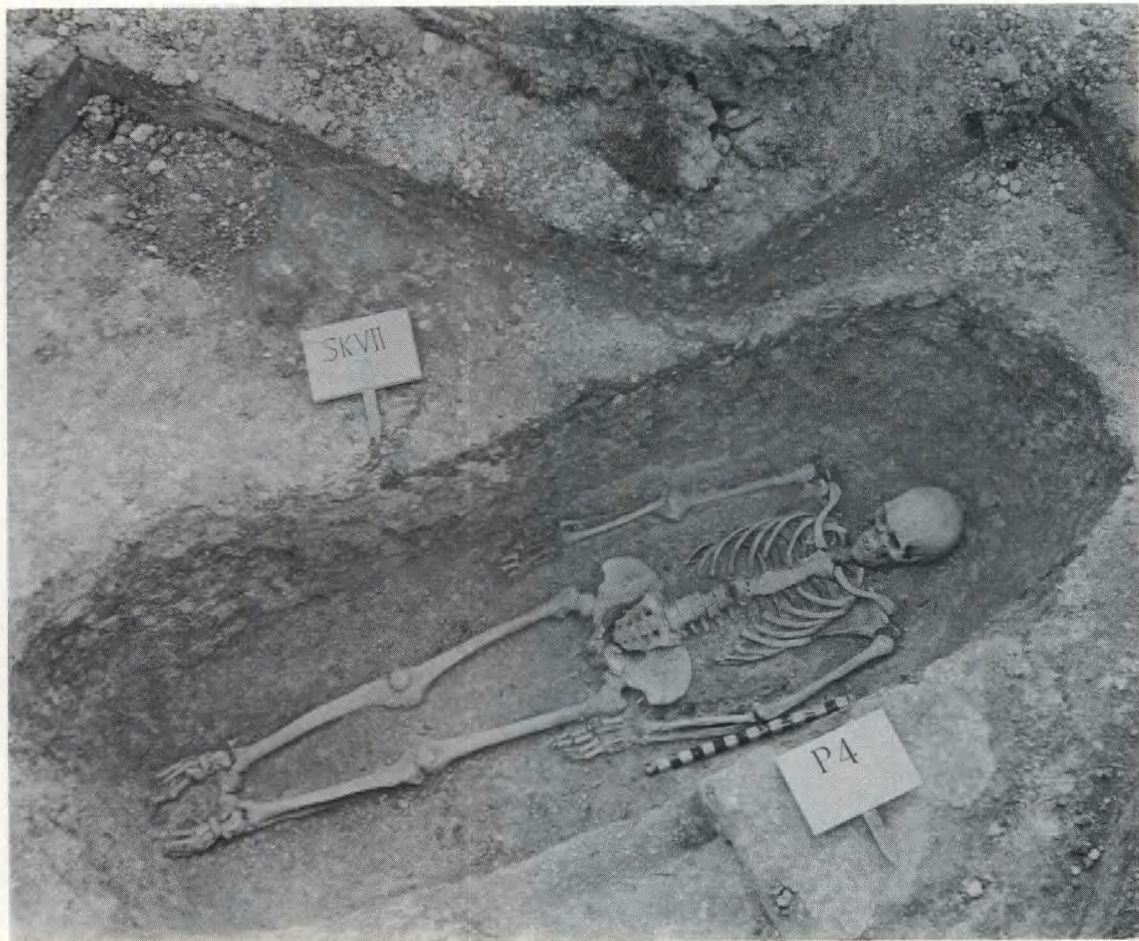
Plate 2 Burial 7 at Blackhorse Road.

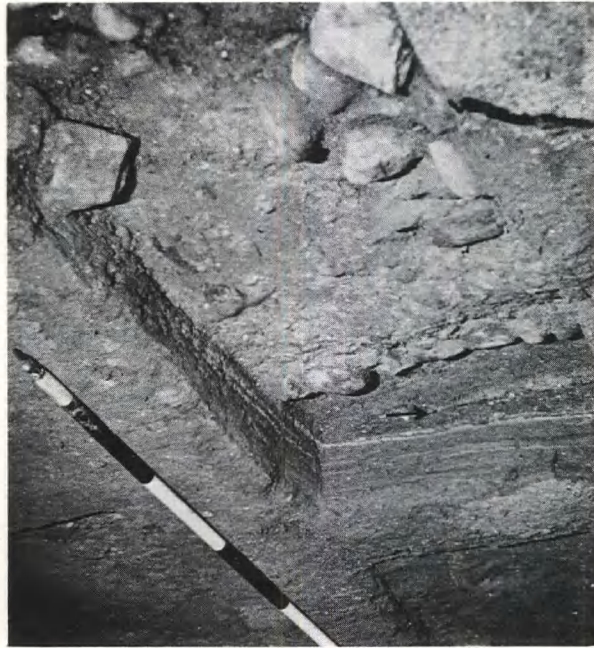
a

Plate 3a Ravensden Church. Trench I, north wall of the first church. Looking south. The black line in the floor section (arrowed) is the first building destruction level.

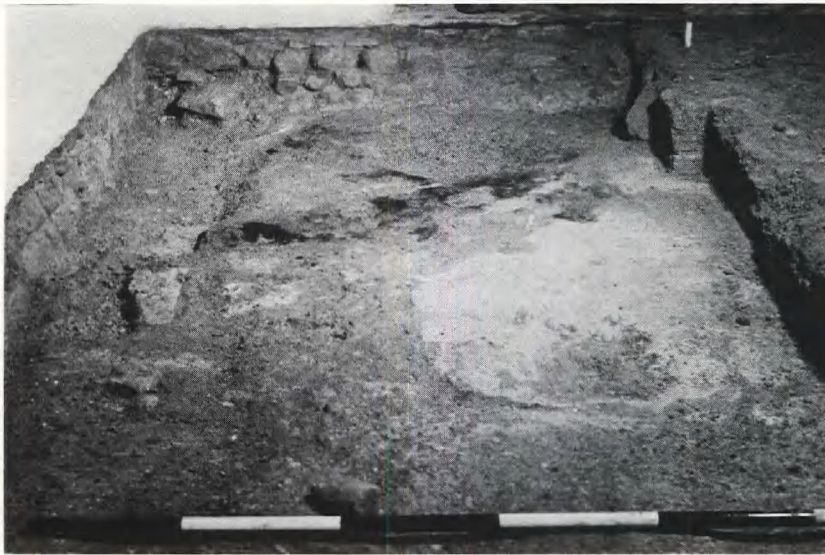
b

3b Ravensden Church. Trench VI, west end looking west. Burnt destruction level of the first building. The stones on the mid left are the corner stones of the door.

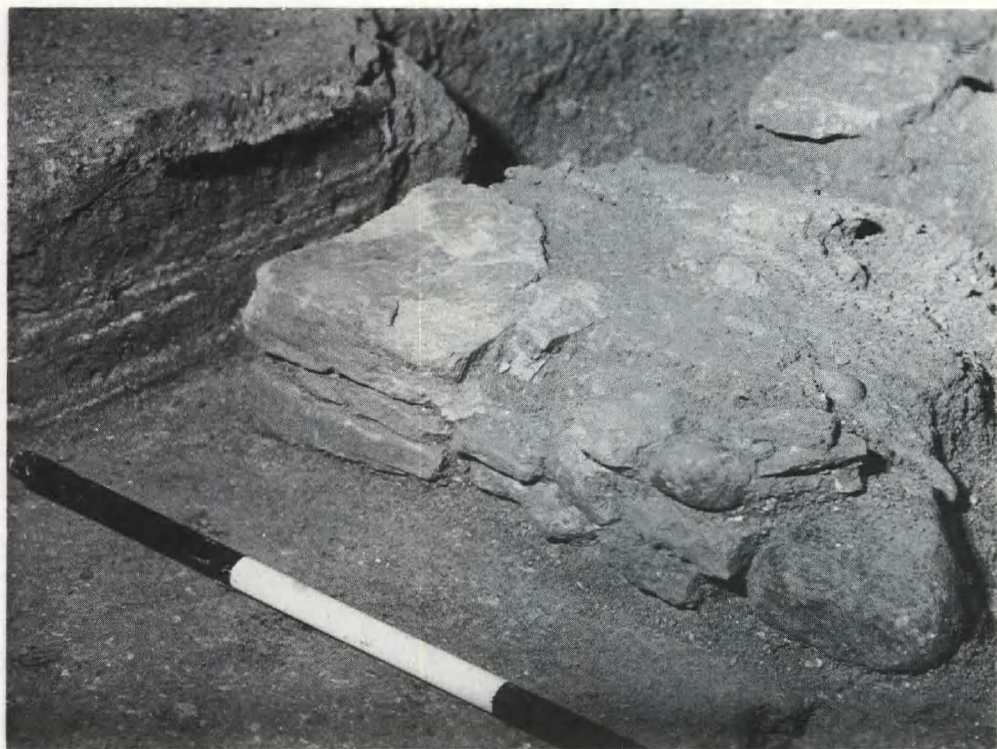
a

Plate 4a Ravensden Church. The south side of the font base. The north west corner stone is visible at the top right.

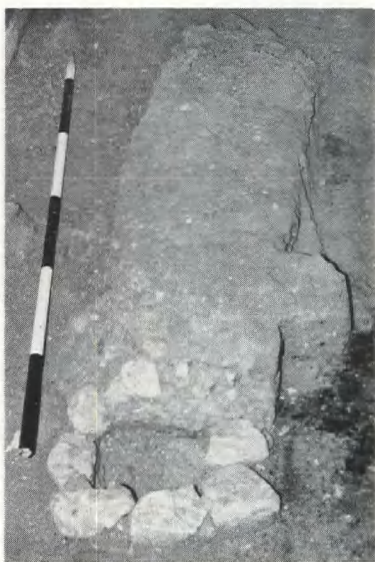
b

4b Ravensden Church. Trenches IV – V. The stones at the east of the nave monument. Note the burnt level on the right. Looking west.

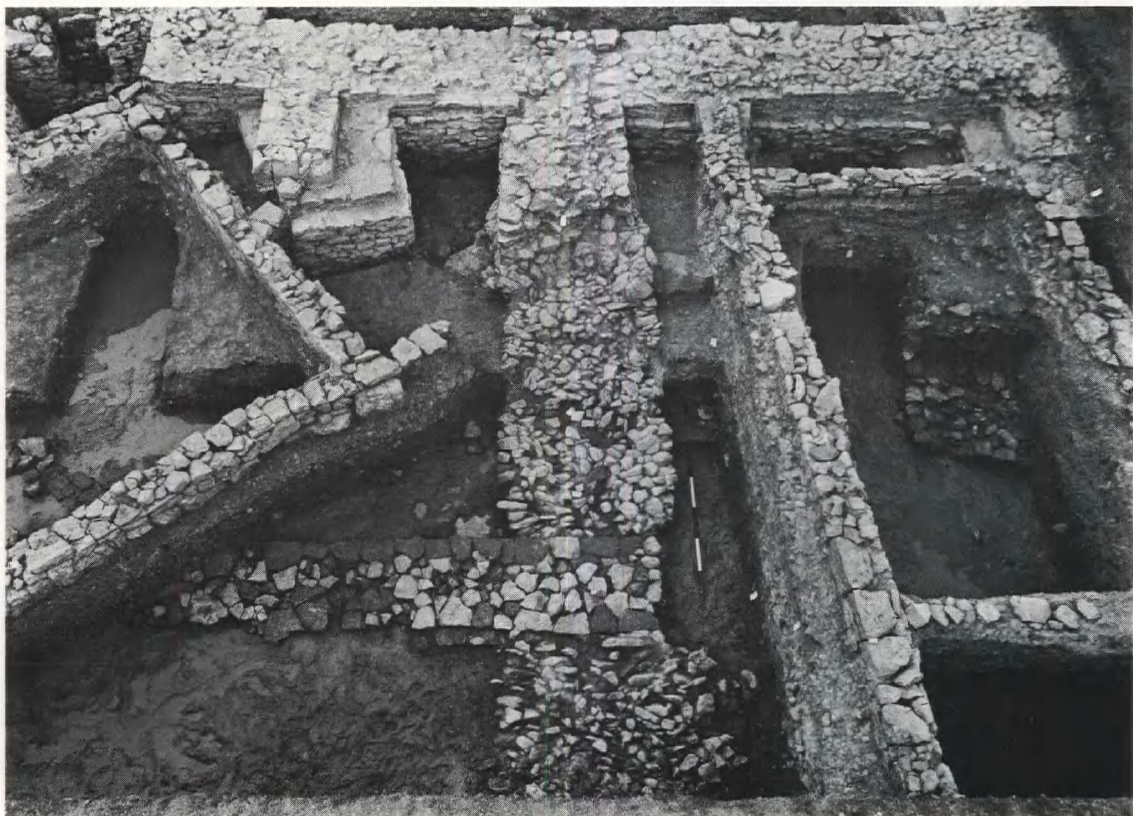
Plate 5 Robbed Norman *Rere-Dorter* under south end of fourteenth century *Dorter* and related out-buildings.

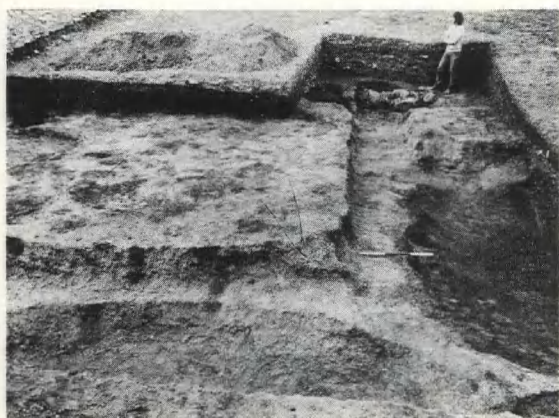
a

Plate 6a Thirteenth/fourteenth century Chapter House extension.

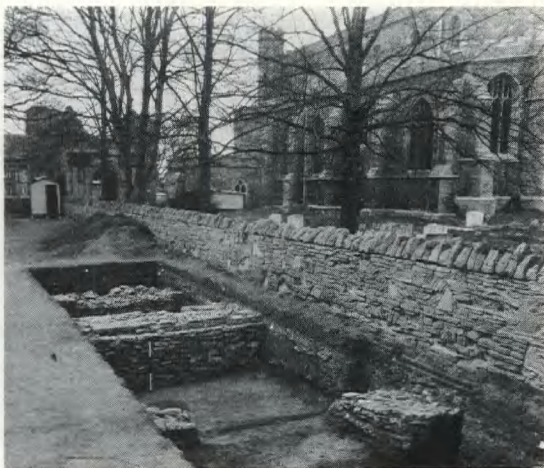
b

6b View facing north-west of east side of fourteenth century *Dorter* range with nave of Abbey church in background.

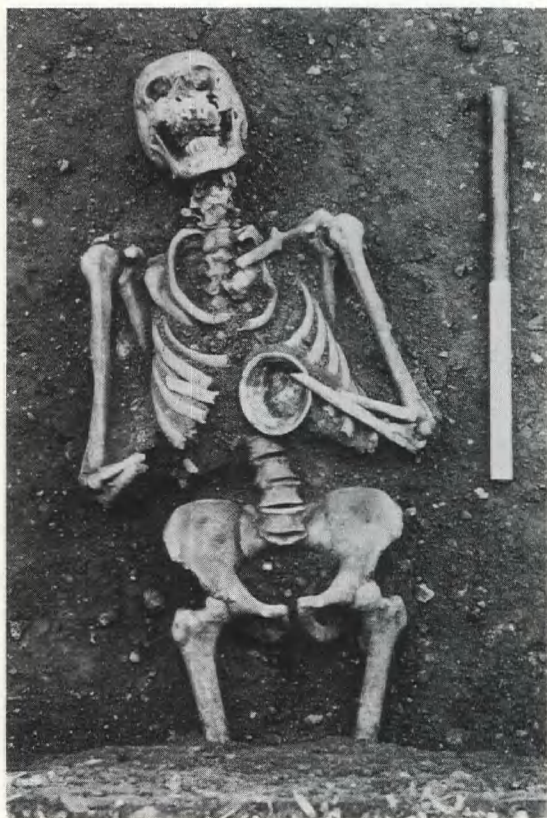
c

6c Monastic burials: priest with dummy lead chalice.

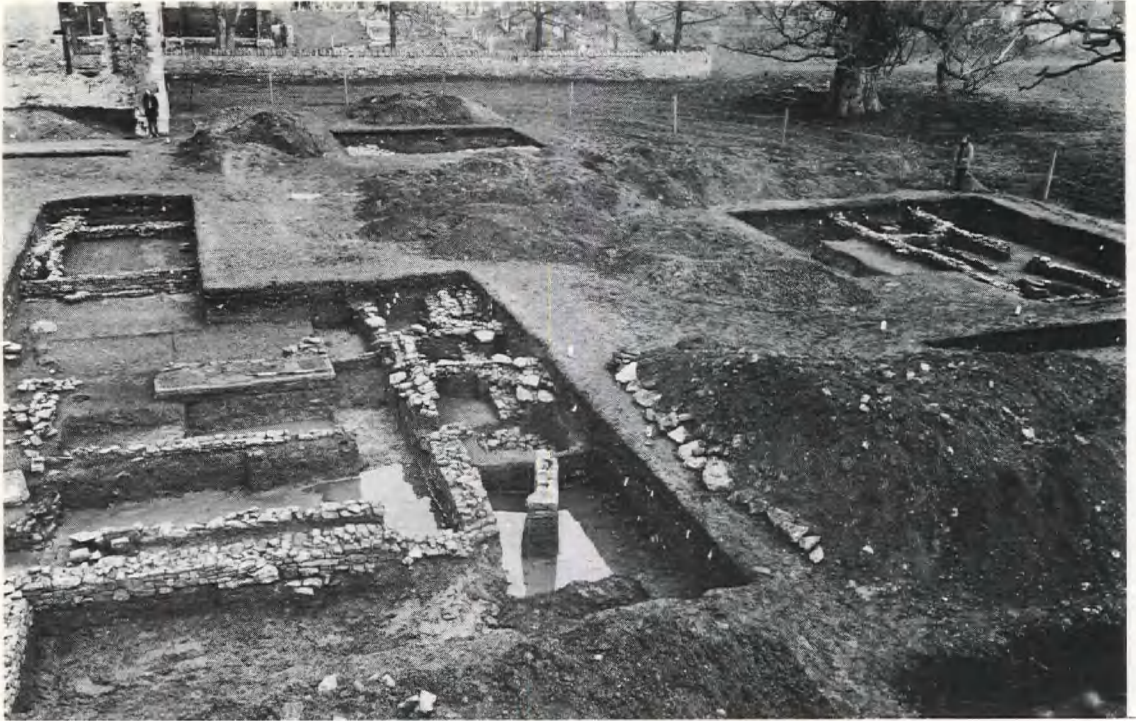
**a**

Plate 7a View facing north of excavations on outbuildings in 1970: M1, M2, M8, M9 at left, M4 at right.

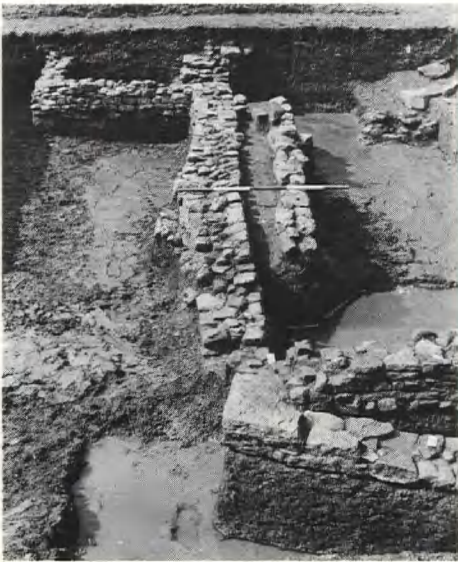
**b**

7b South wall of M2, showing lean and bulge of footing.

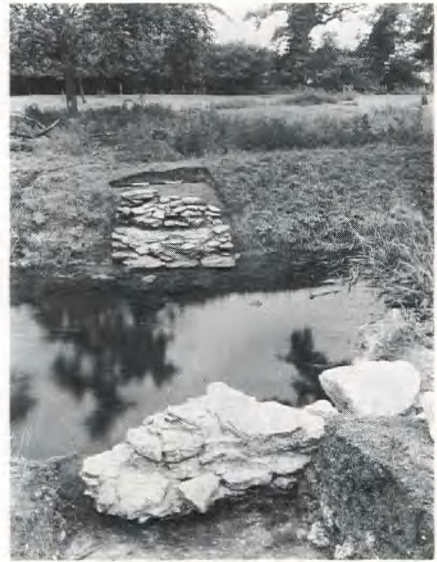
**c**

7c Stream: bridge abutments.

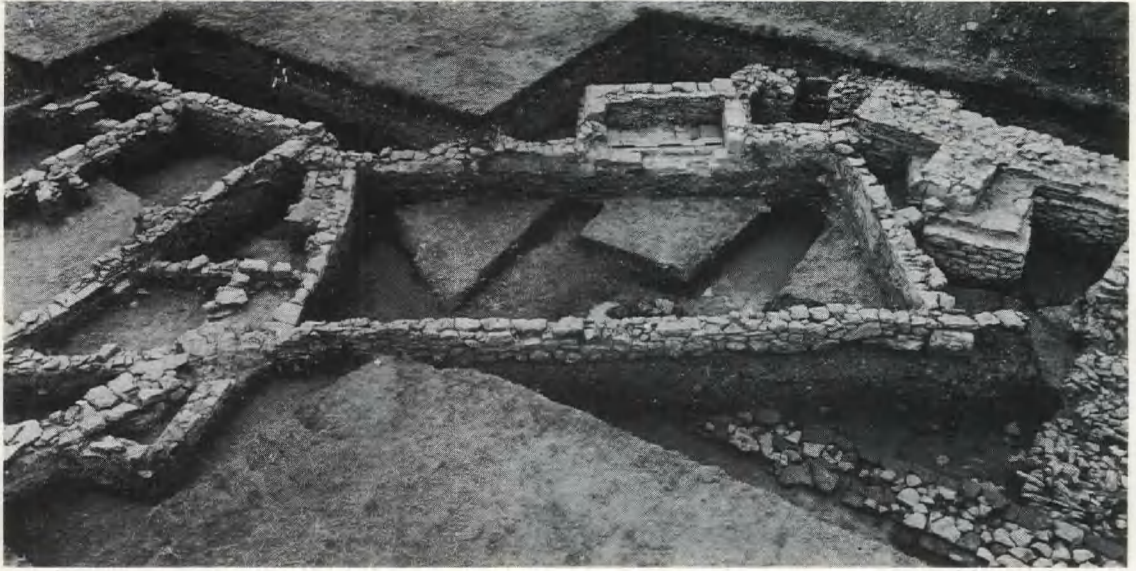
a

Plate 8a M5 facing north-west showing central portion with hearth and side units truncated by later buildings.

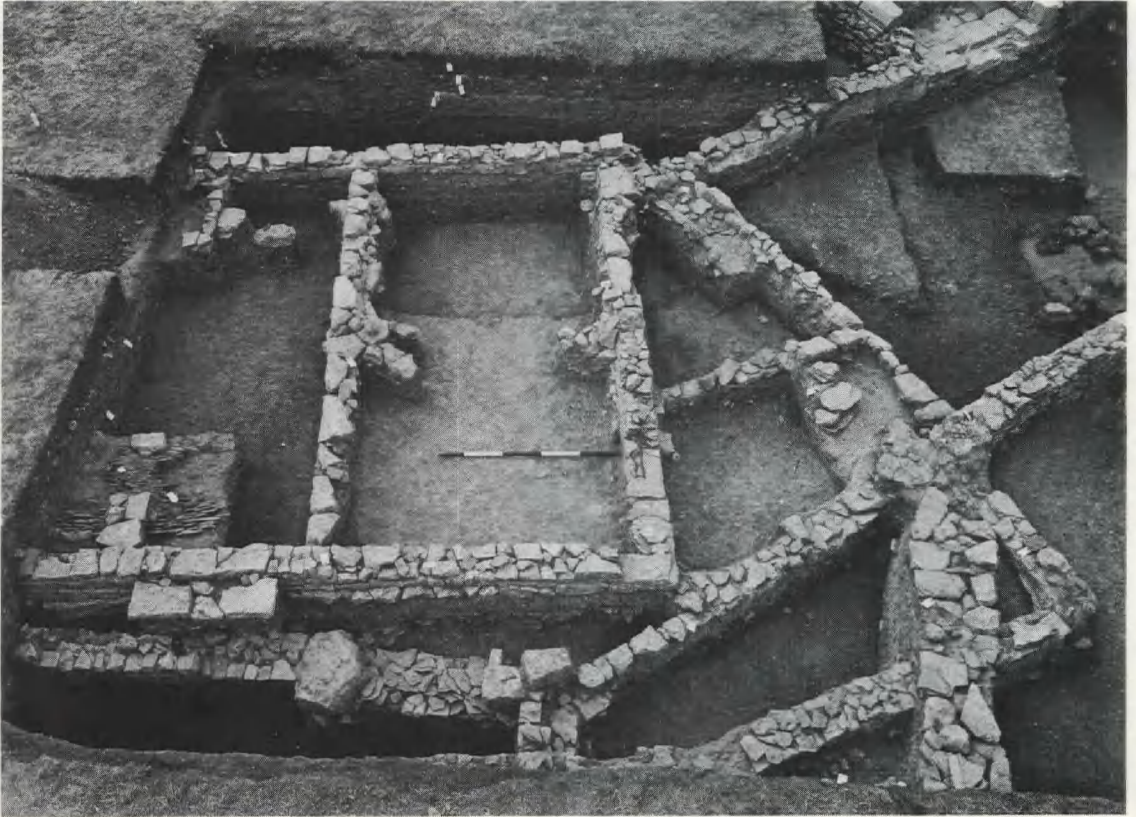
b

8b East side of M1, showing earlier hearth against south wall followed by central corridor and external step.
