## BURNHAM ABBEY.

# BURNHAM ABBEY BUCKS

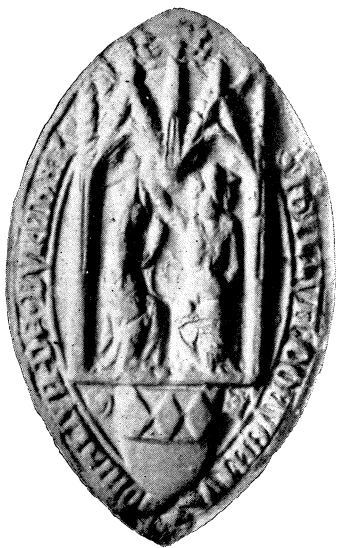
THE ABBEY SEAL.

**SIGILLVM CONVENTVS MONIALIVM DE  
BVRNHAM.**

There are four letters on the portion of the label behind the canopies, but they are illegible. There are also the letters S and M on either side the arms. The seal is a good example of the time of the foundation. The arms are similar to those of the Molyns family, one of whom, Sir William Molyns, gave to the abbey the manor of Silveston in Northamptonshire about 1338.\*\* The arms are strongly suggestive of some connection between the abbey and the Molyns family.

The general suppression followed in a few years' time, and Burnham was dissolved on the 19th September, 1539. The deed of surrender is signed by the abbess and nine canonesses, and bears the seal of the abbey in red wax.§

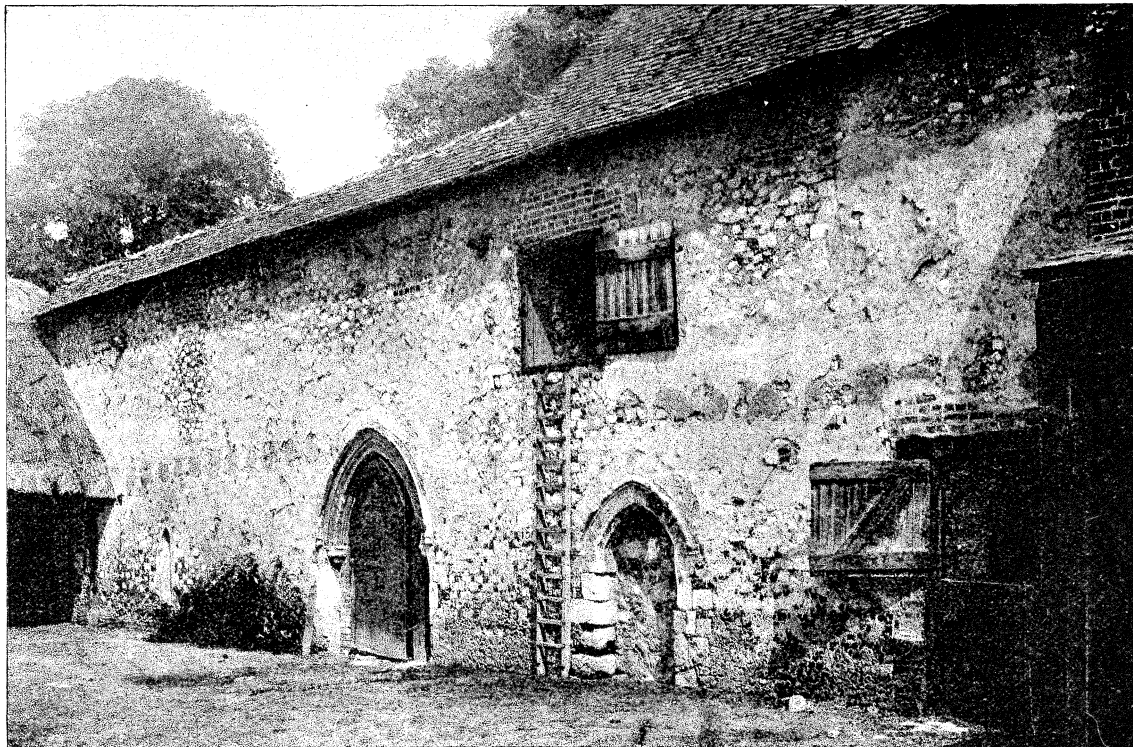
EAST SIDE OF CLOISTER.

The cloister court was 72 feet square, and surrounded by covered alleys having wooden pentice roofs; the blocked up holes for the timbers of which remain all along the east side. Whether the roofs were supported next the court on stone walls or wooden posts is impossible to say.

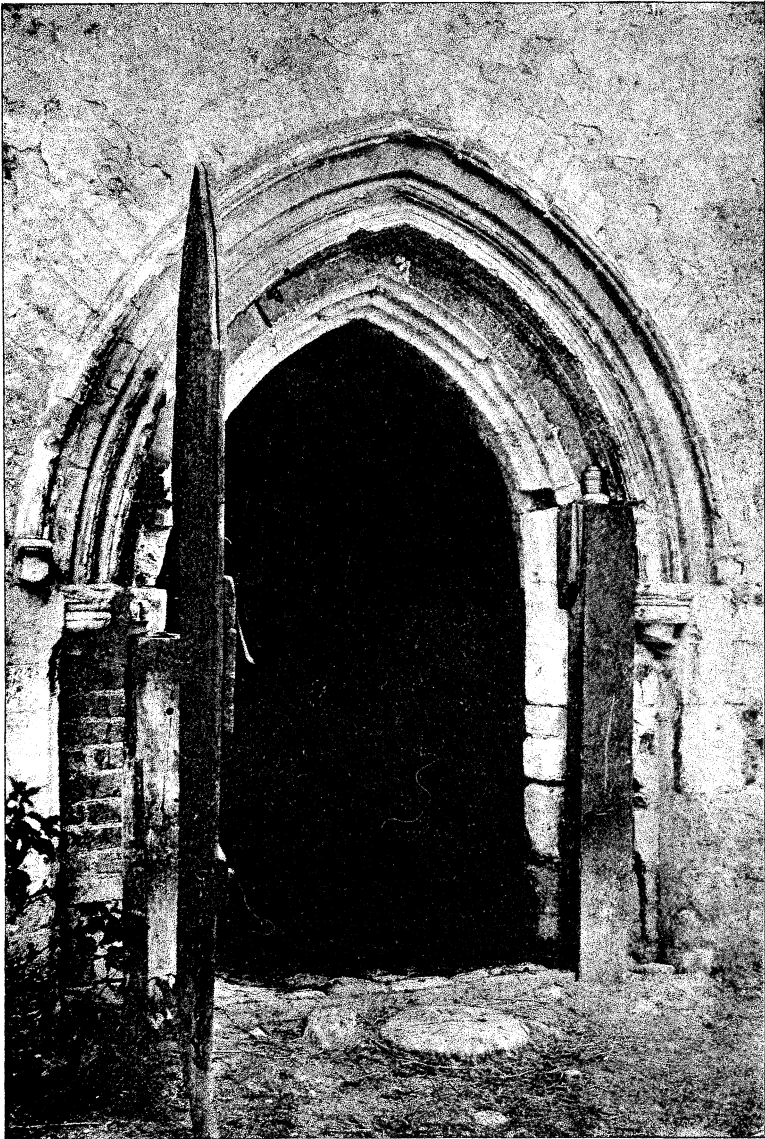
ENTRANCE TO CHAPTER-HOUSE.

It was entered from the cloister by a wide pointed archway of two members inside and out. Externally the inner member is of two chamfers, hollowed in the

arch and plain in the jambs; the outer member is moulded and rested on jamb shafts having moulded caps and bases, and has a moulded label with mask terminals. Internally both members are similar to the external inner member, and the arch has a moulded label which returns at the springing.

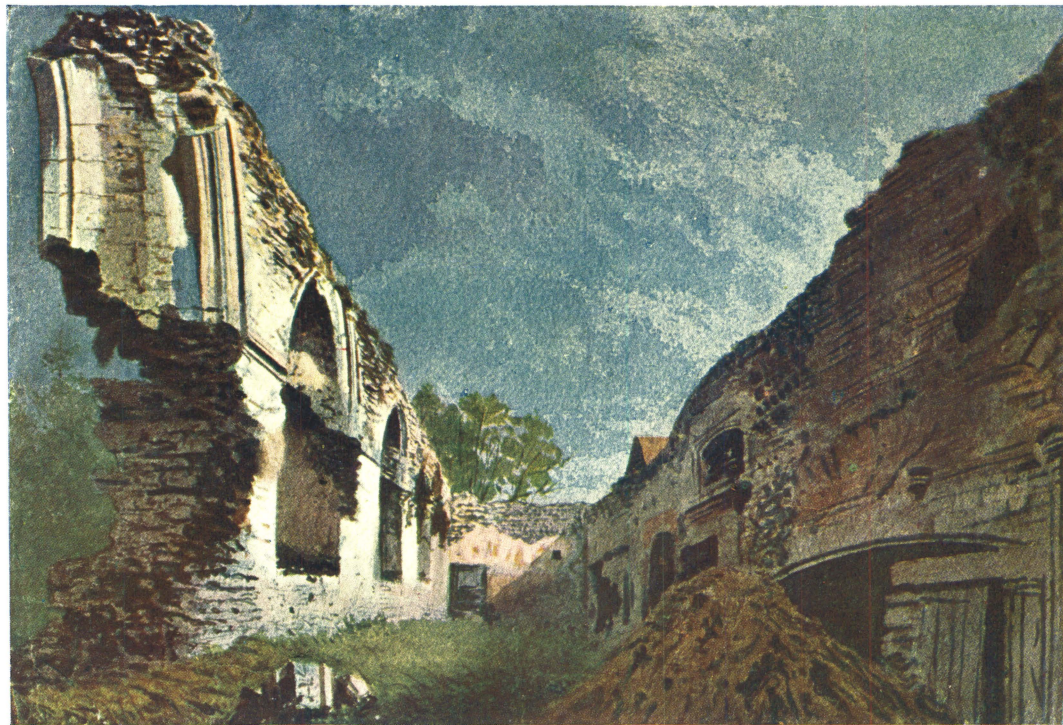
BURNHAM ABBEY.—INTERIOR OF FRATER, 1830.

The north wall remains for a few feet in connection with the east end, and the foundations were traced nearly to the west end, but showed no projection for a pulpit for the use of the reader at table. Dr. Bromet's drawing (plate A.) shows this work standing to its full height and retaining three of its original windows, which were apparently lancets, having moulded rerearches with labels over that were continued along the walls between the windows at their springing.‡

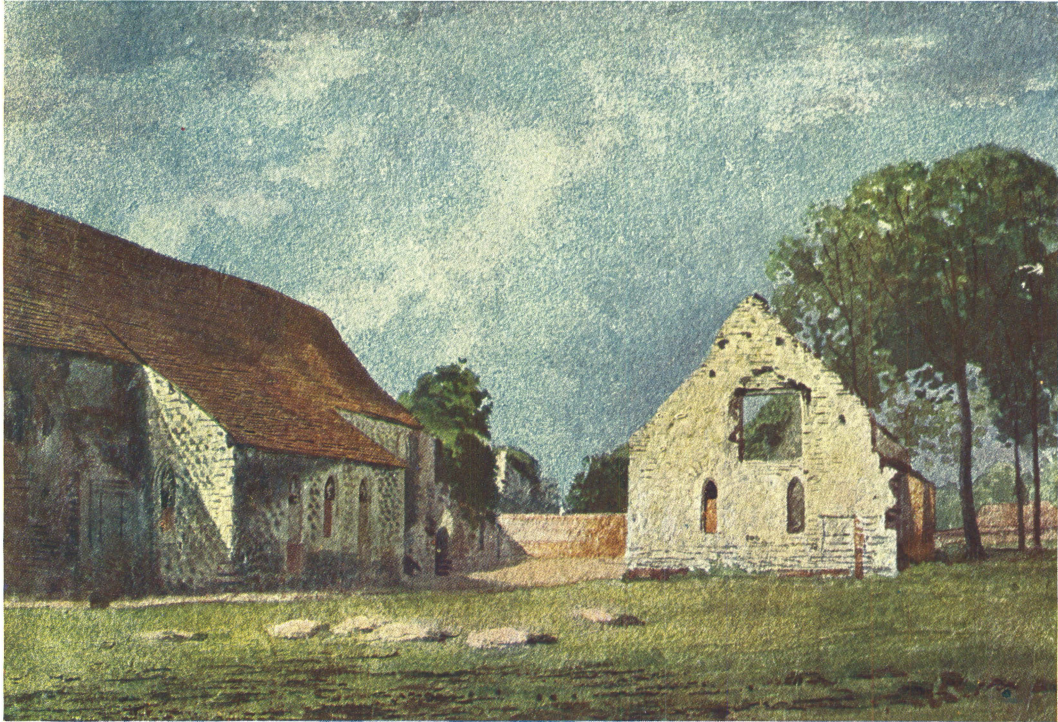
BURNHAM ABBEY.—VIEW FROM THE SOUTH EAST, 1830.

The south wall has now entirely disappeared except the foundations, but was standing complete as late as 1834. This is shown very clearly in Dr. Bromet's drawing (plate B.), and then had two original lancet windows in the lower part, with a blocked brick-lined doorway towards the east. ‡ The gable above was standing to its full height, and it appears to have had originally a lancet in the middle, which had been destroyed by an inserted square window.
