MIDDLE FARM
HIGH STREET
YILDEN
BEDFORDSHIRE

ARCHAEOLOGICAL RECORDING

Document: 2013/101
Version: 1.0

Project Code: MF2198
Bedford Museum accession no.: BEDFM:2013.28
OASIS ID: albionar1-151769

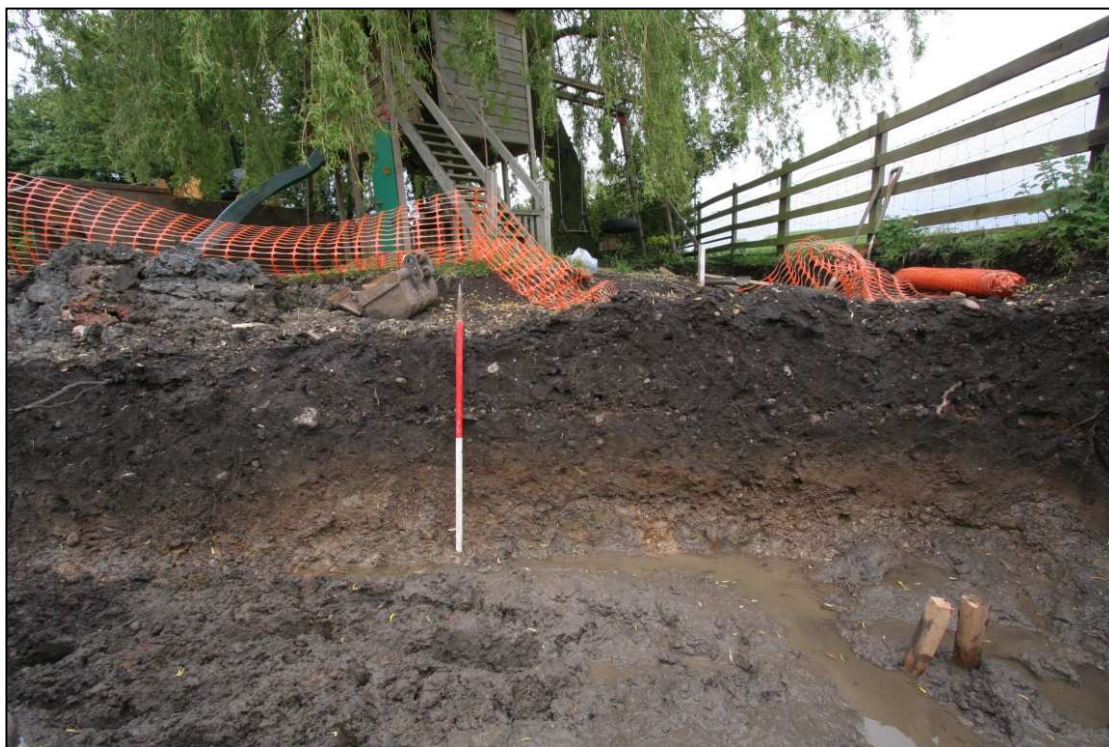
Plate 3: Section 1
Showing garden soils and alluvial gravel

The main part of the soil profile consisted of garden soils. These occurred in two layers (100) and (102). A thin stone layer noted in Section 1 may represent a stone layer formed at the base of cultivation or possibly a pebble layer which has been buried by an imported soil layer.

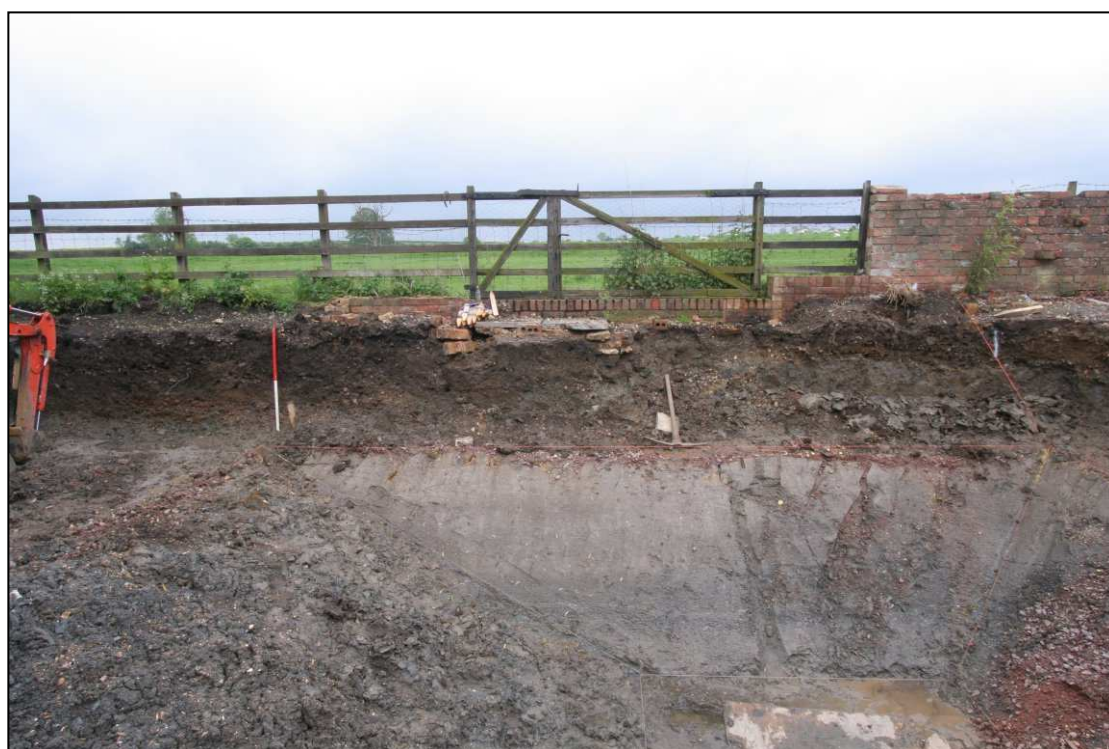
Plate 4: Section 2
Showing garden soils, modern build-up layers and geological deposits

The southern end of Section 2 in the south-east corner of the trench showed a series of modern deposits in the upper part of the soil profile. These consisted of brick rubble (109) and thin horizontal gravel layers (110) and (111).

The undisturbed geological deposit exposed at the south end of the trench consisted of firm, mid grey clay with no inclusions (Section 2). This extended close to the top of the soil profile and was overlain by relatively thin modern deposits.
