**WAITING FOR THE SUN
RUSHDEN ROAD
BLETSOE
BEDFORDSHIRE**

**ARCHAEOLOGICAL OBSERVATION,
INVESTIGATION, RECORDING, ANALYSIS AND
PUBLICATION**

Project: WSF2658
Museum accession No.: BEDFM 2015.76
OASIS no.: albionar1-227449

Document: 2015/200
Version 1.0

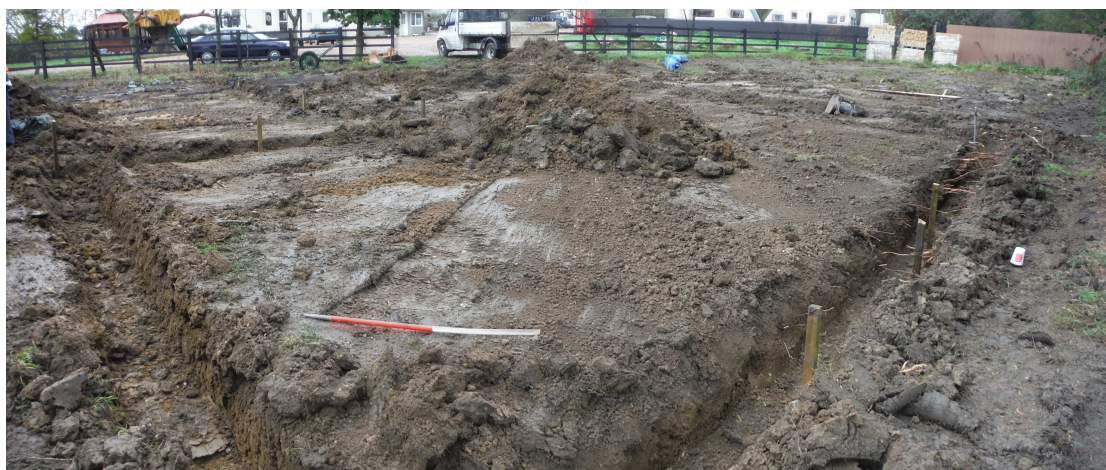
The works comprised the machining under archaeological supervision of the foundation trenches for the new stables and tack room building. The trenches were 0.45m wide and 0.45m deep (Figure 2).

The foundation trenches were relatively shallow at *c.* 0.45m below ground level. Generally, this resulted in the trenches at the southern end of the site failing to penetrate through the subsoil. However, along the northern half of the trenches the underlying geological deposits were clearly exposed.

Plate 1: Photo montage of the foundation trenches, looking north-east

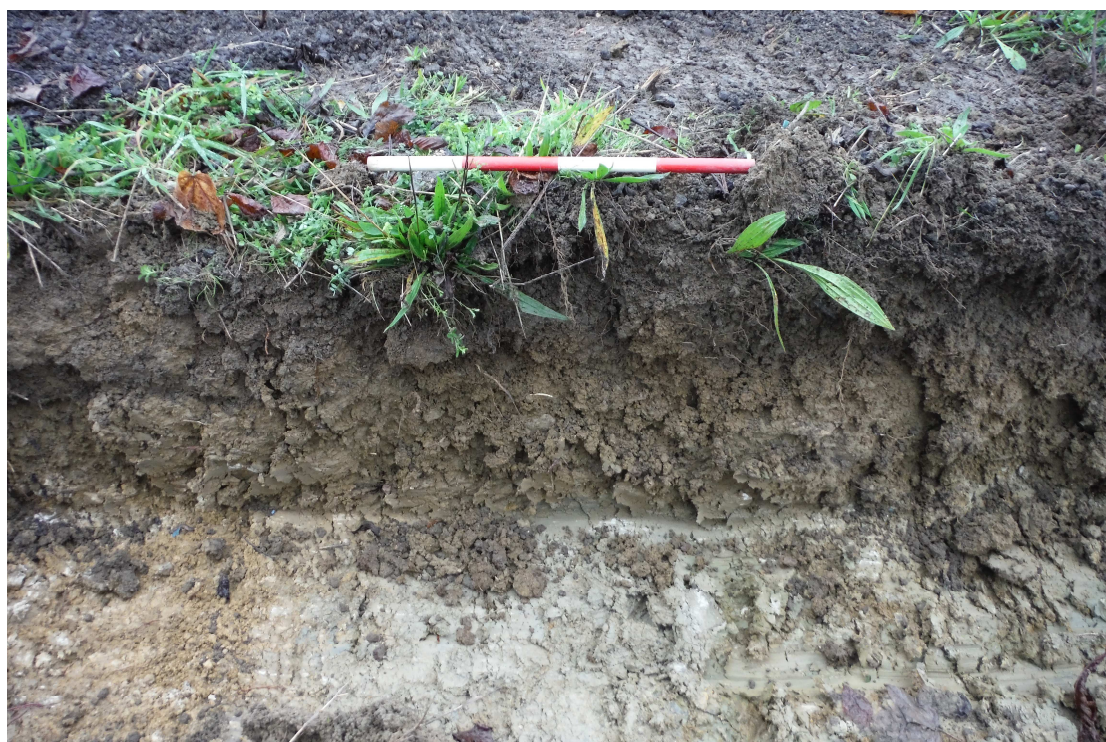
The overburden across the site was a *c.* 0.20m-thick topsoil of dark grey-brown clay silt (1), above a 0.20–0.25m-thick subsoil of mid orange-brown, silty clay (2).

The undisturbed geological deposit (3) comprised light grey yellow clay with occasional 'seams' of yellow-white limestone.

Plate 2: Representative section through the topsoil and subsoil (scale 0.4m)
