Abbey Wood Station Car Park general watching brief

Weekly report for w/e 27th June 2014

Client: Crossrail

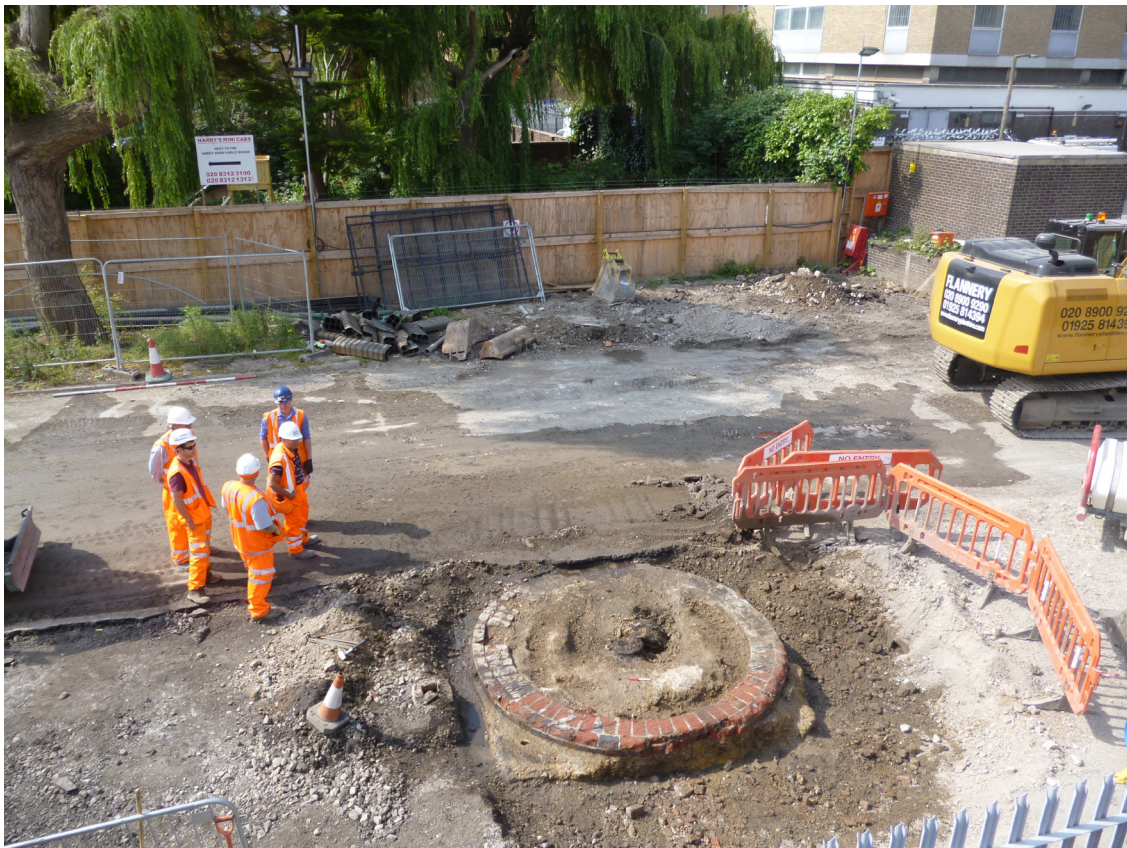
Part of the former car park area to the south of Abbey Wood Station was stripped back by machine. This revealed a large circular structure immediately below the tarmac c 5m to the south of the footbridge of Abbey Wood Station.

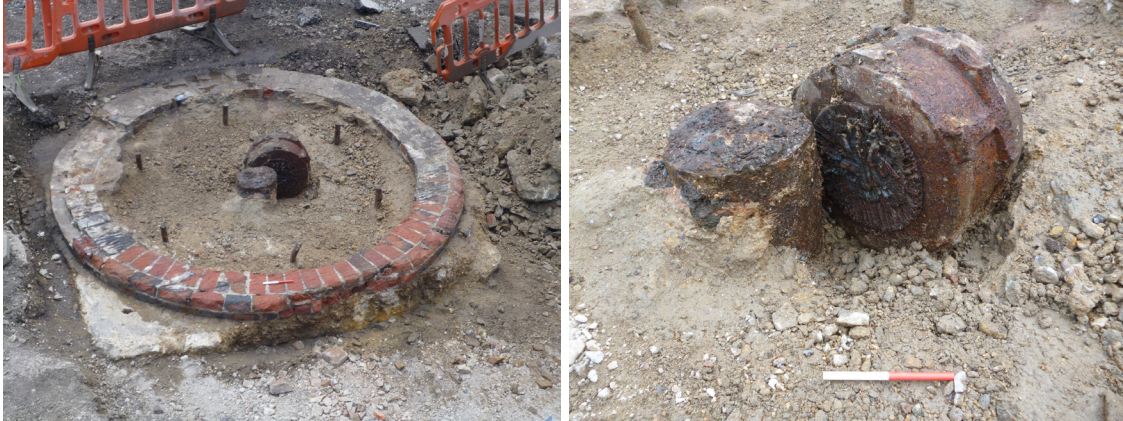
The structure measured 3.0m N–S by 3.0m E–W and consisted of a substantial square concrete footing and a circular brick superstructure (two courses of unfrogged red bricks on bed bound with white/grey cement mortar). In the centre of the structure was a large upright iron pillar with what seemed to be a broken off cog wheel. Six smaller iron rods lined the inside of the brickwork. The structure was infilled with concrete and rubble.

The structure is very likely to be the base of a Victorian crane, associated with the nearby railway and presumably used for lifting material from the train carriages to the former railway yard.
