THE OLYMPIC PARK, WATERWAYS AND ASSOCIATED
BUILT HERITAGE STRUCTURES: CARPENTER'S LOCK, CITY
MILL RIVER FOOTBRIDGE, PUDDING MILL LOCK, OLD
FORD LOCKS, OLD FORD LOCK HOUSES, MARSHGATE
LANE LOCK, STONE AND BRICK RIVERBANK WALLS,
PUDDING MILL RIVER

A landscape and standing buildings survey report

September 2008

Site Code: OL-01207, OL-02007, OL-02707, OL-03007, OL-03507, OL-05007, OL-05407,
OL-07207, OL-07307, OL-07407, OL-07407

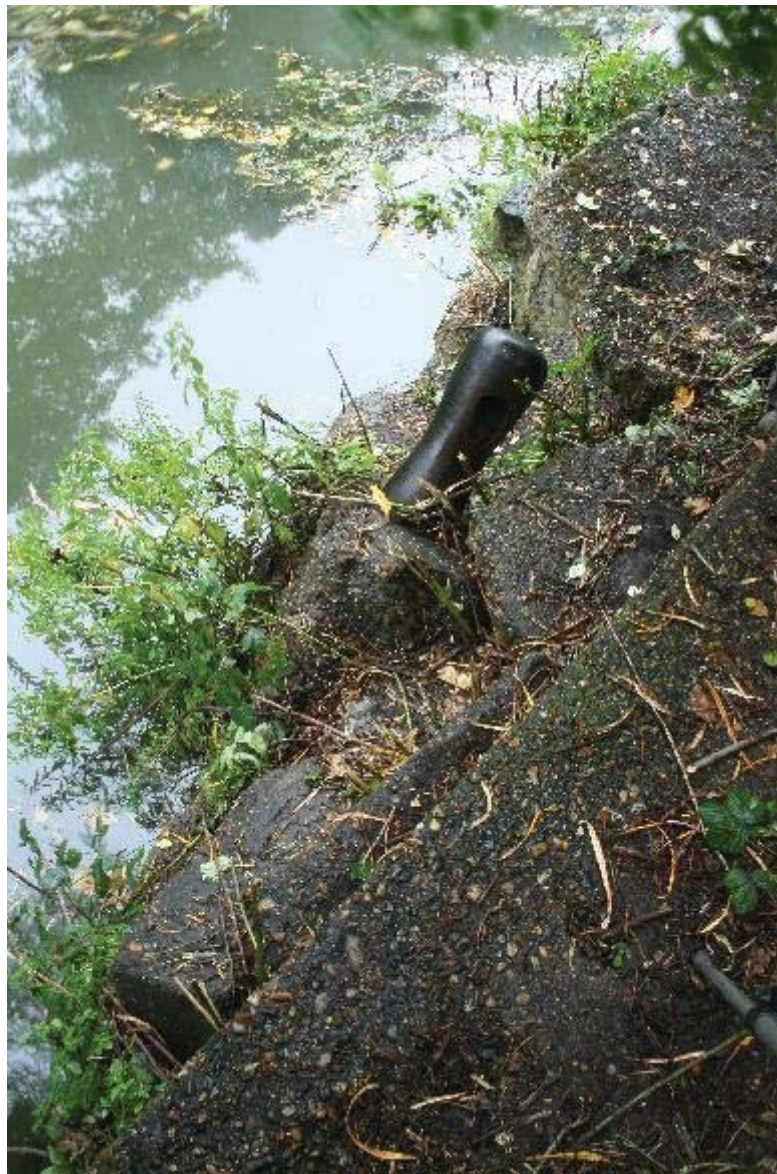
Plate 61 Detailed view of damaged eastern wing wall with metal mooring post, Pudding Mill River, looking north-northwest: OL-05407

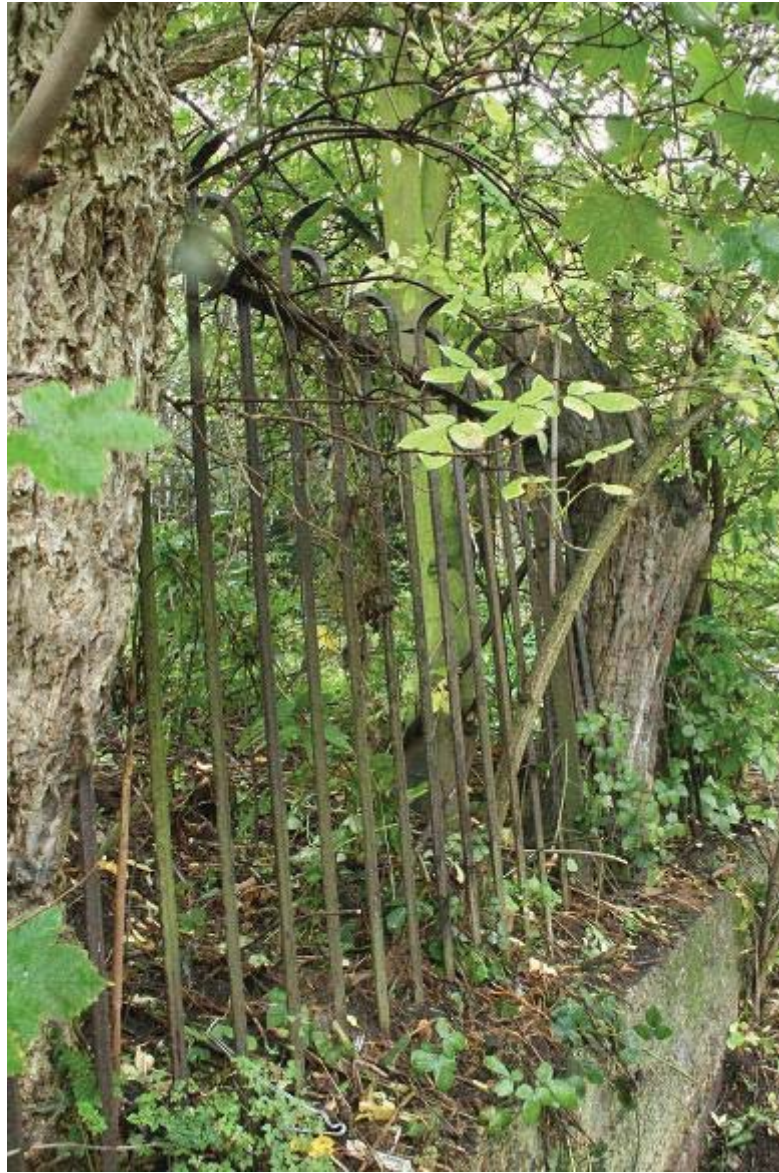
Plate 62 View of metal fencing on east side of Pudding Mill Lock, looking south: OL-05407
