THE OLYMPIC PARK, WATERWAYS AND ASSOCIATED
BUILT HERITAGE STRUCTURES: CARPENTER'S LOCK, CITY
MILL RIVER FOOTBRIDGE, PUDDING MILL LOCK, OLD
FORD LOCKS, OLD FORD LOCK HOUSES, MARSHGATE
LANE LOCK, STONE AND BRICK RIVERBANK WALLS,
PUDDING MILL RIVER

A landscape and standing buildings survey report

September 2008

Site Code: OL-01207, OL-02007, OL-02707, OL-03007, OL-03507, OL-05007, OL-05407,
OL-07207, OL-07307, OL-07407, OL-07407

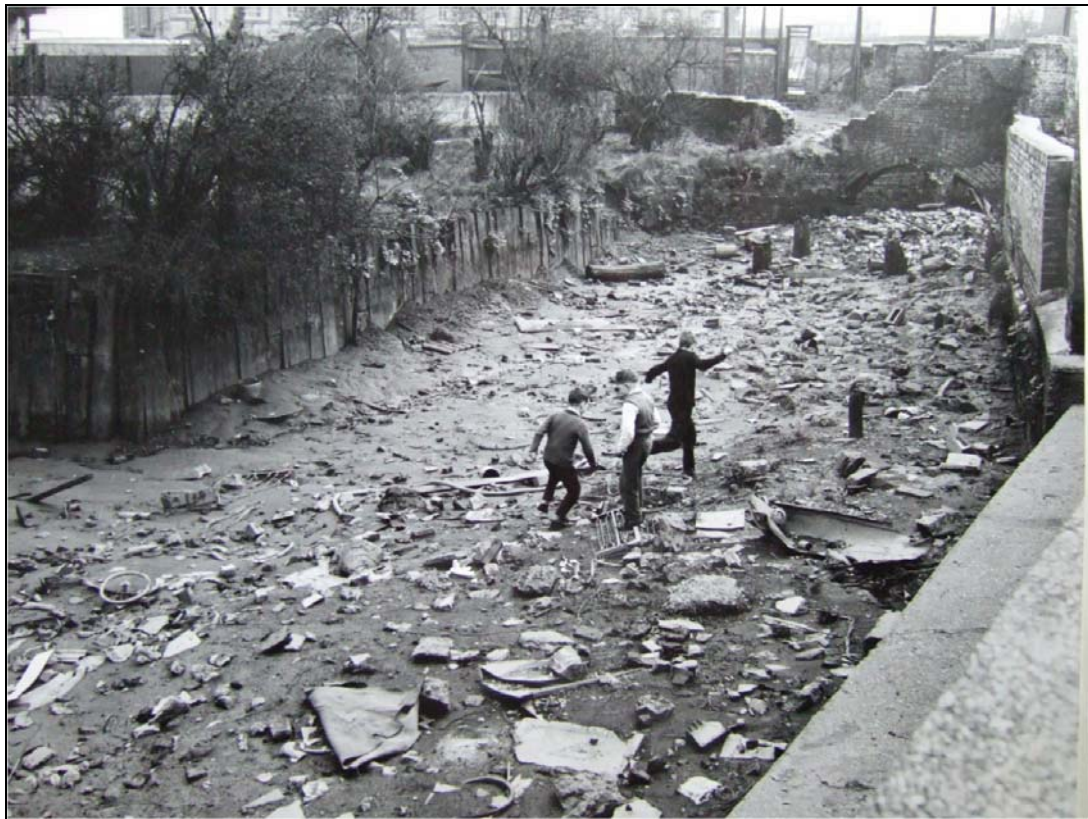
Plate 8 View of bomb damage to eastern lock chamber at Old Ford Locks, October 1940 (ACC/2423/P/459/8A, courtesy of London Metropolitan Archives): OL- 05007
