THE OLYMPIC PARK, WATERWAYS AND ASSOCIATED
BUILT HERITAGE STRUCTURES: CARPENTER'S LOCK, CITY
MILL RIVER FOOTBRIDGE, PUDDING MILL LOCK, OLD
FORD LOCKS, OLD FORD LOCK HOUSES, MARSHGATE
LANE LOCK, STONE AND BRICK RIVERBANK WALLS,
PUDDING MILL RIVER

A landscape and standing buildings survey report

September 2008

Site Code: OL-01207, OL-02007, OL-02707, OL-03007, OL-03507, OL-05007, OL-05407,
OL-07207, OL-07307, OL-07407, OL-07407

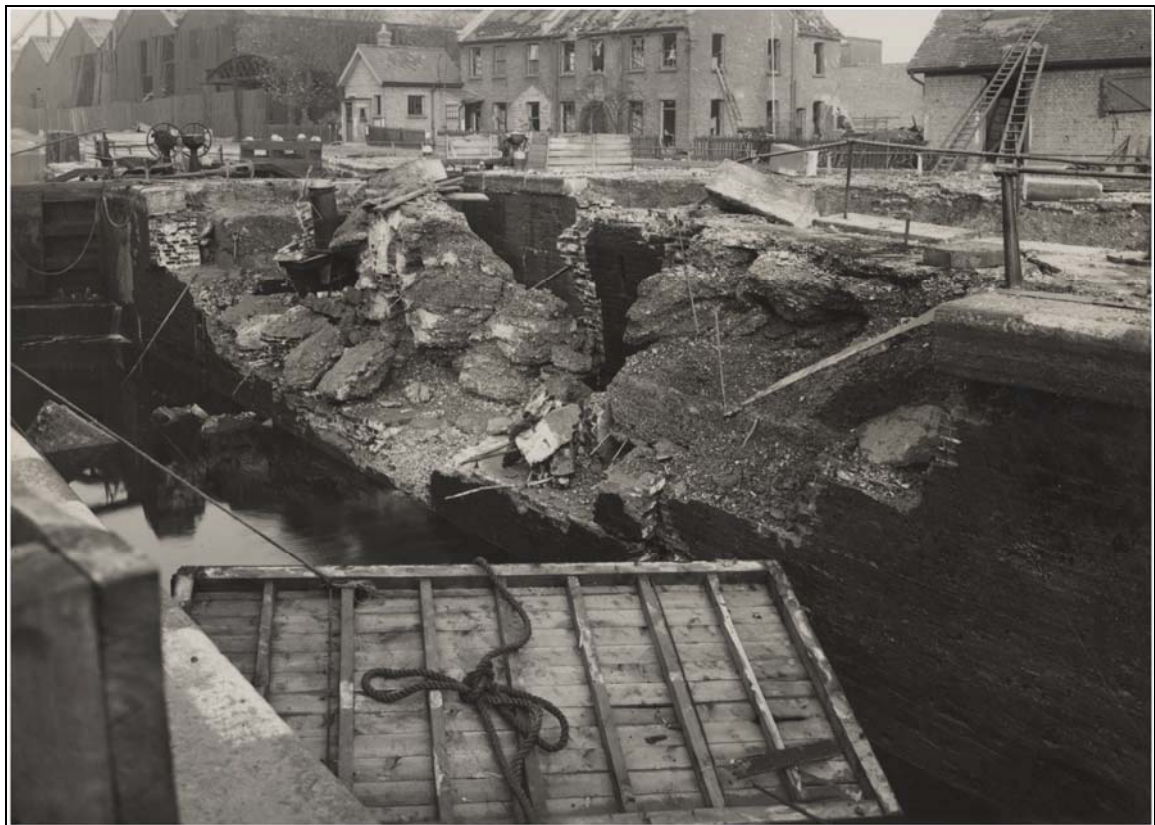
Plate 7 View of bomb damage to central pier at Old Ford Locks, October 1940 (LD PEM PS 159/0976, courtesy of Newham Local Studies and Archive Library): OL- 05007
