THE OLYMPIC PARK, WATERWAYS AND ASSOCIATED  
BUILT HERITAGE STRUCTURES: CARPENTER'S LOCK, CITY  
MILL RIVER FOOTBRIDGE, PUDDING MILL LOCK, OLD  
FORD LOCKS, OLD FORD LOCK HOUSES, MARSHGATE  
LANE LOCK, STONE AND BRICK RIVERBANK WALLS,  
PUDDING MILL RIVER

A landscape and standing buildings survey report

September 2008

Site Code: OL-01207, OL-02007, OL-02707, OL-03007, OL-03507, OL-05007, OL-05407,  
OL-07207, OL-07307, OL-07407, OL-07407

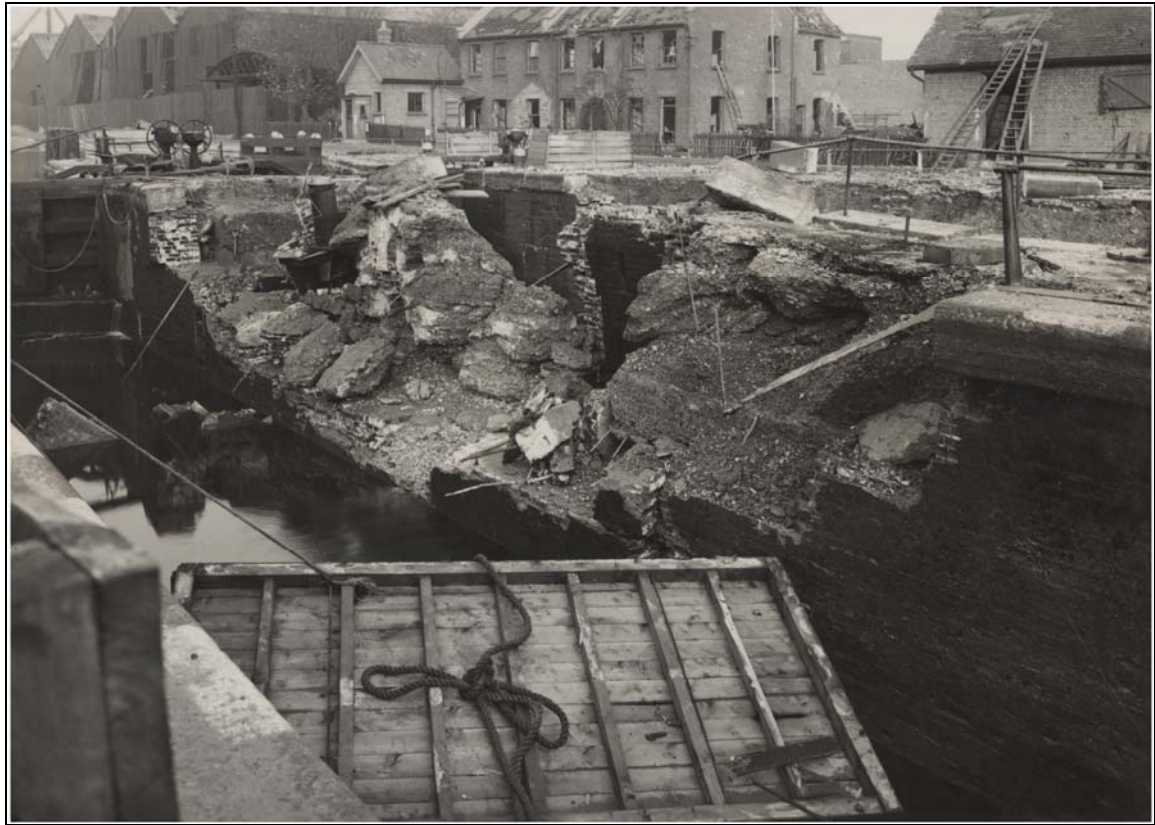
*Plate 7 View of bomb damage to central pier at Old Ford Locks, October 1940 (LD PEM PS 159/0976, courtesy of Newham Local Studies and Archive Library): OL- 05007*

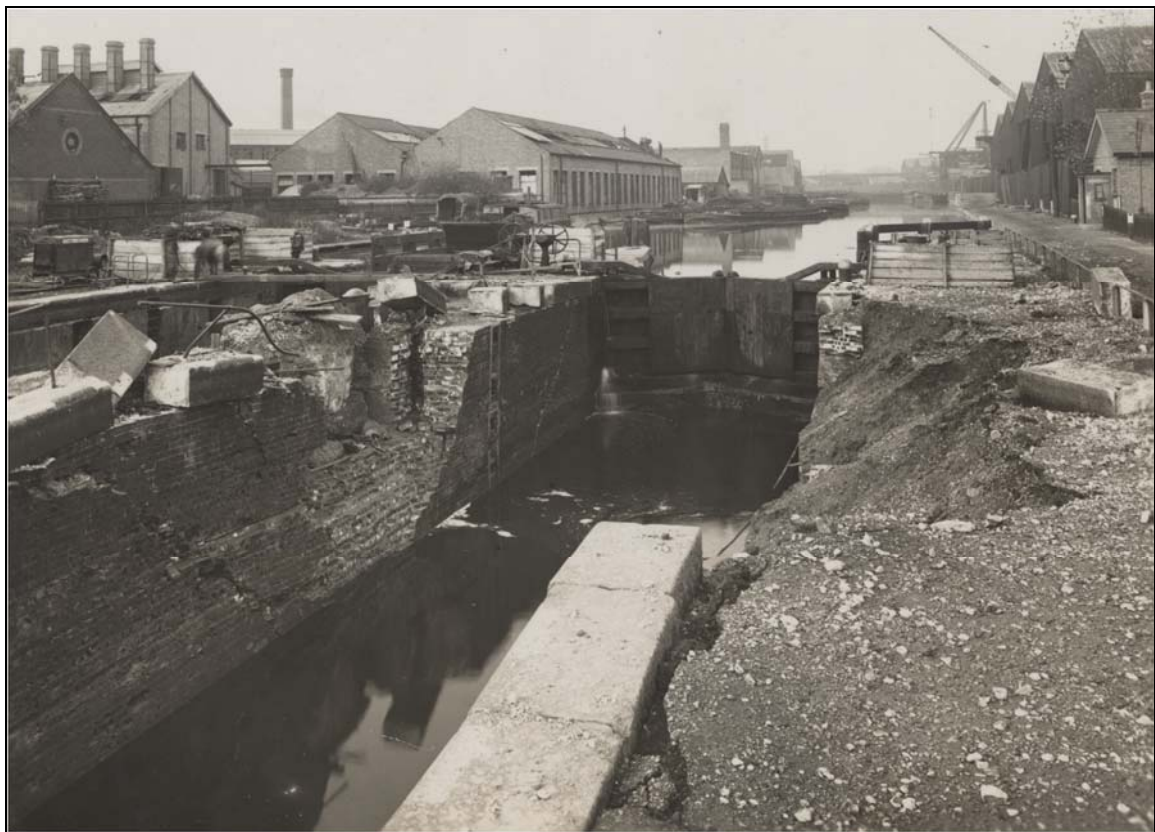
*Plate 8 View of bomb damage to eastern lock chamber at Old Ford Locks, October 1940 (ACC/2423/P/459/8A, courtesy of London Metropolitan Archives): OL- 05007*

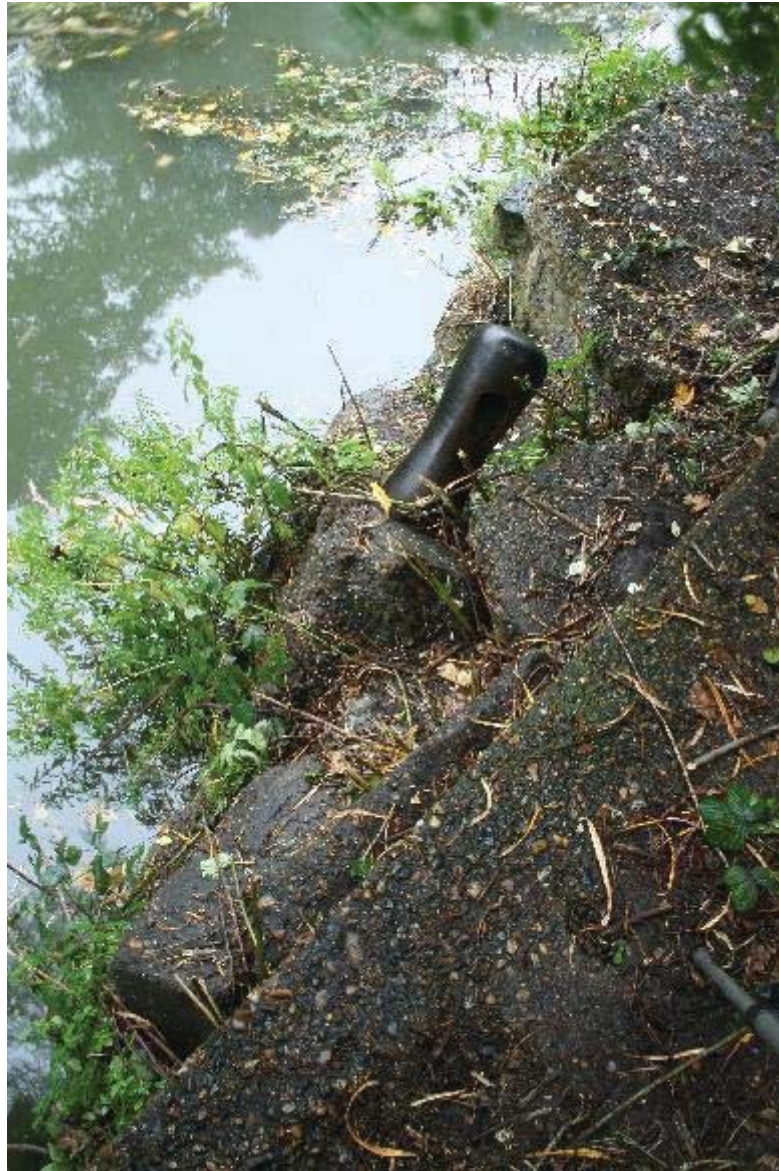
*Plate 61 Detailed view of damaged eastern wing wall with metal mooring post, Pudding Mill River, looking north-northwest: OL-05407*

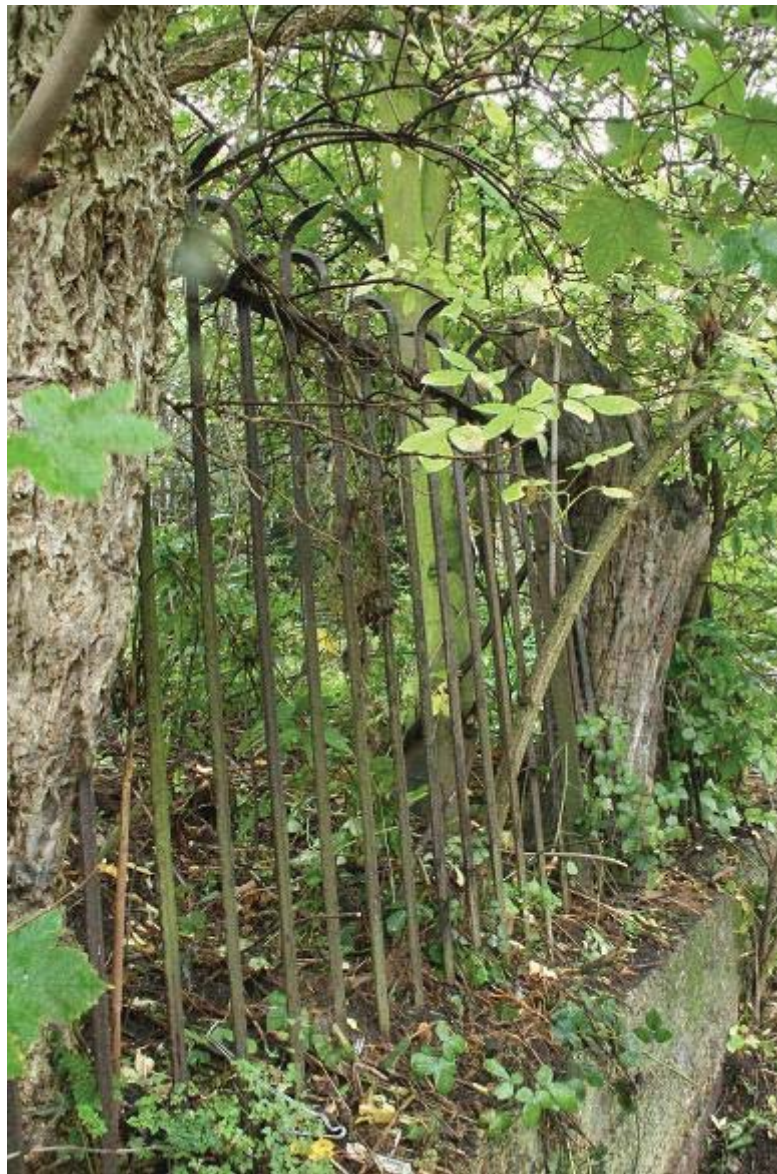
*Plate 62 View of metal fencing on east side of Pudding Mill Lock, looking south: OL-05407*
