## Church Stowe Elevation

| PLAN / SECTION NO.<br>#001 | DRAWN BY<br>LW | DATE<br>05.02.2021 | | | NOTES<br>Plan of tower<br>ground floor | SITE<br>Church Stave<br>ENNIO9979 | MOLA<br>Northampton |

| Project name: Church Stowe, St Michael's | | | Site code/<br>Accession No.: ENN109979 | | |

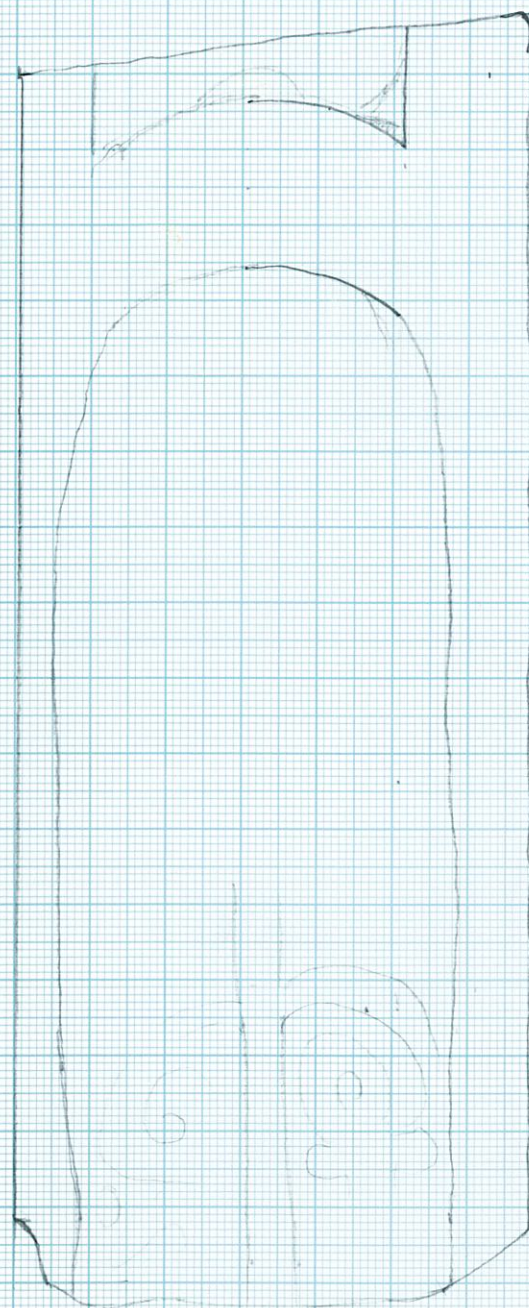
| PLAN / SECTION NO.<br>#002 | DRAWN BY<br>LW | DATE<br>15/05/2020 | | NOTES<br>Plan of tower attempt 2 | SITE<br>Church<br>stone<br>ENN109979 | MOLA<br>Northampton |

lesenes  
are set  
within stone

have roof line  
visible of previous  
higher open & pitched  
masonry w/ sandstone  
masonry w/ orange mortar  
w/ high aggregates

a lot of smaller  
stones used rather  
than the fairly  
consistent casing  
seen lower

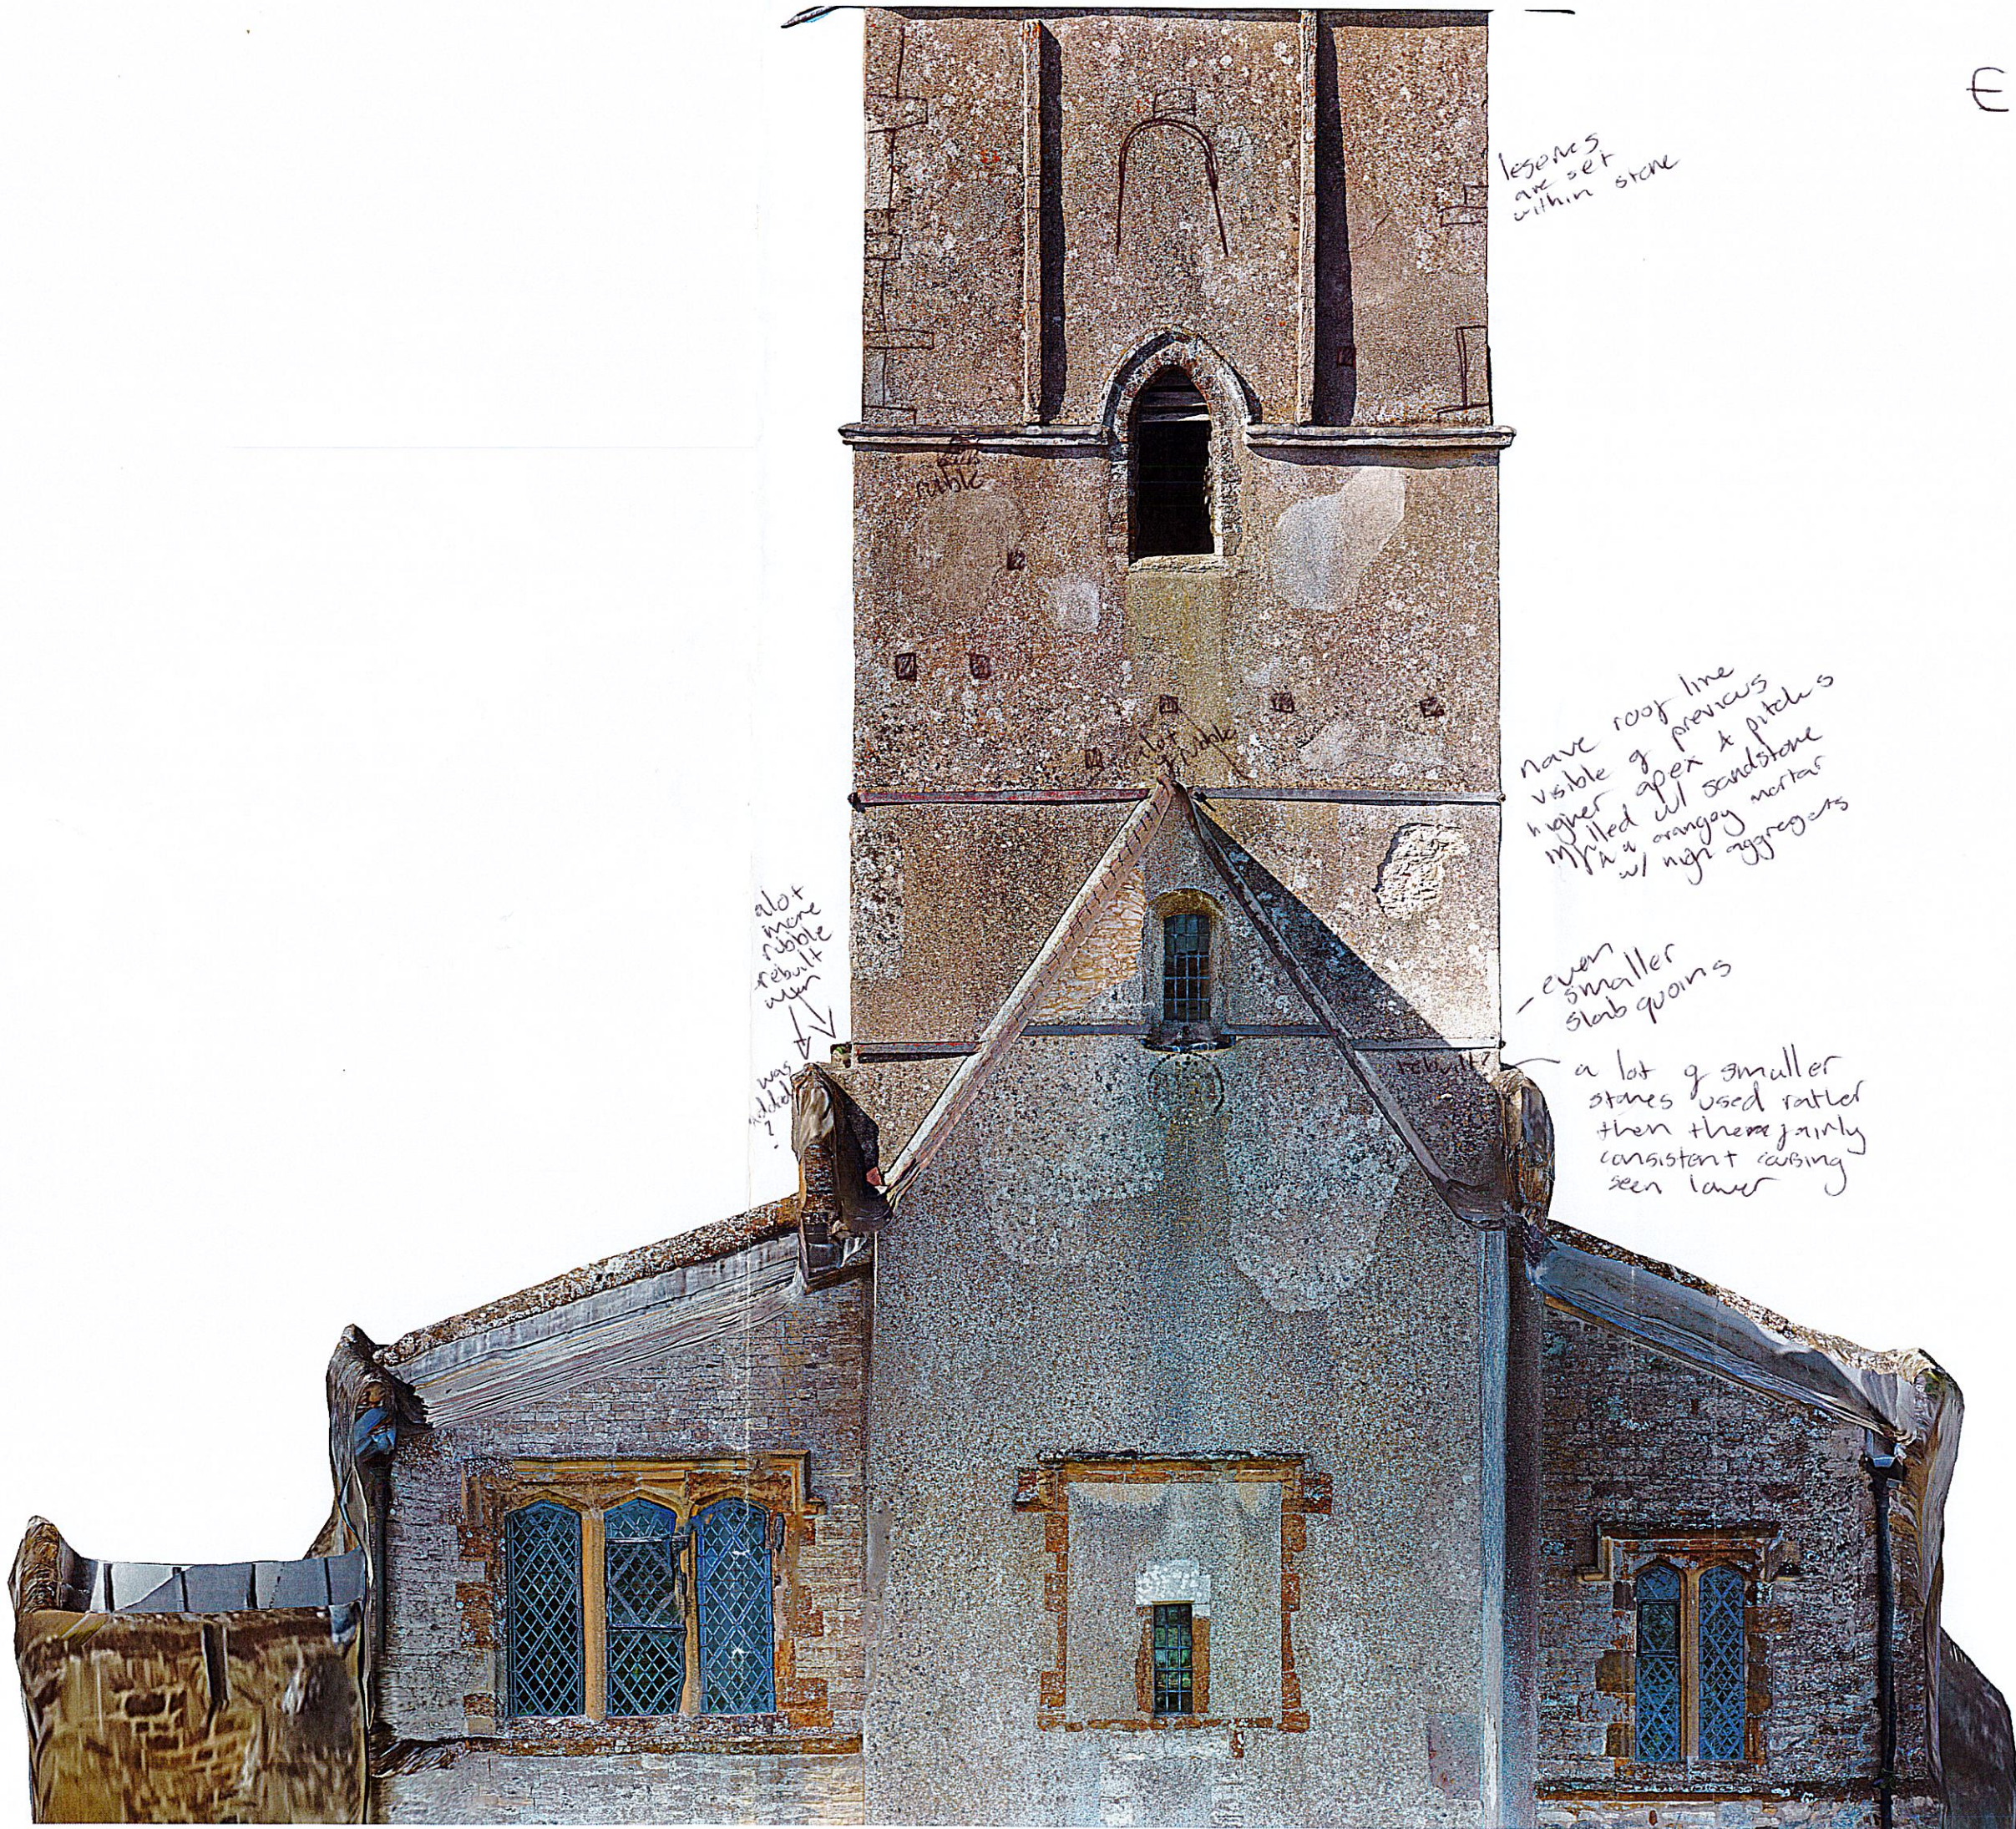
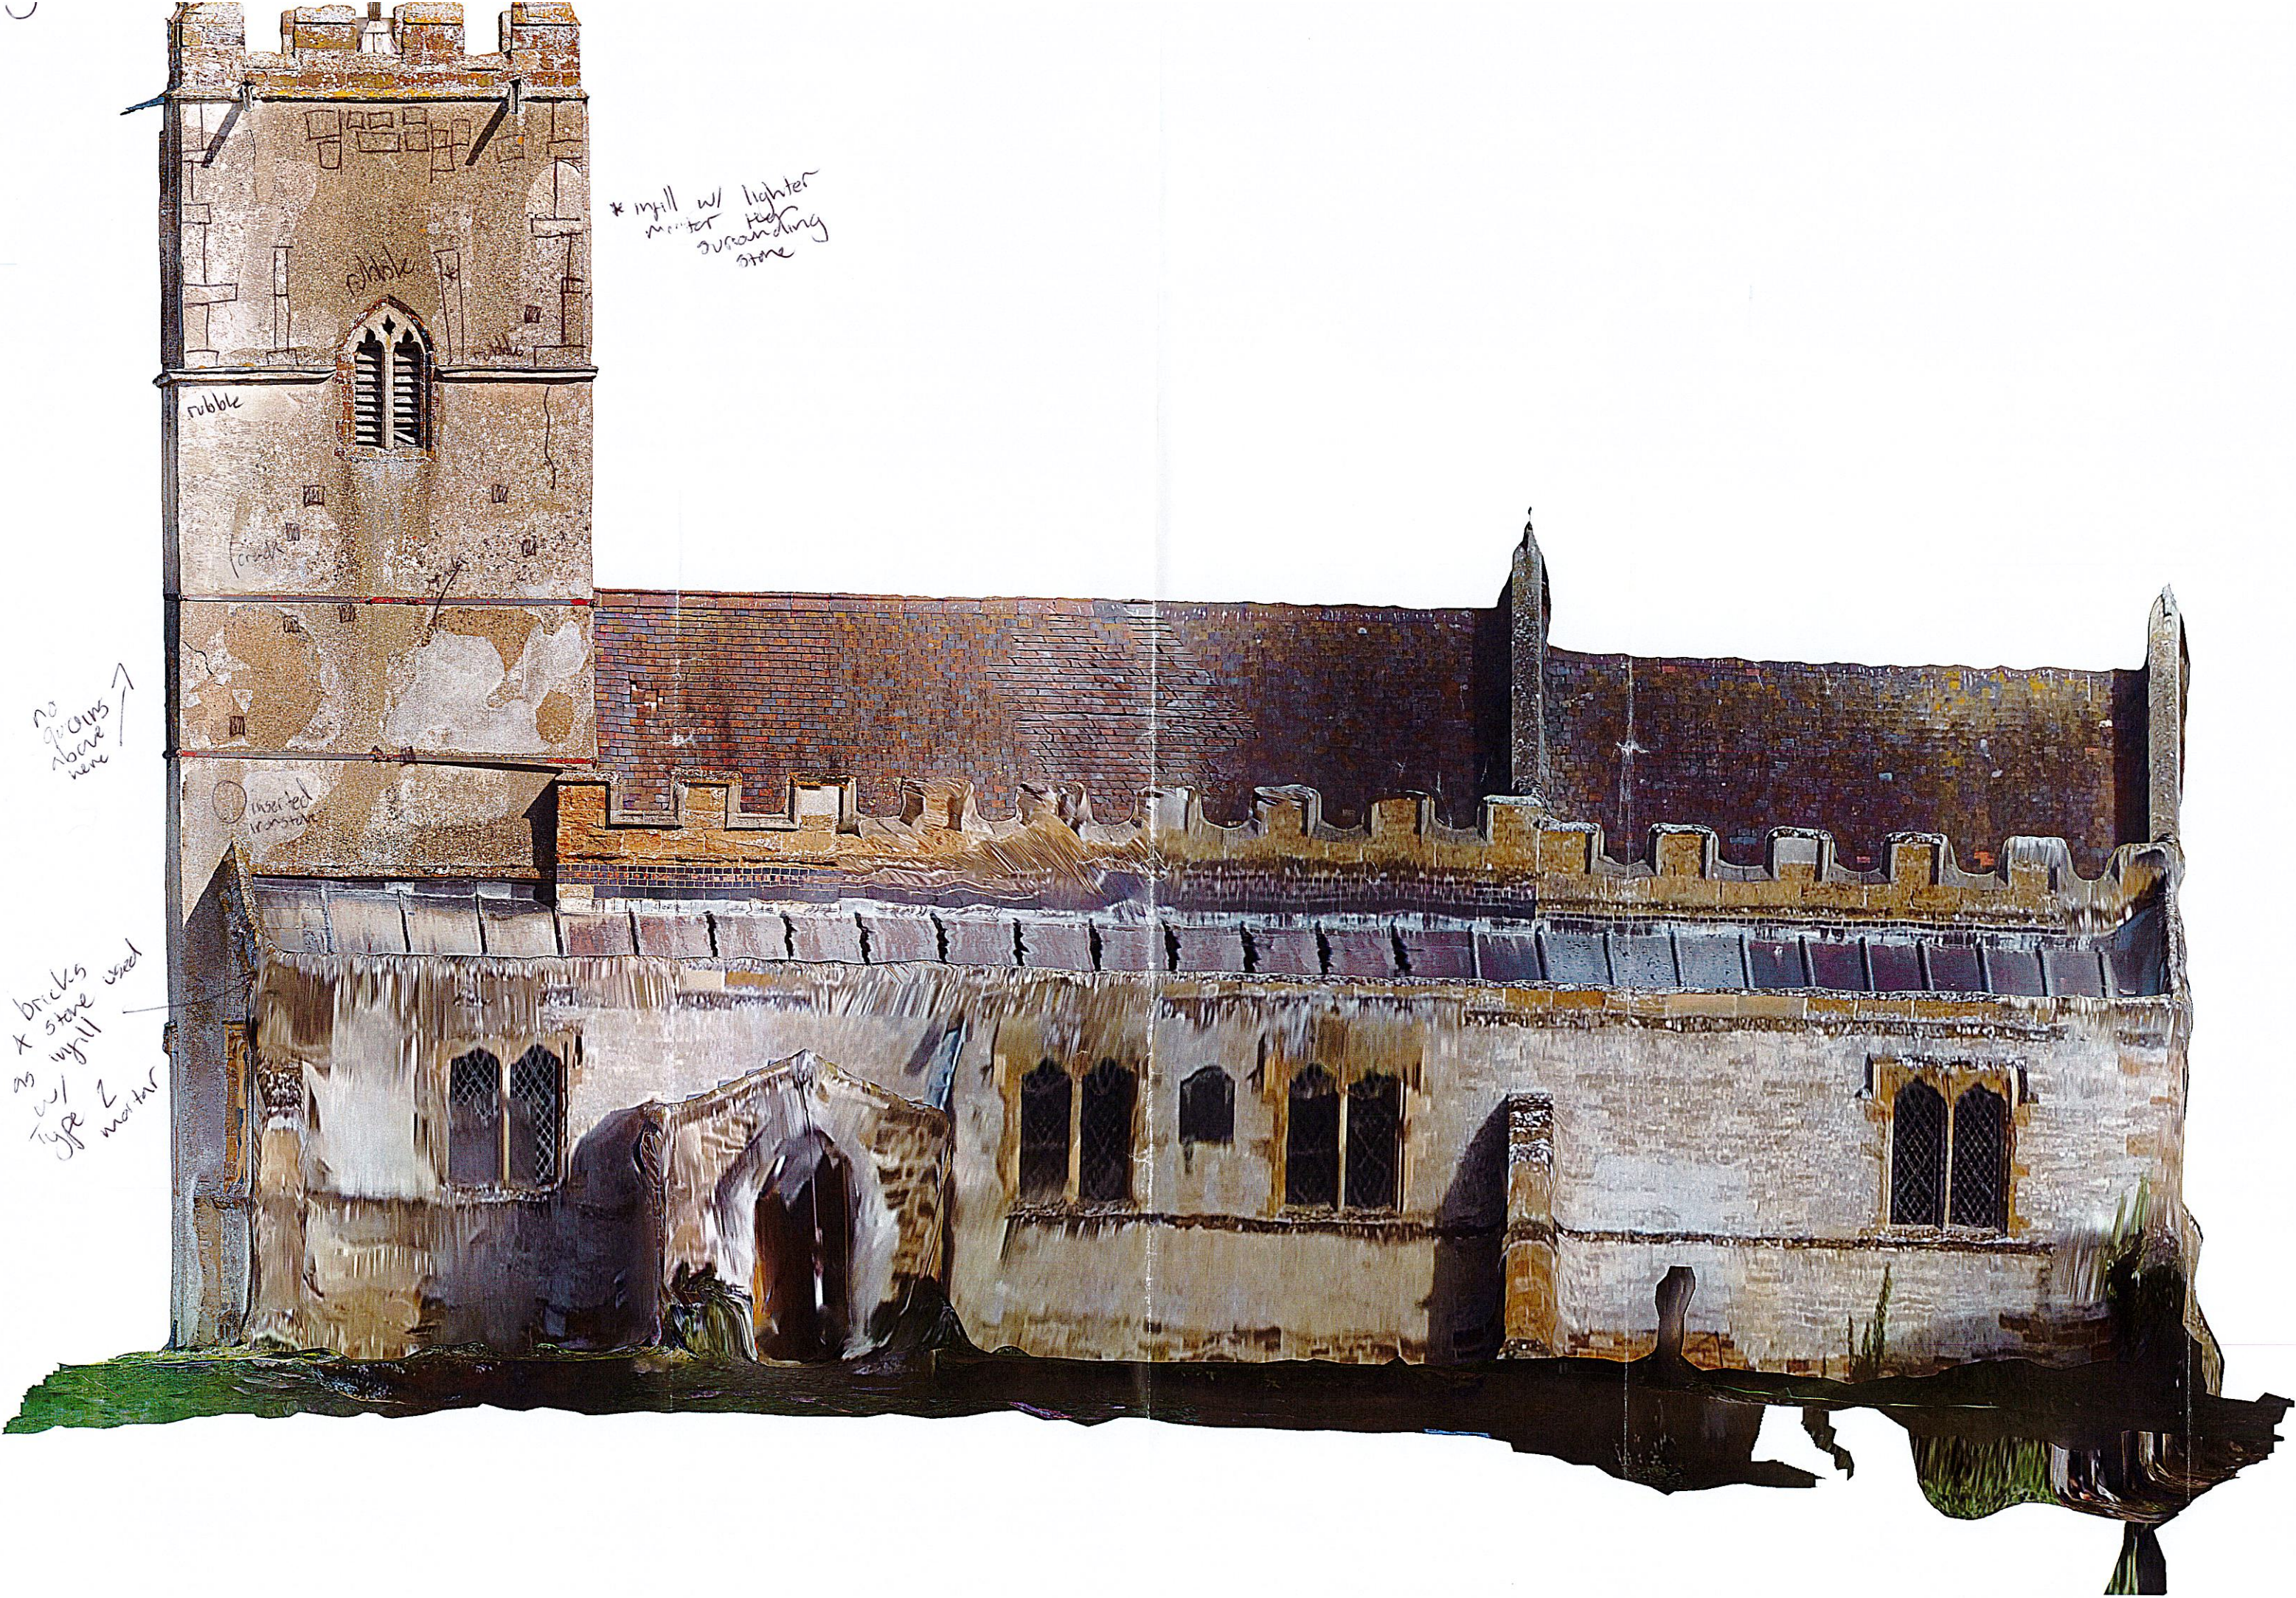
\* infill w/ lighter  
mortar  
surrounding  
stone

no  
gables  
above  
here

x bricks  
w/ stone  
infill  
type 2  
mortar

inserted  
transept

Type 1  
does appear  
original where  
has been left

Window  
has large  
gap between  
stone either  
side

PT  
masonry  
has been  
pinkish  
x large  
aggregates  
visible

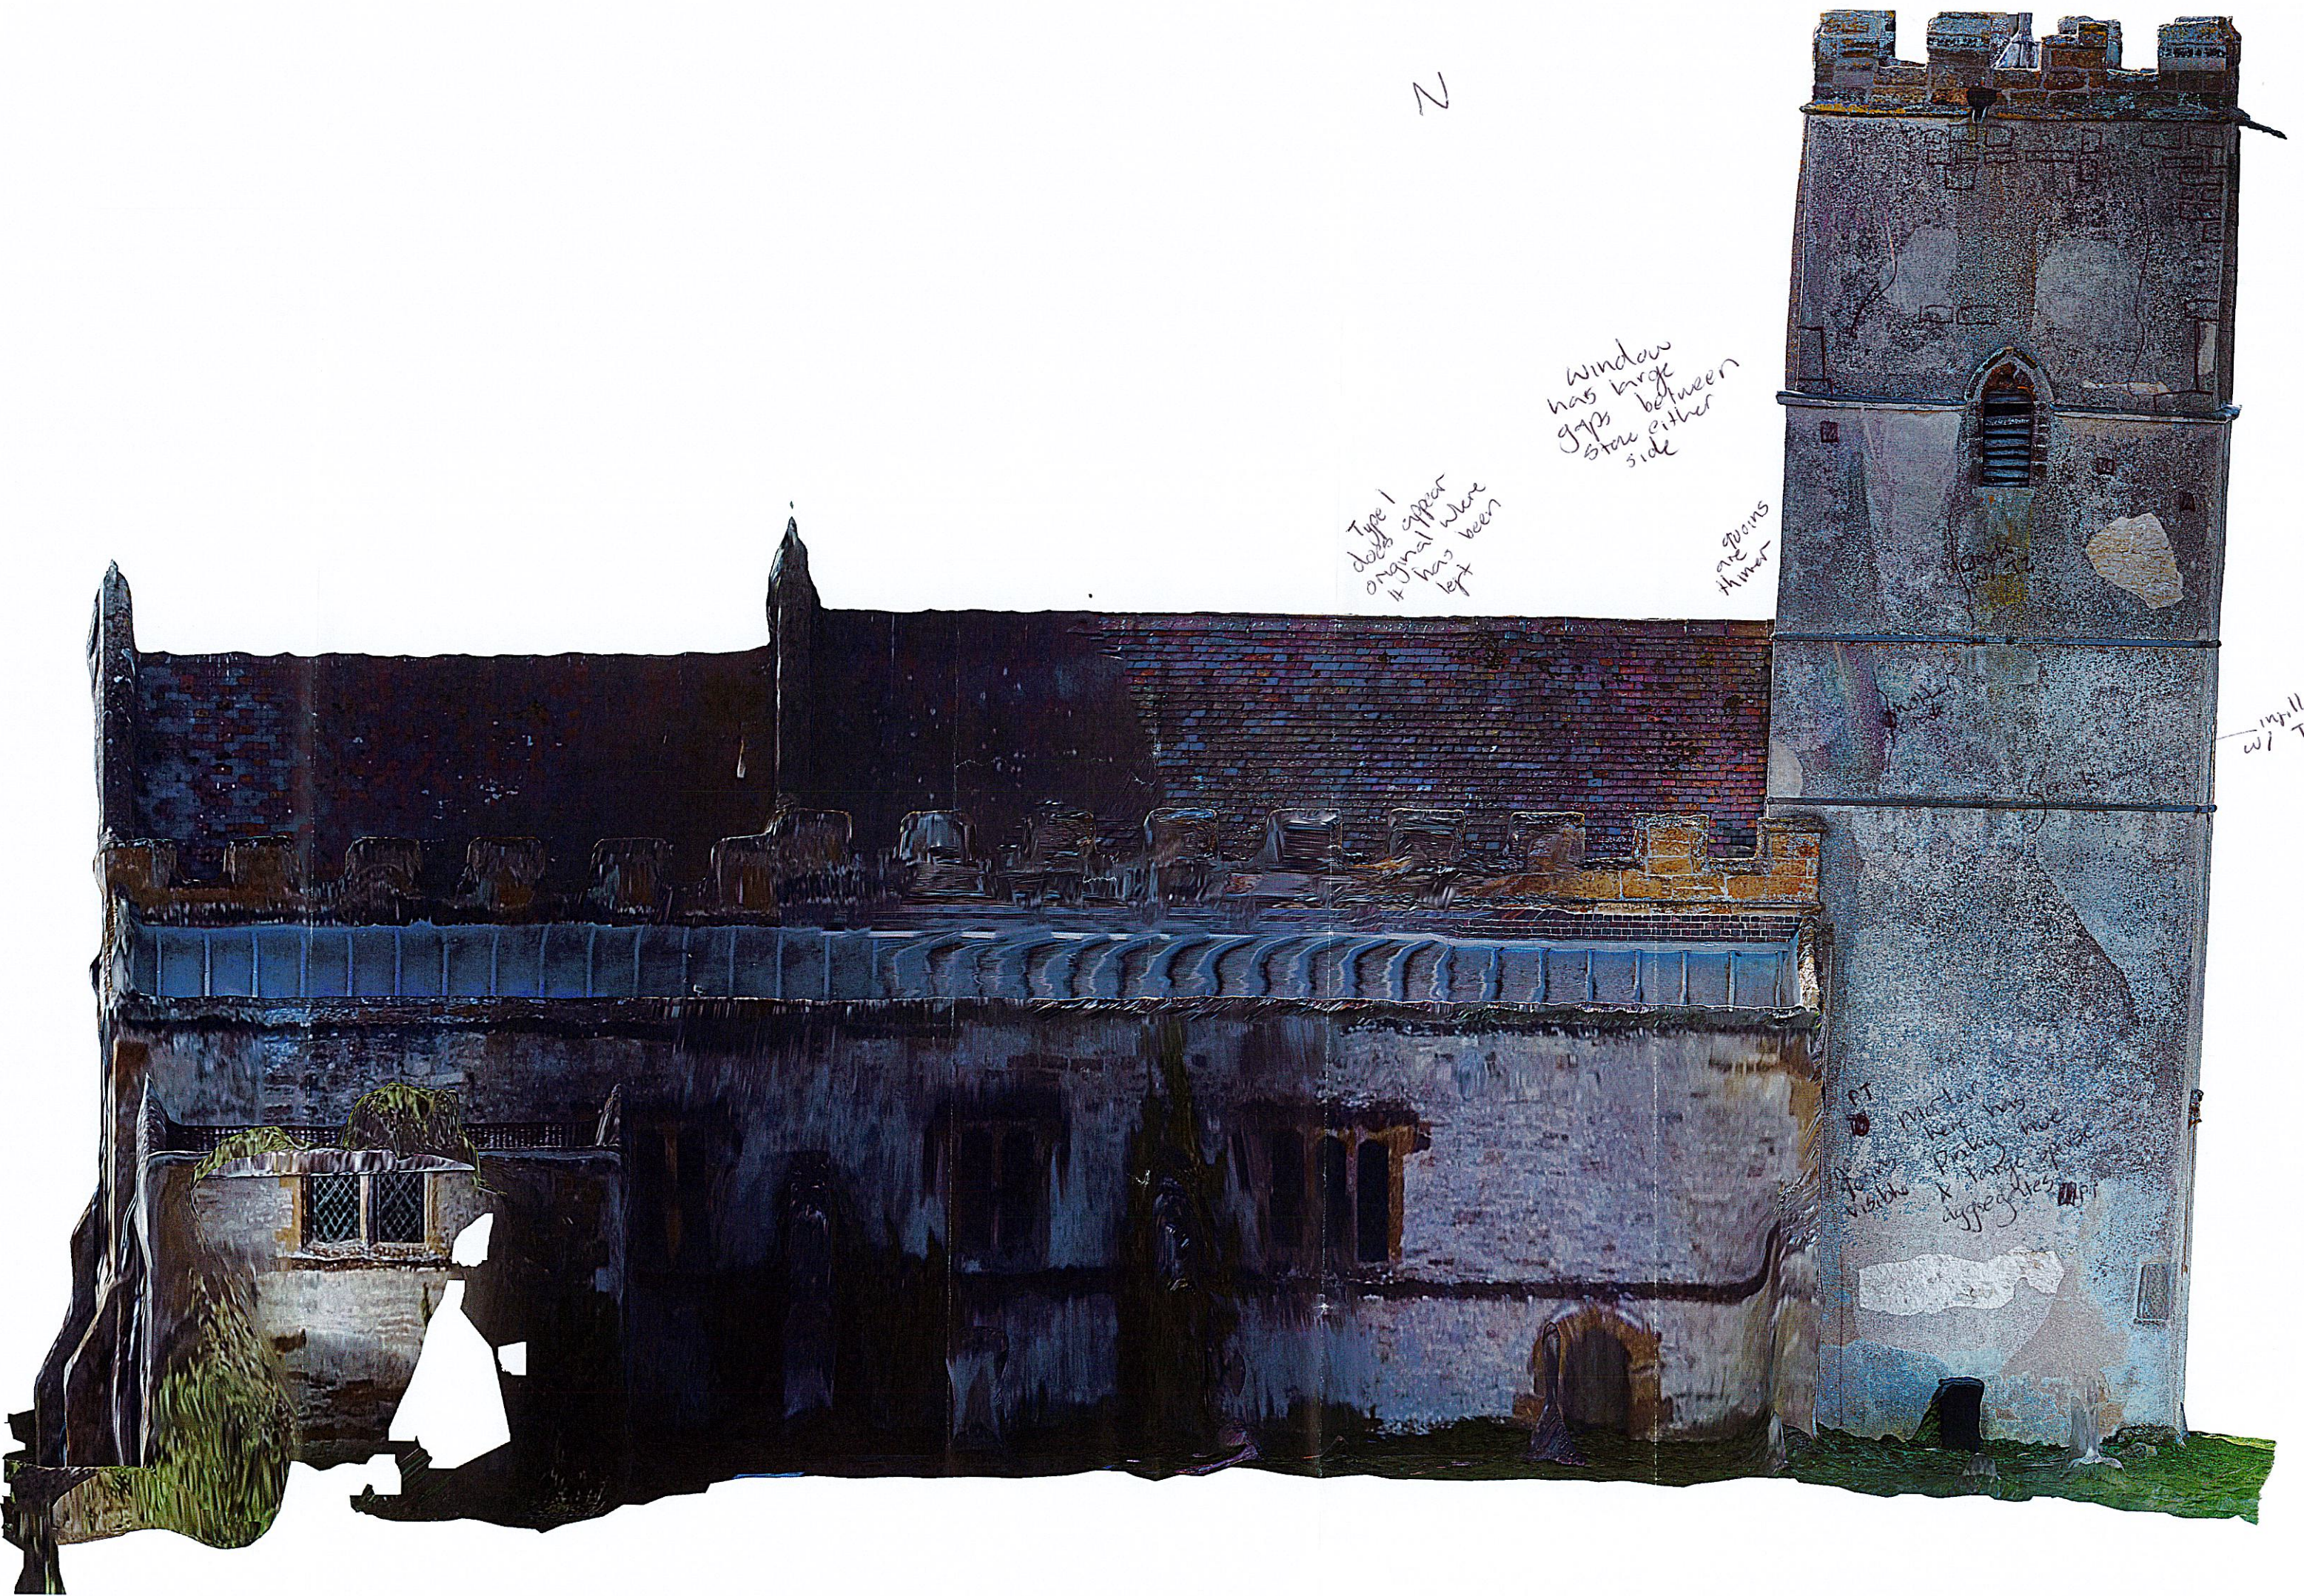
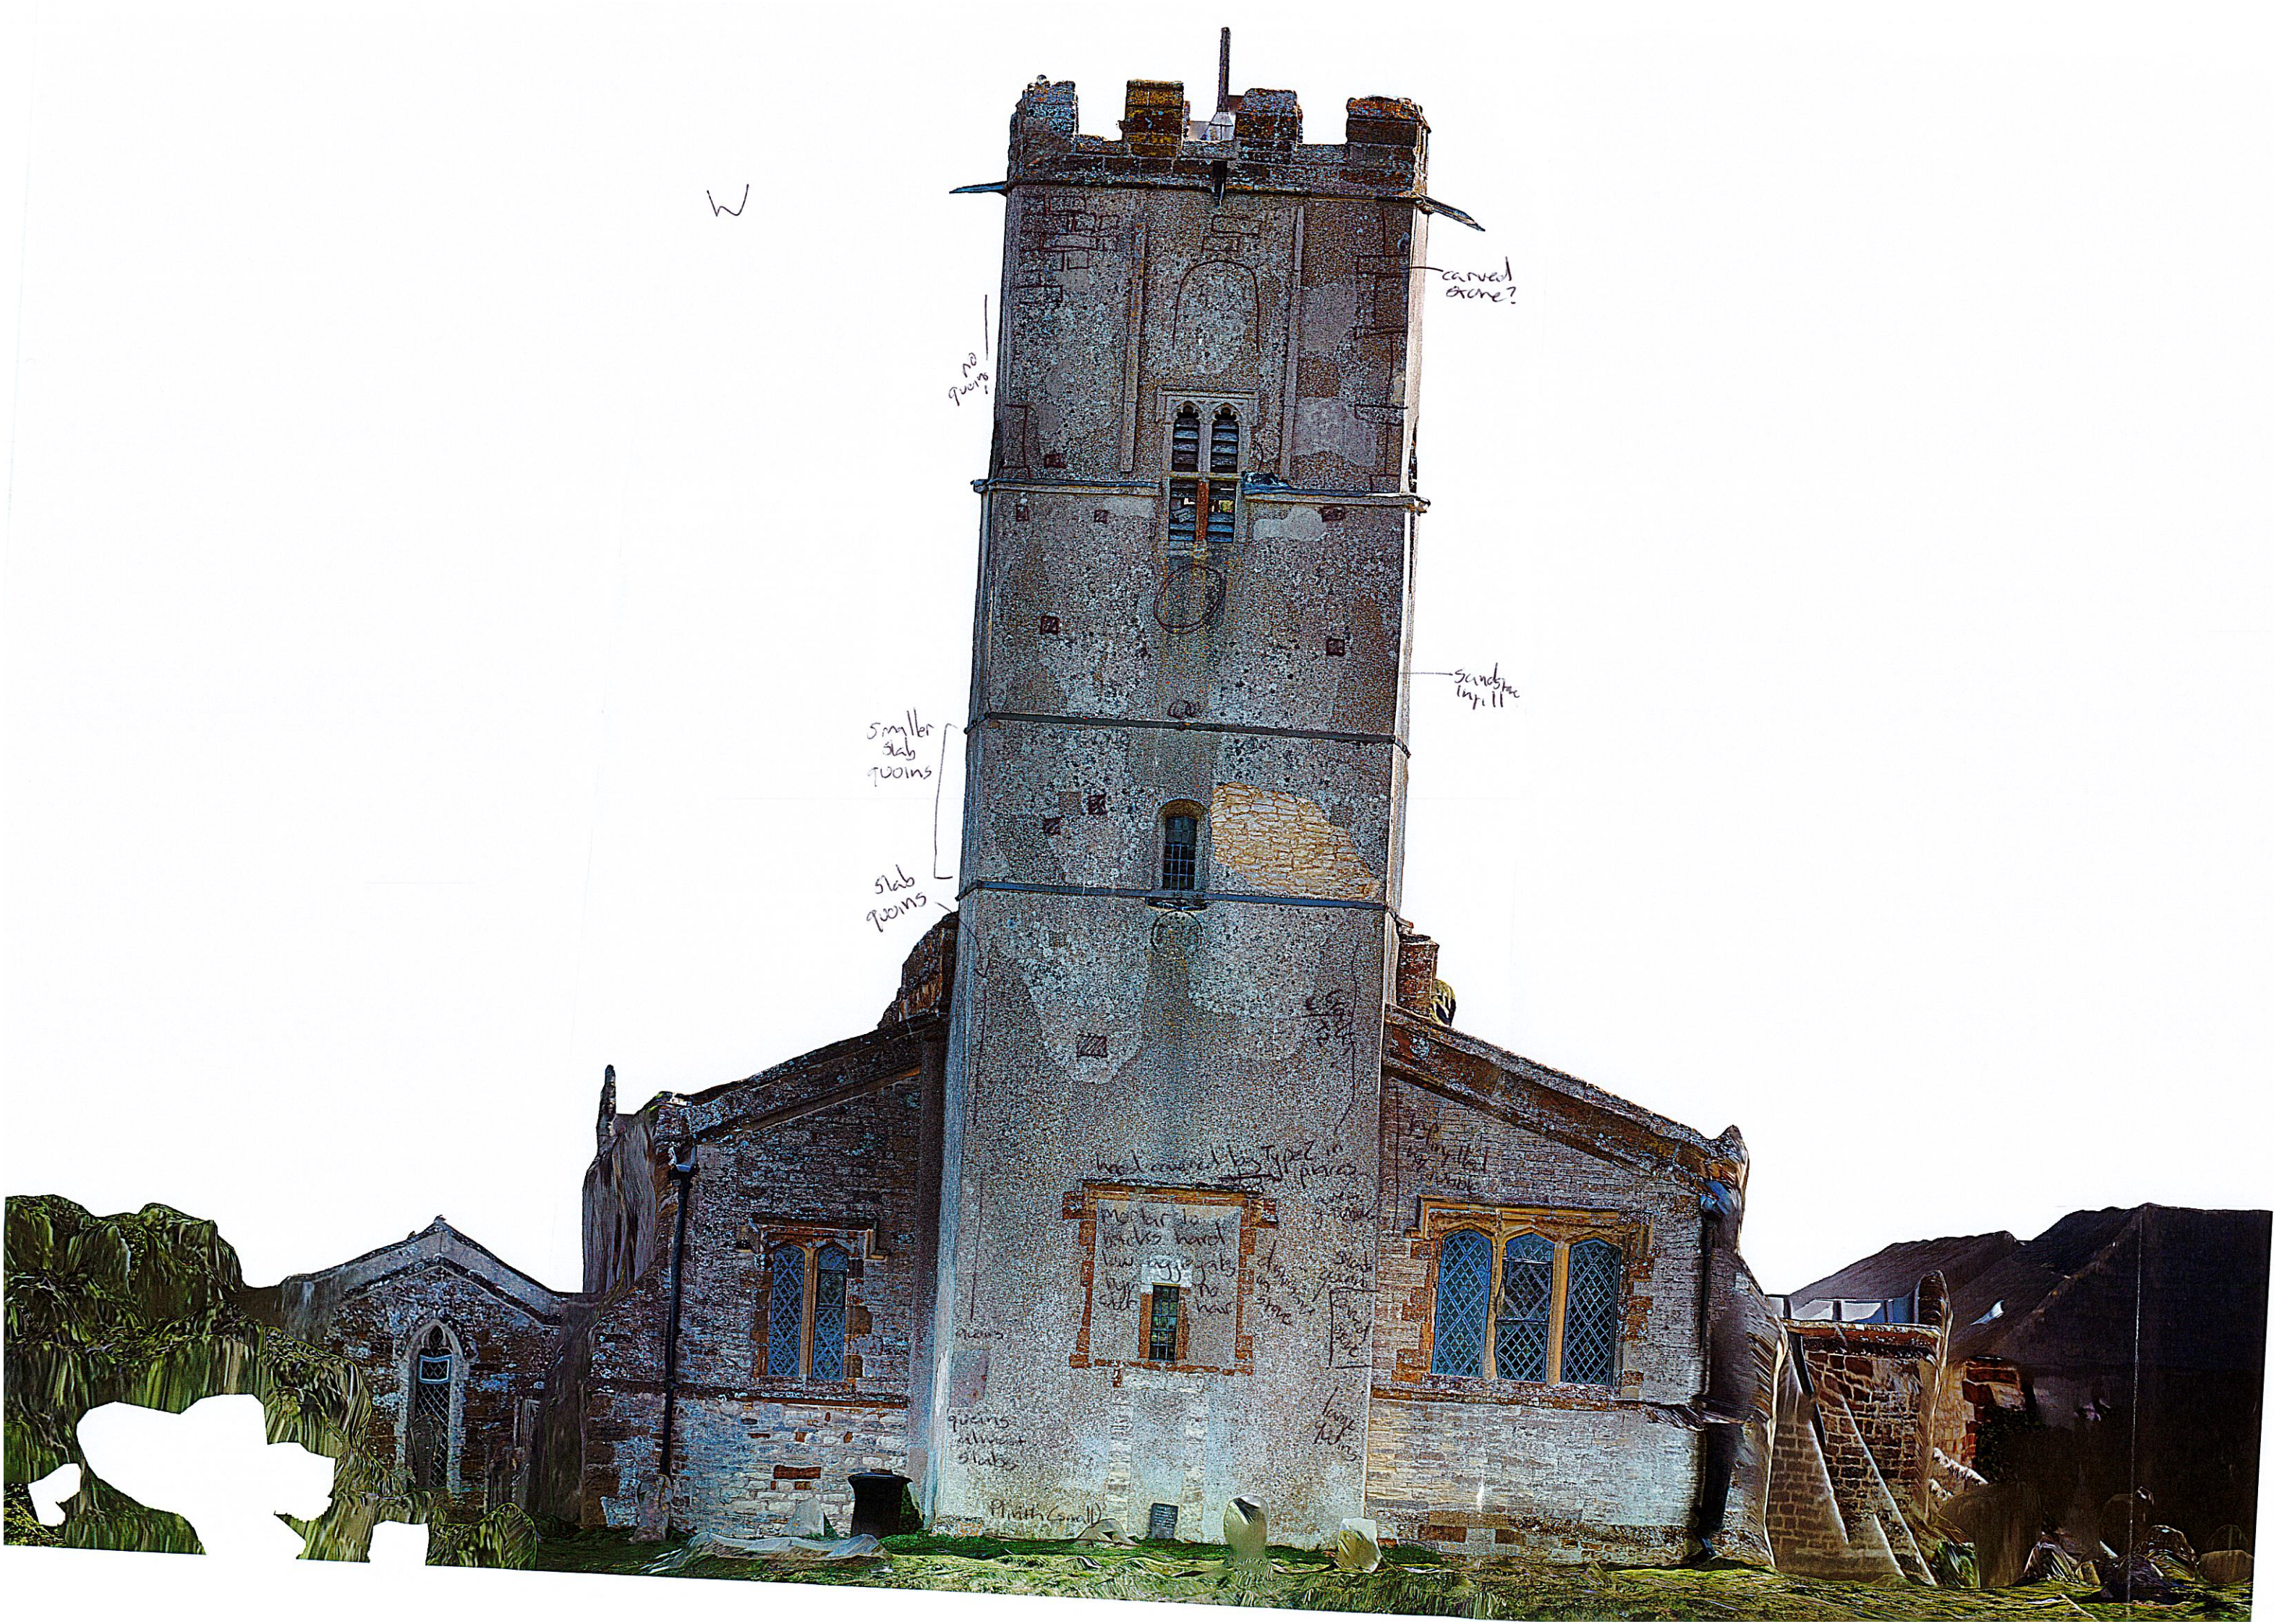
no  
quoins

carved  
stone?

sandstone  
infill

smaller  
slab  
quoins

has lowered by type in piers

quoins  
almost  
slabs

Plinth (small)

large  
quoins
