Monitoring SI Works

1. As an element of the proposed Site Investigation works at Clydebank Business Park two trenches were excavated across the abandoned line of the Forth-Clyde Canal. The location of these trenches was agreed with James Barr on behalf of Northern Marine Management and approved by West of Scotland Archaeology Service (WoSAS). The trenches were located on site by the URS engineer, William Warnock. BACTEC bomb disposal were also present on site.

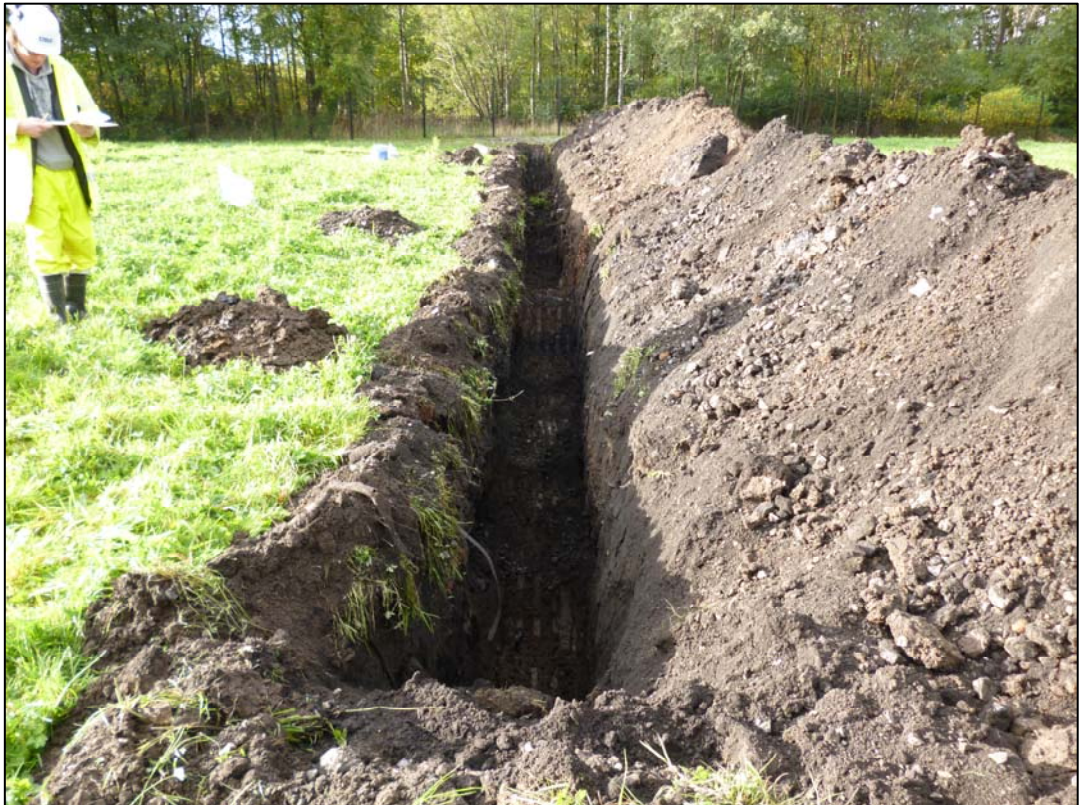
Figure 1: Trench 1 from the north-east

3. Trench 1 (NGR: 49040 70903 to 49010 70884) was excavated to an approximate south-west to north-east orientation for a total length of 32m. Its location was chosen in order to give the best possible chance of encountering remains of the original canal. The approximate location of the original canal was based on interpretation of the 1st edition Ordnance Survey mapping and so we can be confident of accuracy to an error of at most a few meters. Trench 2 (NGR: 49004 70936 to 49000 70906) was excavated to the north-west of Trench 1 and to an angle closer to north/south. Trench 2 was 28m long. Coordinates of the trenches were recorded using a hand held GPS showing an accuracy of about 3m.

5. Where possible both trenches were excavated to a depth of at least 2.5m. Trench 1 reached a maximum depth of 2.8m, Trench 2 to a maximum of 2.7m. Both trenches were excavated entirely through made ground. The base of each trench was light brown silty-clay. Examination of bucketfuls of this clay brought up by the machine confirmed that it contained modern rubbish, including, late 20th century glass, brick rubble and industrial waste. This suggests that the disturbed ground continues to a minimum depth of approximately 3m below current ground surface.

6. The fills of each trench, as was observable in both sections, comprised multiple overlapping layers and deposits of made ground mostly containing material which was obviously late 20th or 21st century in date. These layers included wood, plastic, glass, brick, fabrics metal and general trash. In neither trench was there any sight of intact structural remains either in the form of a wall or in the form of packed clay which would suggest a canal. In neither trench was there a large vertical cut which would suggest excavation for a canal. In neither trench was there a large single or consistent backfill which would suggest filling a large cut in a single event. In neither trench was material that could be interpreted as natural, undisturbed subsoil observed. It is reasonable to interpret that there is no sign of the canal in either trench and therefore if it does survive in this area, it is at a depth of more than 3m.

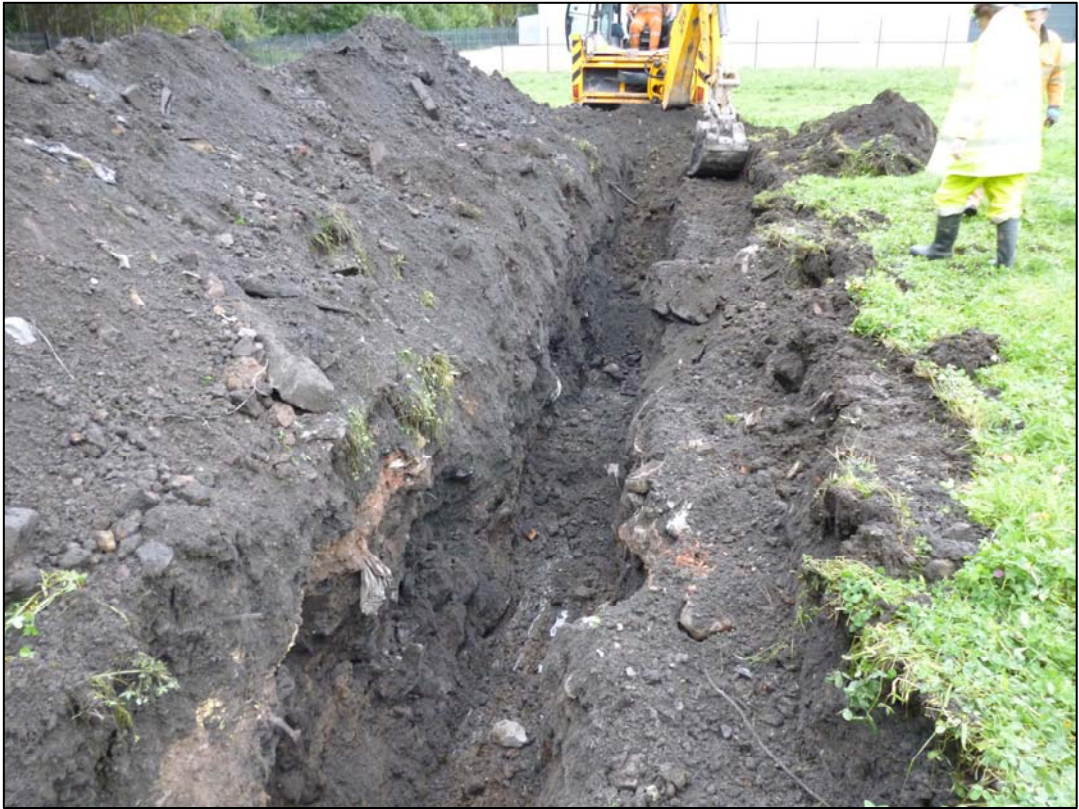
Figure 2: Trench 2 from the south

4. Excavation was carried out using a JCB 3CX with an 800mm toothed bucket. A toothed bucket was necessary because of the number of large stones which had to be removed from the excavated trench and also to permit safe excavation at depths of more than 2m. The trenches were prone to collapse due to the unconsolidated and variable nature of the deposits. Neither of the trenches was safe to enter. In order to permit safe observation of Trench 2, the top 1m of the trench was stepped back by about 1m.

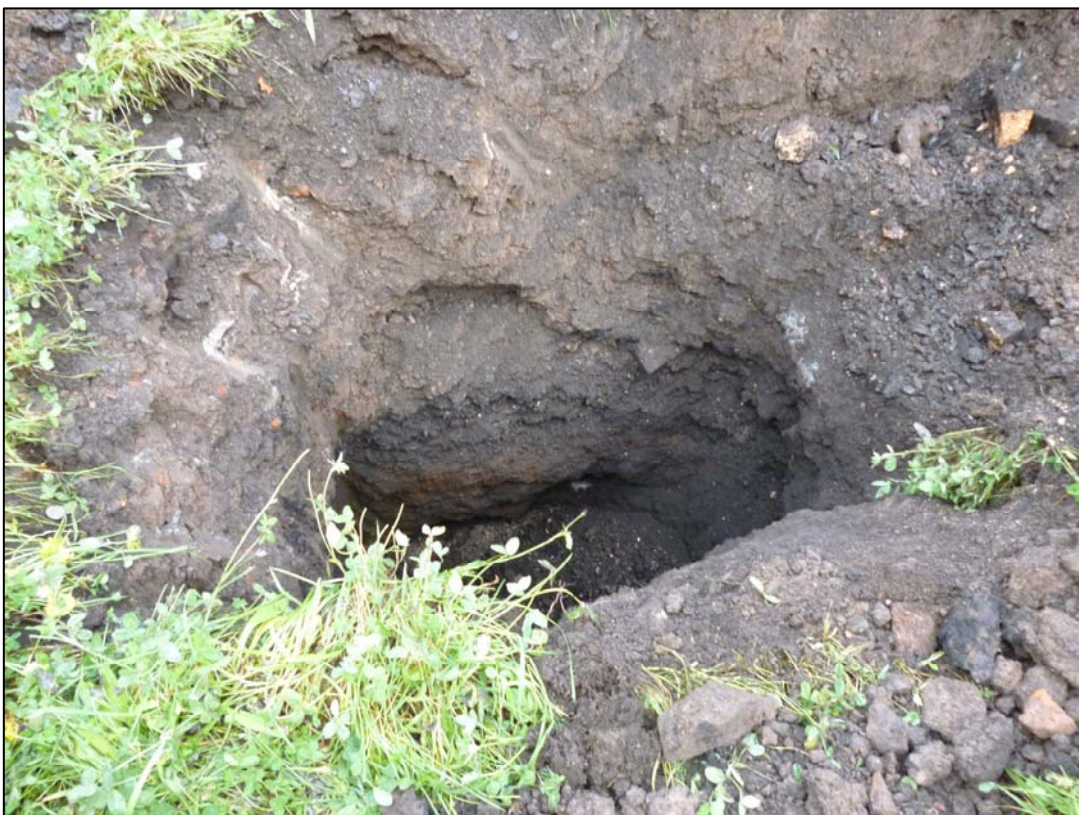
Figure 3: Test Pit 1 from the south

7. In addition to the two trenches a single test pit was excavated in the north-west corner of the site. This test pit was one of eight which are planned to be completely excavated

on the 25th October 2013. The test pits are being excavated as an element of the Site Investigation works. The test pit excavated reached a depth of 2.4m. The remainder of the test pits are expected to be excavated to a depth of less than 3m. Most of these test pits are to be located well outside the possible abandoned line of the canal. It is unlikely that these test pits would disturb the material remains of the canal if it survives and so it was agreed, after consultation with WoSAS, that there was no need to monitor their excavation.
