### *Context*

### *Description of the Pulpit*

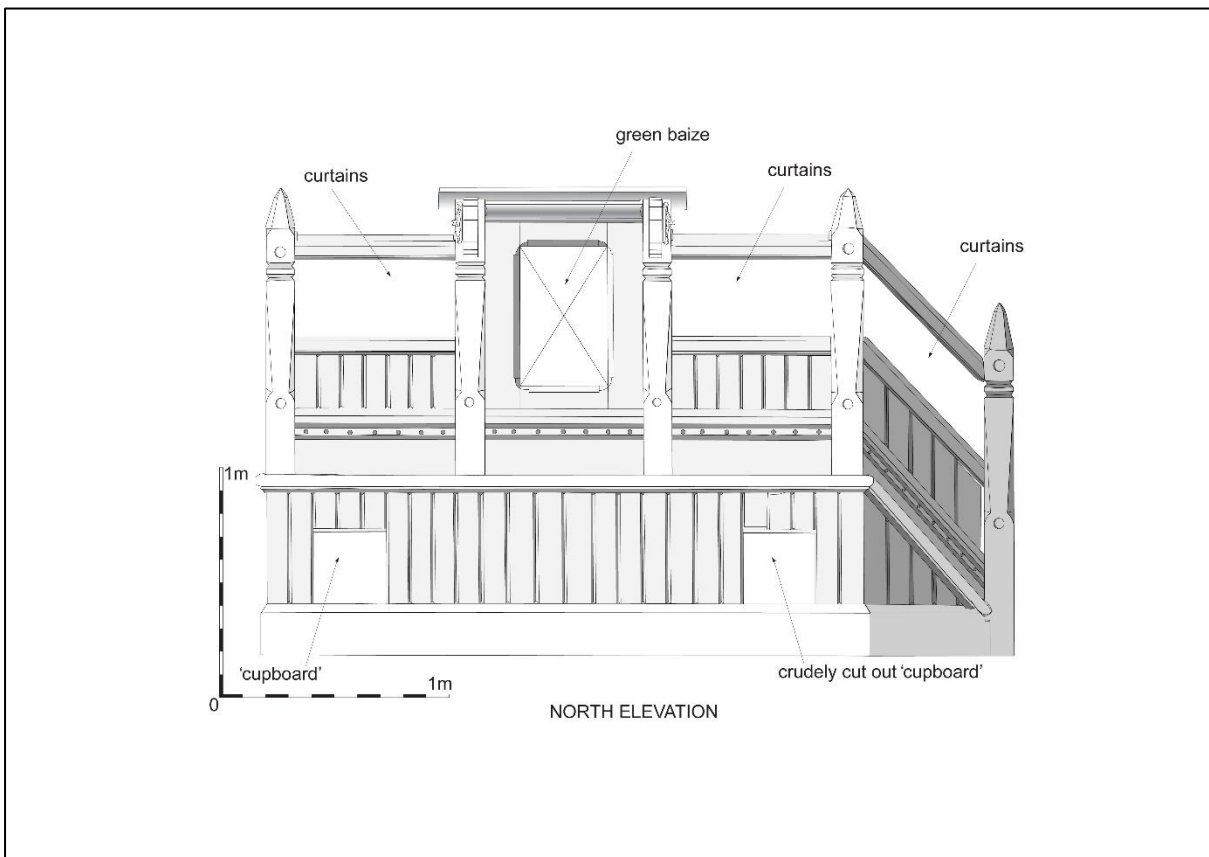
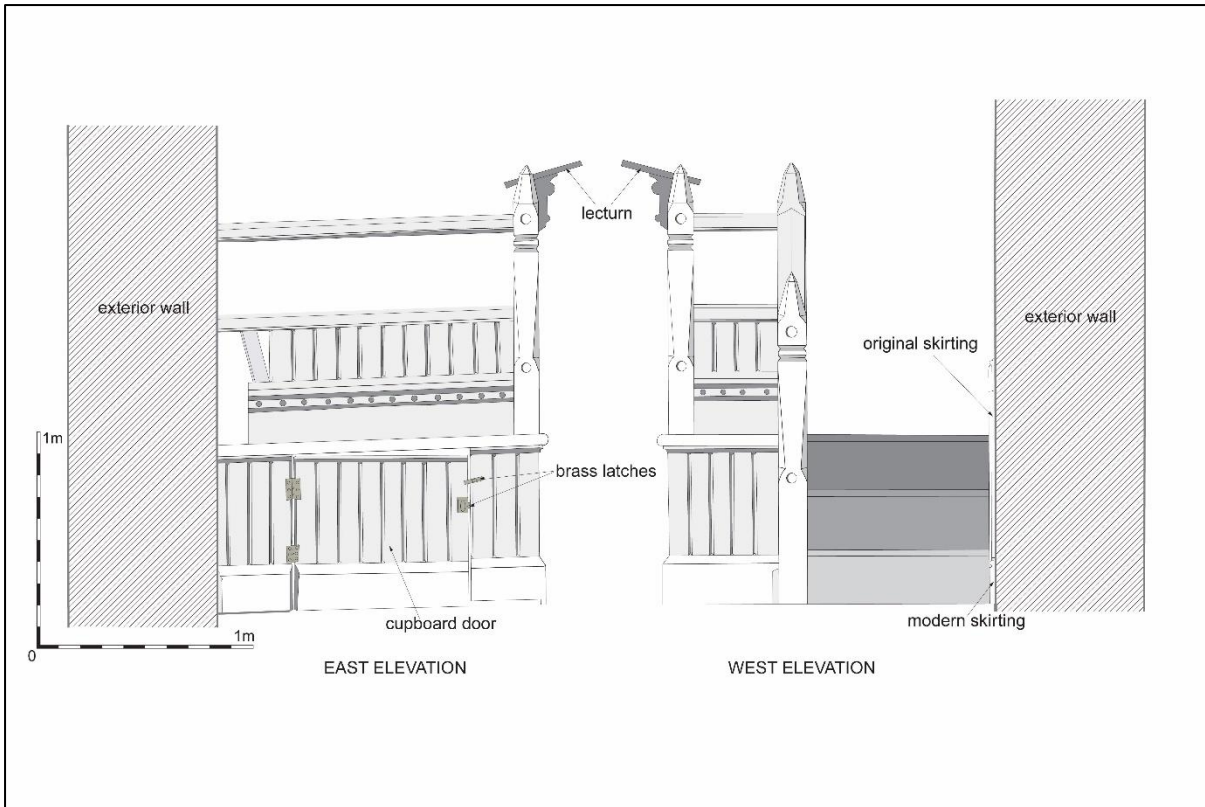
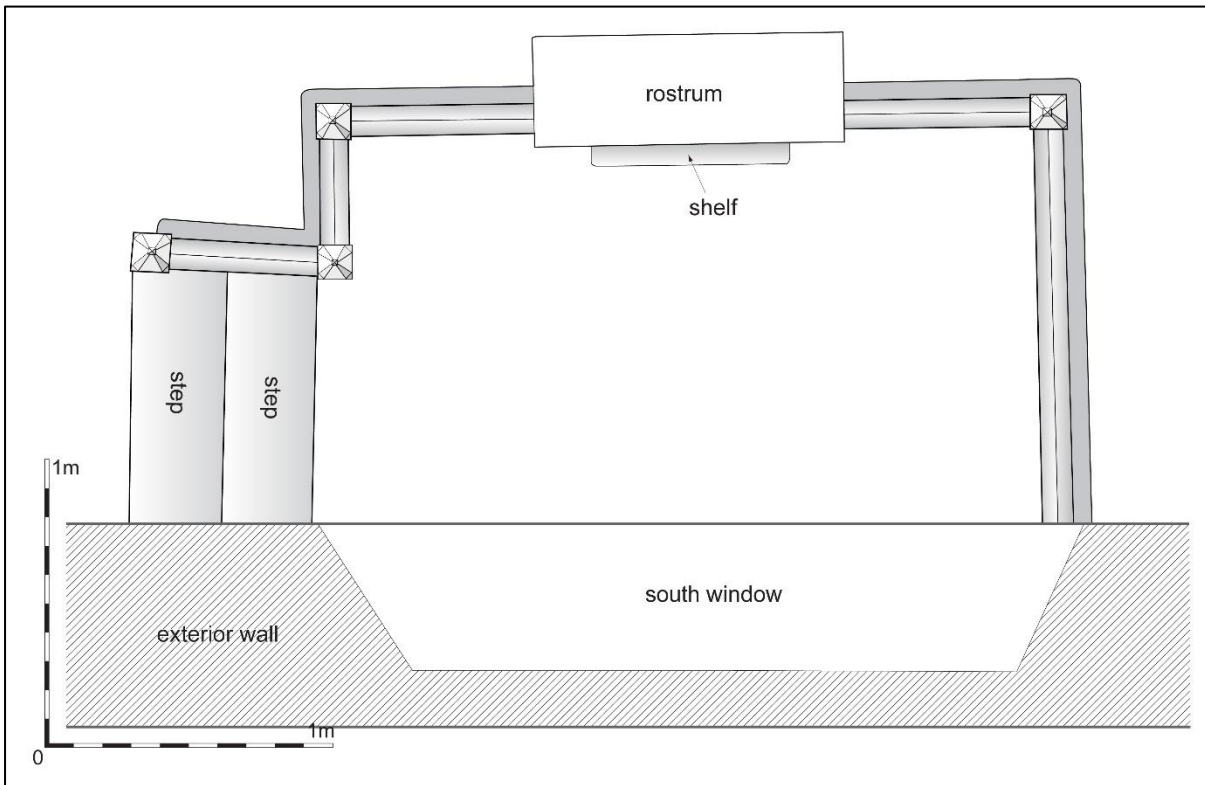
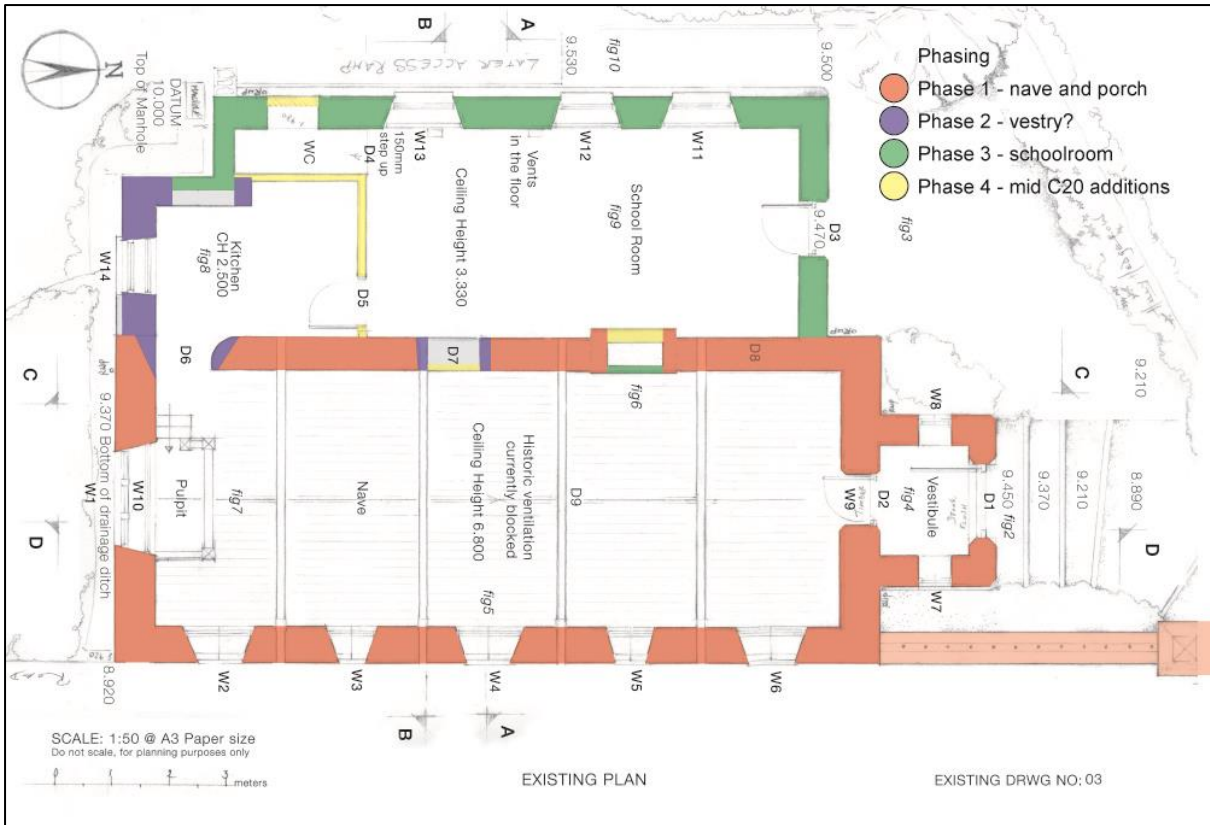
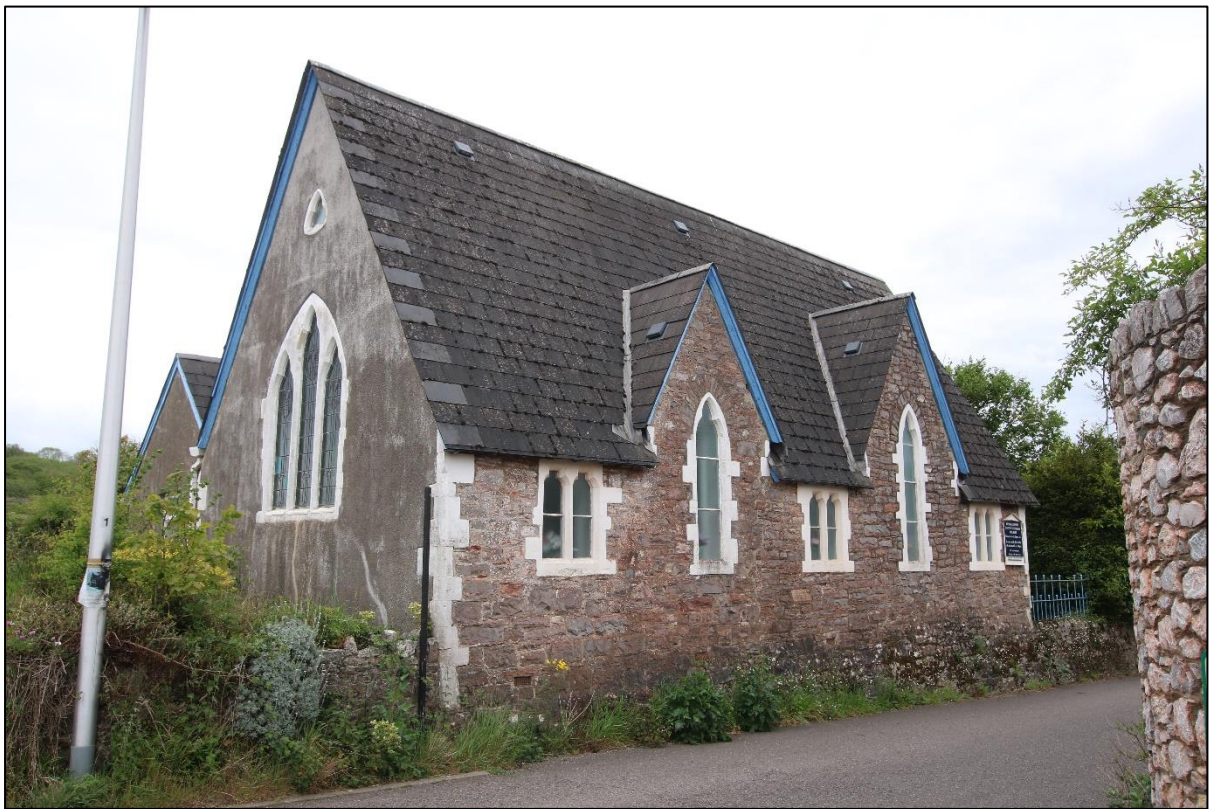
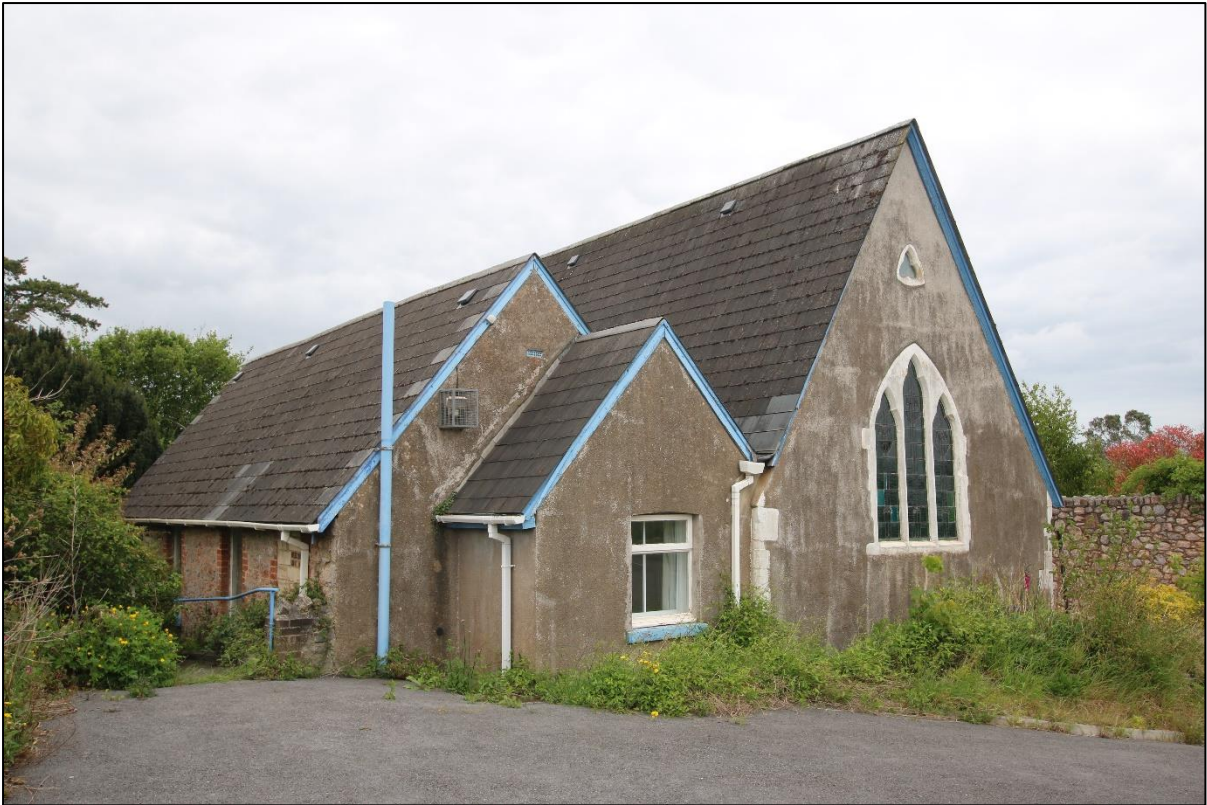
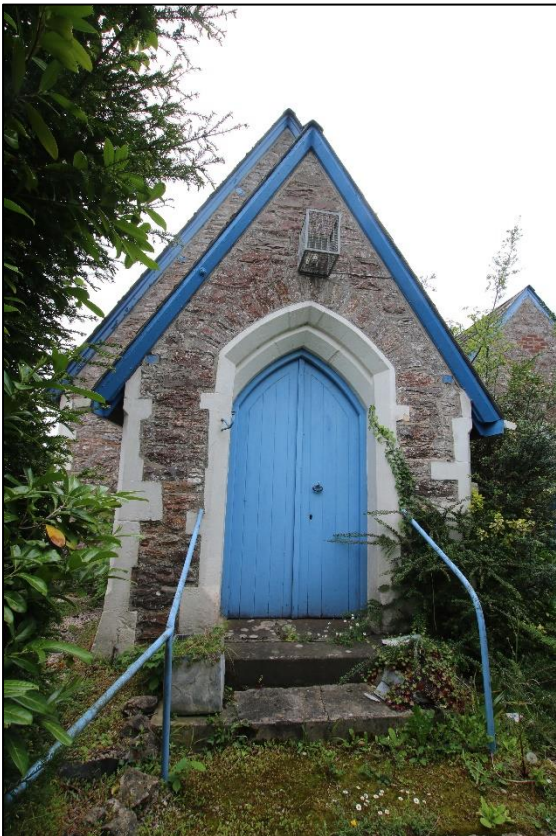
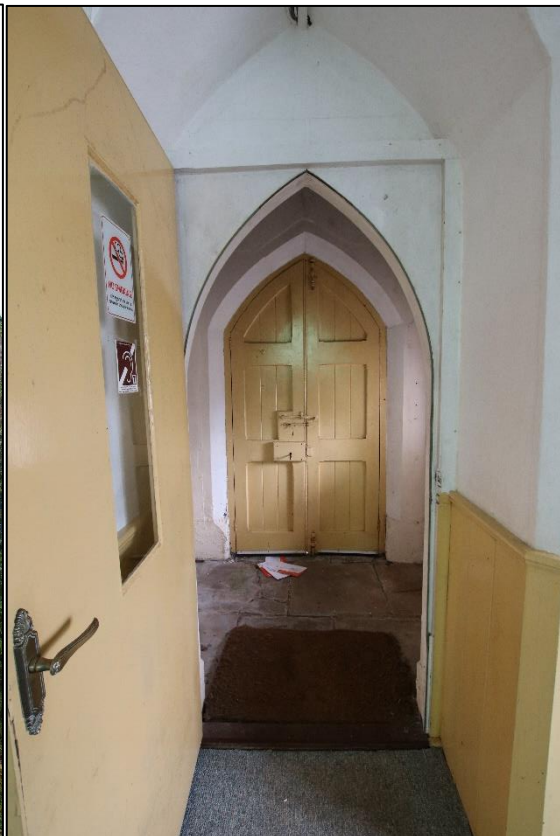
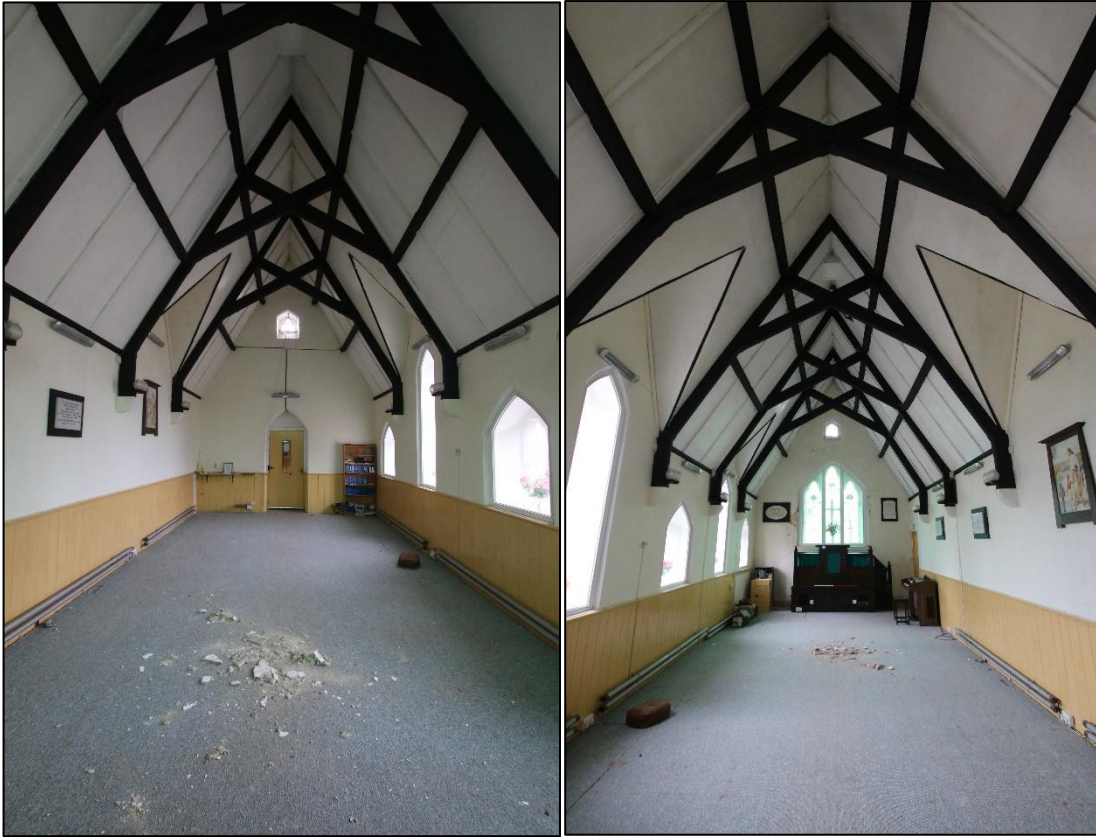
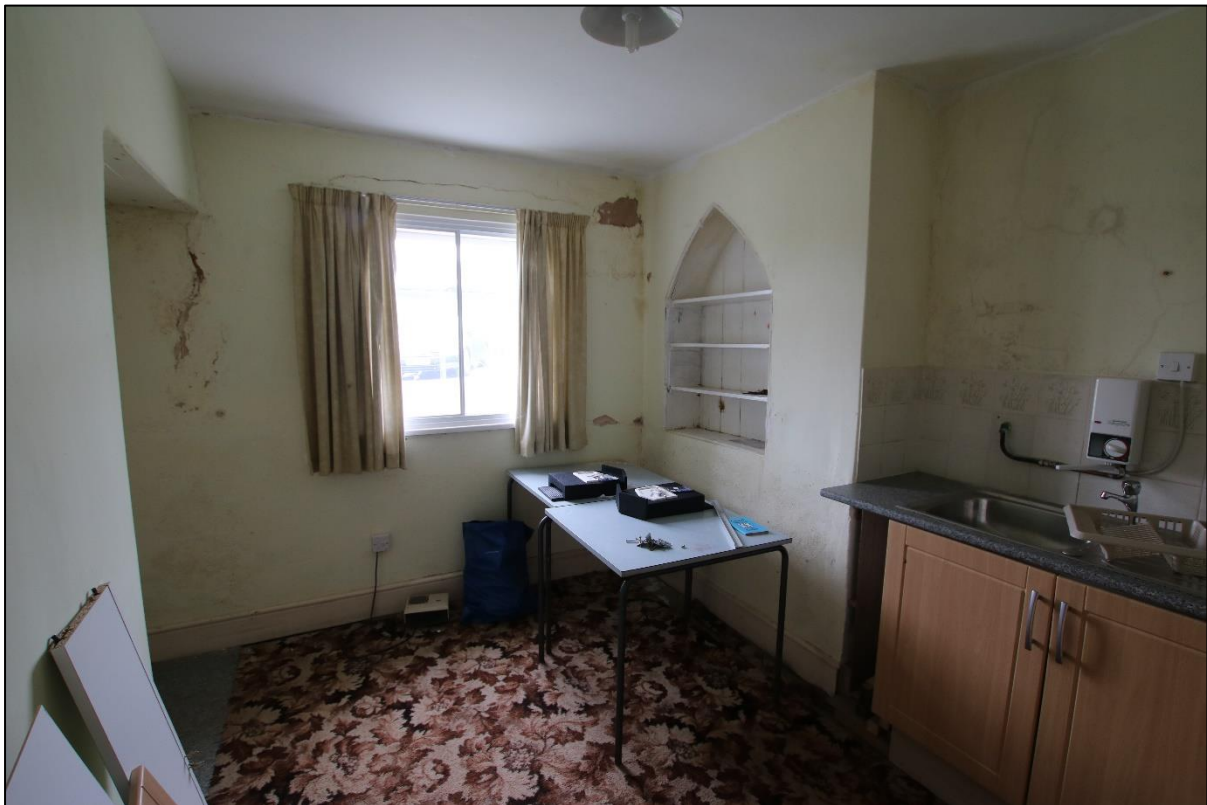
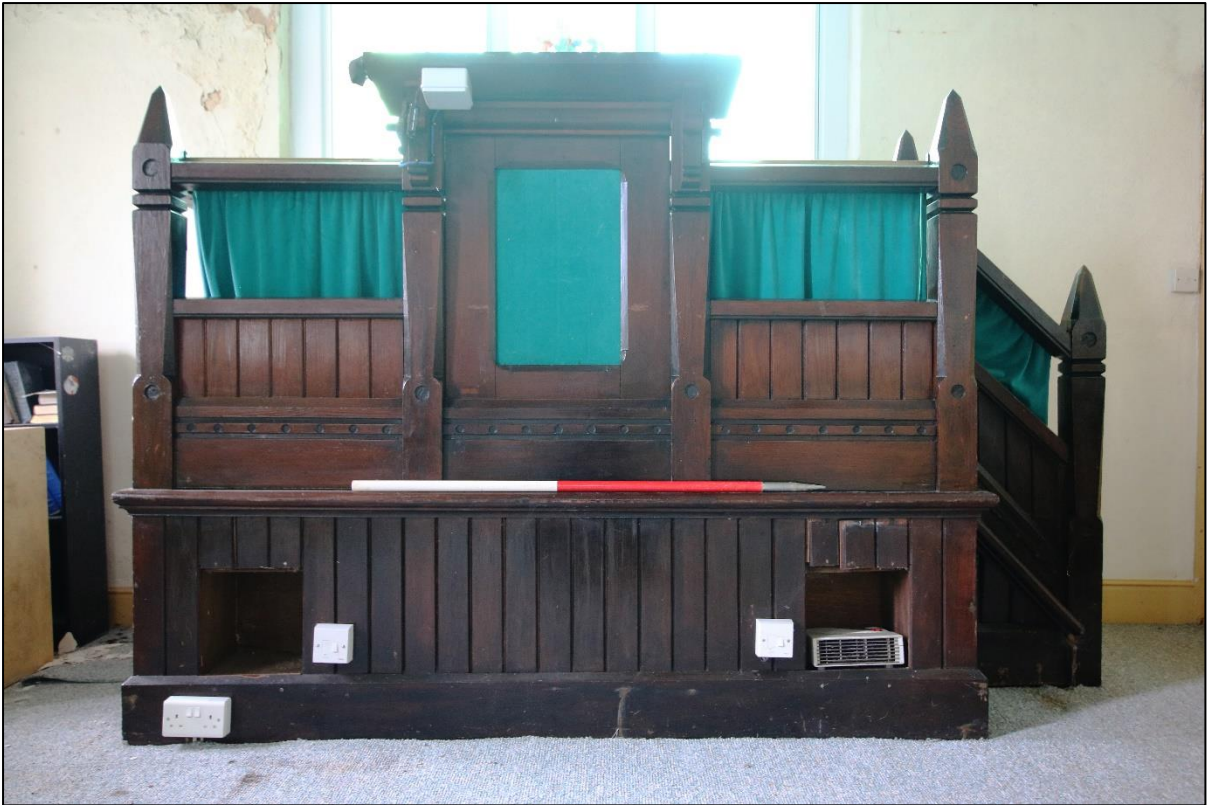
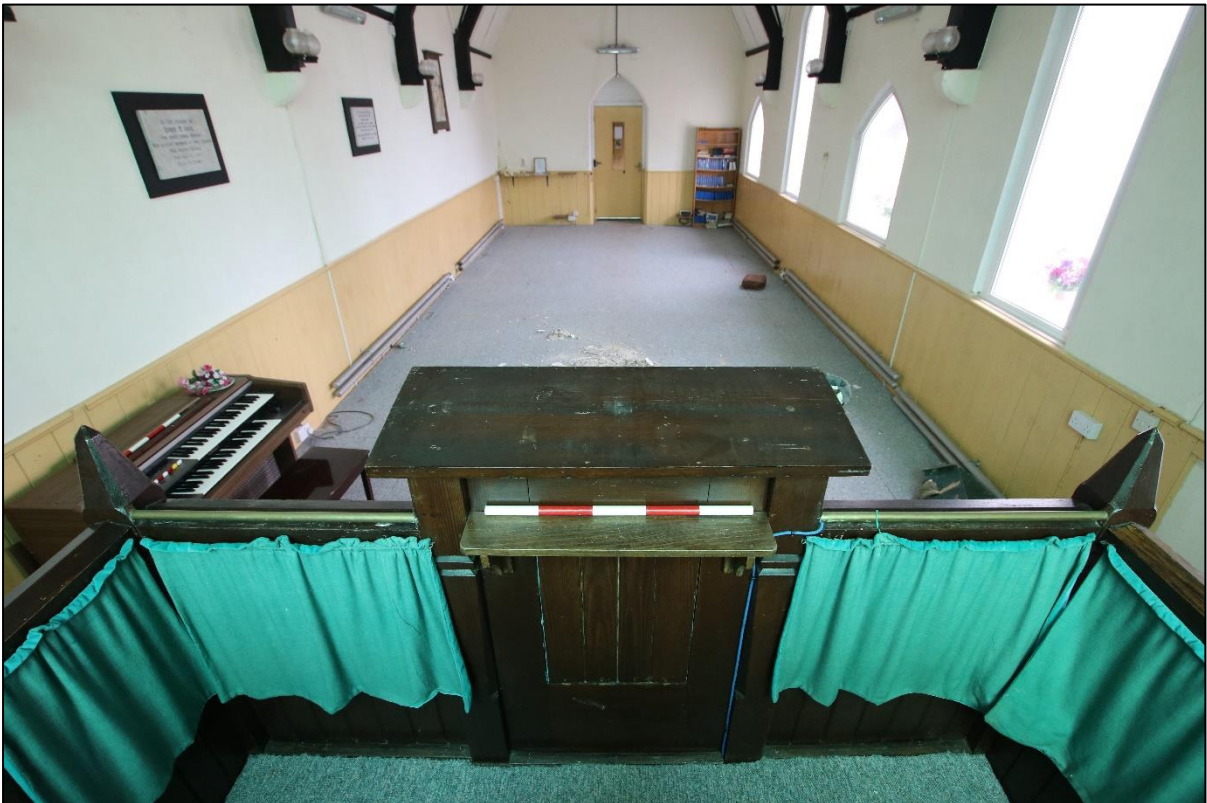
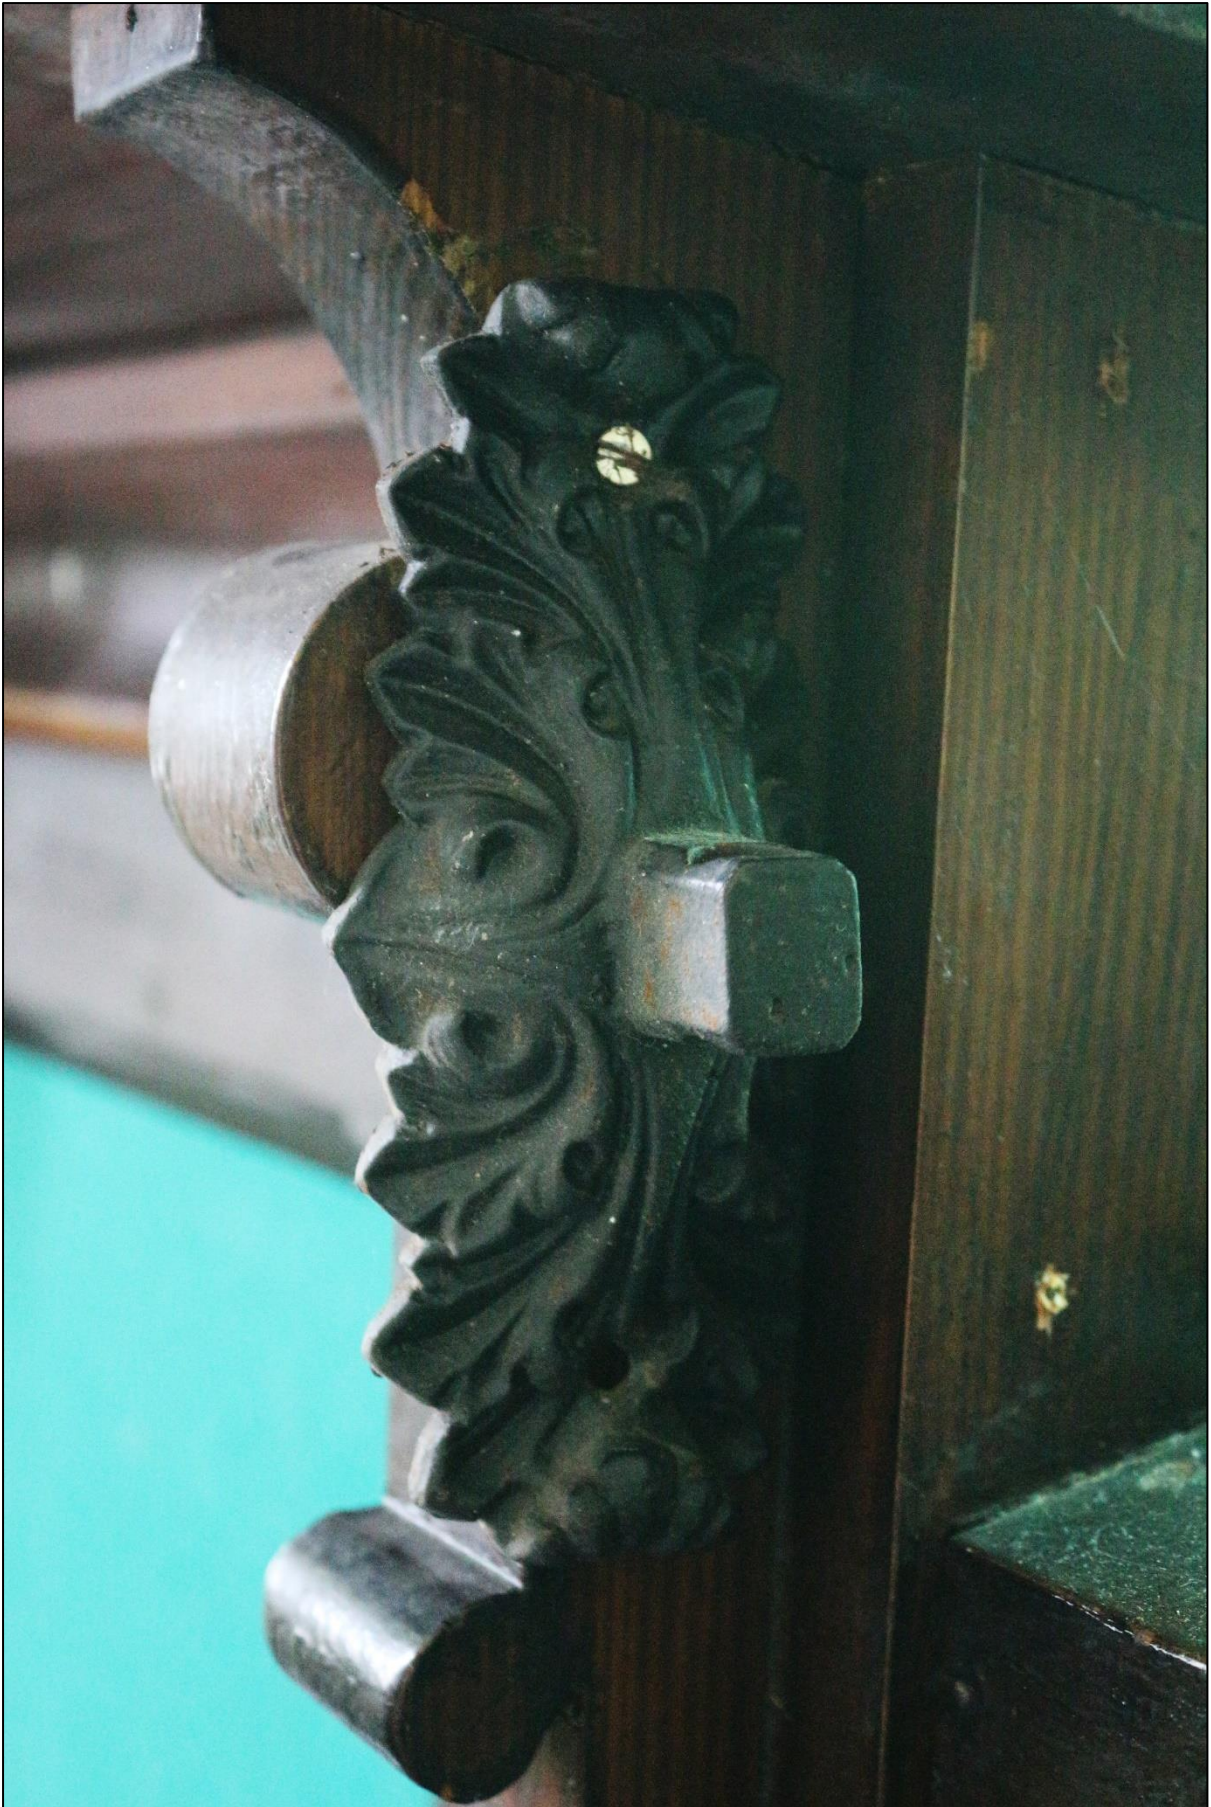
The pulpit is respected by the beaded stair plate and skirting which rises with it along the wall but is ultimately a freestanding structure built over a base with a few tying in timbers affixing it to the wall. It is of typical design with single-storey raised platform accessed via a set of steps to the west and is of mid-later 19<sup>th</sup> century Jacobethan (Jacobean Revival) design, a freer, more vernacular Gothic style mixing Elizabethan geometric, typical Gothic details, with Jacobean decorated forms, popular in domestic country house architecture and institutional buildings from the c.1820s, popularly used in carpentry and stairs into the late 1800s and early 1900s, where a bolder version morphed in Edwardian Baroque. This example exhibits well executed, artisan carpenter details like pegged joints and dovetails, but is pine, stained dark, not particularly decorative and is of surprisingly heavy scantling for such a small space.

Its Jacobean-style newel and corner posts are combined with more typical Gothic incised plat band detailing and run out chamfered details. The breadth of this pulpit would suggest the pastor sat in a chair behind his book stand for the entire service, an additional small shelf beneath the book stand

provided for his notes, glasses etc. Three steps access the platform from the west, carpet-covered plank treads and risers beneath, the bottom step is noticeably deeper to shorten the pastors time in ascension. The stairs are of closed string form, with plank boarded string board to front, with raised separate handrail above; the strong board has a chunky framed rail bracing it with deeply chamfered outer band and incised detail, with repeating geometric circles within closed incised bands. The string board and handrail are braced by Jacobethan style newel posts, forming a balustrade, which then continues around the front north and east side of the platform. The newel posts are square in profile with incised roundels formed by lozenge-shaped chamfer details, turned above to form square bead with integral turned blocky pyramidal chamfered finials above, also with incised roundel to each face. The handrail is chunky, chamfered to top and sides, with narrow hollow-chamfered detail to underside. Between the handrail and stair board the open space is screened by curtains on brass rods. The balustrade continues in the same style around the pulpit. To the centre of the balustrade is the book stand which has two newel posts braced by a chamfered screen with central recessed panel with plank framing, covered by green baize and above it has a plain book stand carried on elaborate carved scrolled brackets, with chunky roll moulding detail connected by a moulded band. To either side of the book stand the gap between handrail and base board is again open, screened by green curtains on a brass rod. Beneath the base board is a deep projecting roll moulded kerb and beneath is plank boarded framed panelling with deep chamfered skirting. Two later cupboards or openings have been cut into this, presumably for a sound system, and two single electrical switches, and one double electrical socket, have been attached. To the east side a low door has been created to access the cavity beneath the pulpit; this reuses the existing planks etc., is carried on simple hinges, and is fastened by both a single small rim latch and a brass turn button catch. The south-eastern side has also dropped (presumably due to the floor beneath failing) and some of the vertical planking has been lost.
