# **WHEAL ELLEN ENGINE HOUSE PORTHTOWAN ST. AGNES CORNWALL**

Historic Building Recording & Heritage Impact Assessment

South West Archaeology Ltd. report no. 170612

By E. Wapshott & N. Boyd  
Report Version: FINAL  
12<sup>th</sup> June 2017

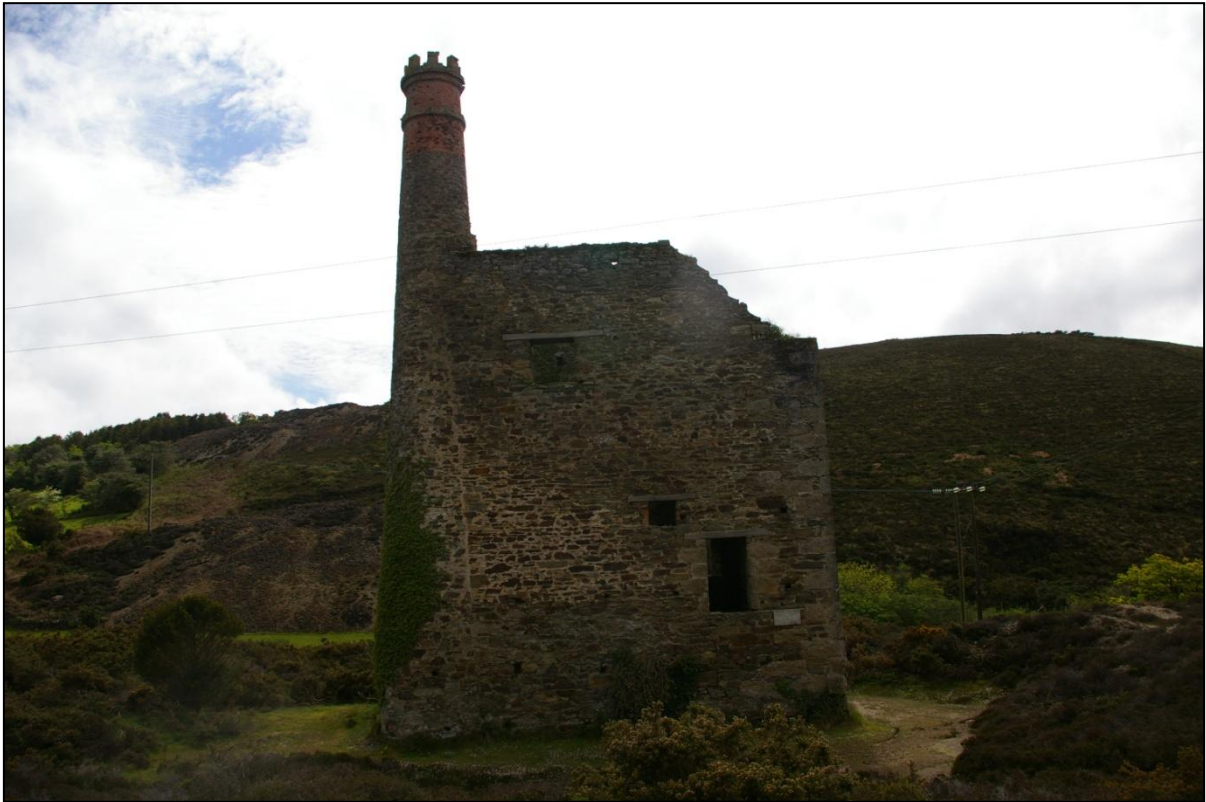
The long north-east elevation is a tall three storeys, with three irregularly placed openings, the round chimney shaft bracing the south-east corner. Heavy dressed and faced granite quoins can be seen to the north corner, to the upper section of the wall. The base of the elevation exhibits heavier battered stonework, of more irregular build and form, using larger stones. The bottom quoins are more roughly dressed granite. The stonework above (approximately 2m) becomes looser spread, with a more typically 19<sup>th</sup> century rubble form. The stonework is graduated, becoming lighter weight as the wall rises. Patches of the stonework here exhibit a mix of the original mortar pointing, cement repairs and a large area of more recent pointing, a fresher cream-brown colour, evidence of ongoing maintenance. Three openings span the wall, one on each floor level at the north end; a large rectangular opening on the bottom, a low doorway, with granite reveals and timber lintel; a small square opening just above, with patched brick reveals and narrow timber lintel. On the second floor, there is a large sub-square irregular opening, with narrow timber lintel and sill, with ragged patched reveals, seemingly forced into the elevation. The chimney is a tapering round shape, built onto the engine house with straight joins, also of rubble build and tied in to the main building. The top of the chimney has a red brickwork top, with a projecting cornice to the top and crenulations.

FIGURE 2: THE NORTH-EAST ELEVATION; FROM THE EAST, NORTH-EAST.

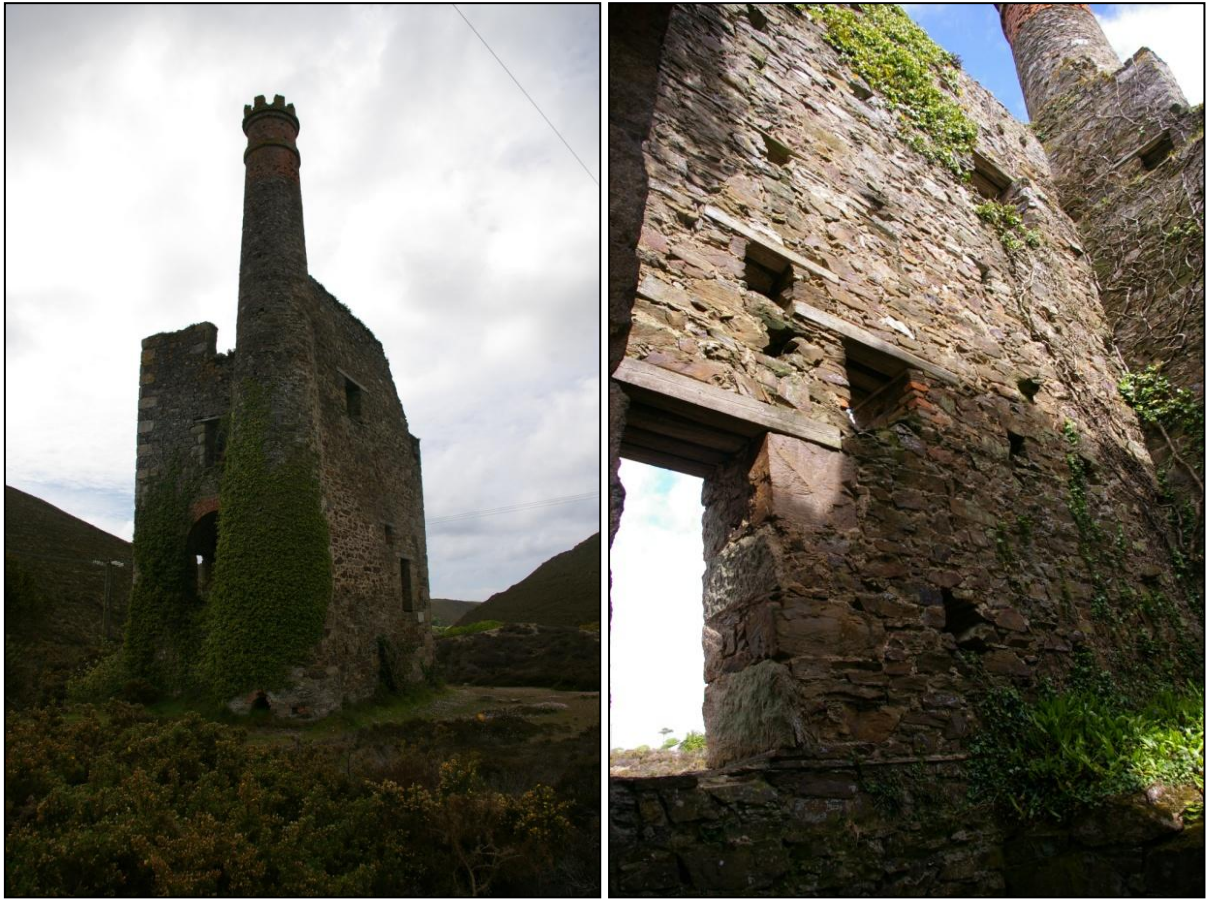
FIGURE 3 (LEFT): THE CHIMNEY WHICH CLASPS THE CORNER OF THE ENGINE HOUSE, FROM THE SOUTH, SOUTH-EAST.

FIGURE 4 (RIGHT): INTERIOR FACES OF THE TWO LONG WALLS IN THE ENGINE HOUSE; FROM NORTH AND WEST.

The rear, south-east elevation rises to a full three storeys, with three centrally positioned openings, one on each floor. It is dominated by the large round chimney shaft at its east side. Heavy dressed and faced granite block quoins on the west corner. The largest opening is on the lower level, a large round-headed arched doorway, with segmental quadruple-row brick relieving arch, similar to the opening in the front bob wall. This opening also has granite dressed reveals, obscured by dense ivy. Above this, on the first and second floors are small square windows, with granite block reveals; the middle opening has a narrow timber lintel, the top opening only part surviving. The chimney on its east, south-east side has a large arched opening at its base for feeding the fire, with rounded headed segmental double-row brick arch and stone reveals to the sides.

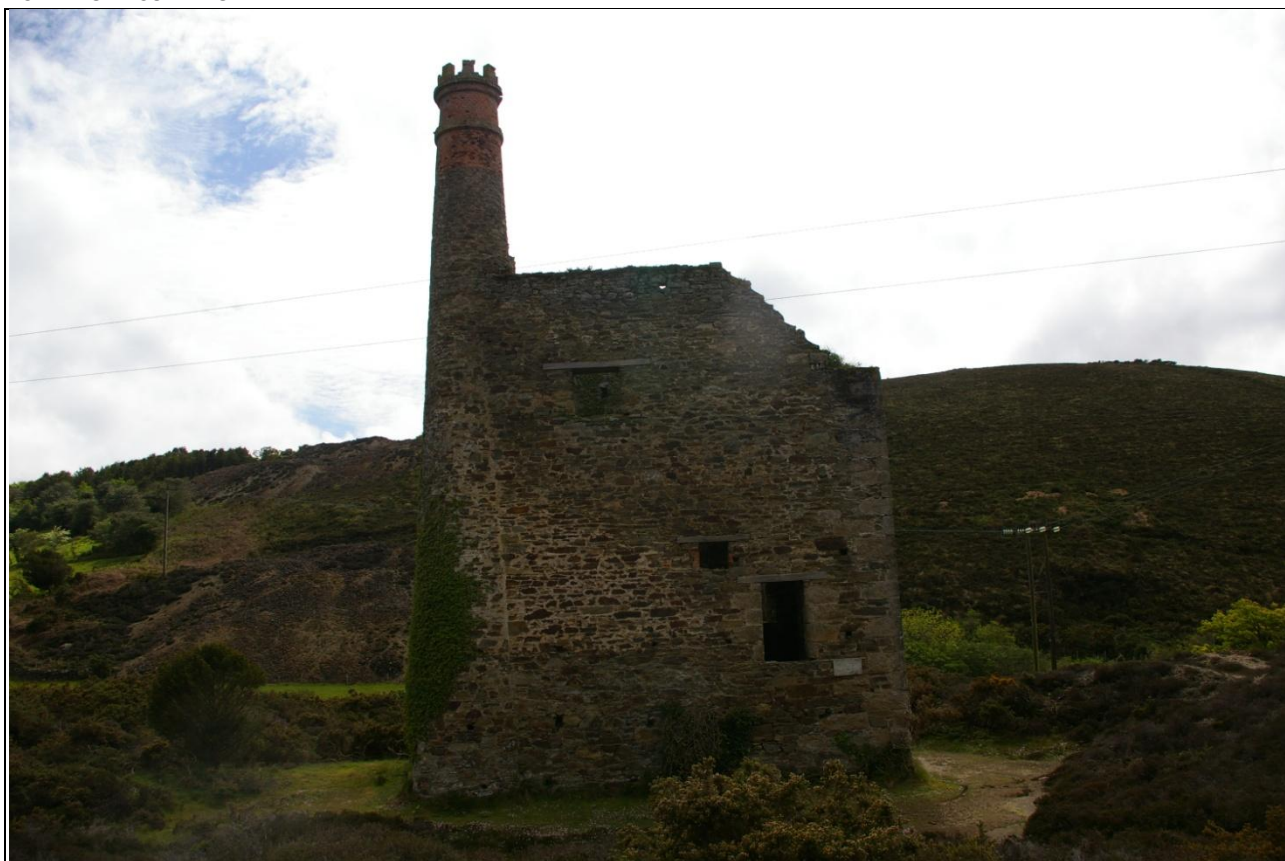
THE NORTH-EAST ELEVATION; FROM THE EAST, NORTH-EAST.

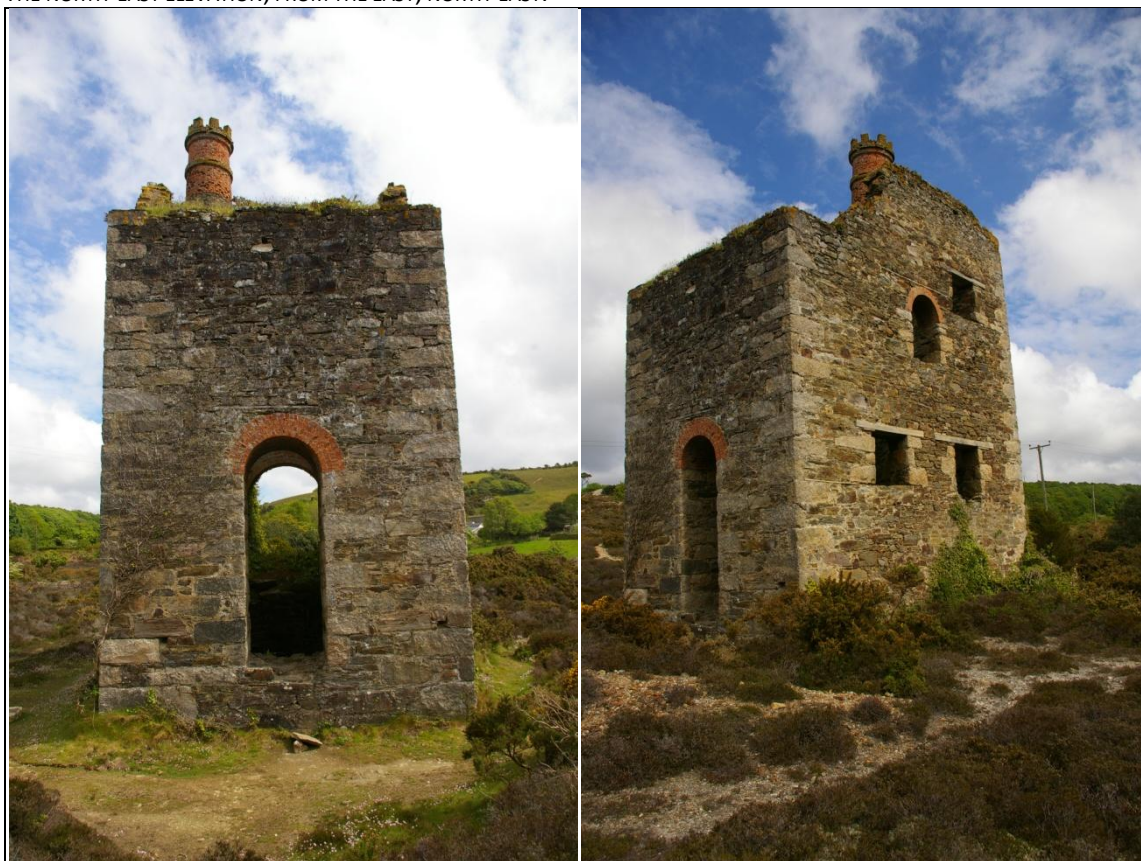
The front wall, facing north-west, is the narrow former 'bob wall', a much more substantial build form, as would be expected. The wall only just rises to three storeys, the lowest of the elevations. It has heavy irregular stonework to the base, graduating as it rises to looser set and lighter weight stonework, all of killas rubble. There are formal quoins to the east and west corners, of dressed and faced granite blocks. There is a double height round-headed doorway raised up within the elevation, with granite block reveals and a segmental round-headed quadruple-row brick relieving arch. This elevation shows evidence of removed ivy and some mortar patching indicative of ongoing maintenance.

The long south-west elevation is a tall three storeys, with four irregularly placed openings. Heavy dressed and faced granite quoins to the north and south corners. The elevation is of killas rubble, graduated as the wall rises becoming lighter weight, the stonework above 2m becomes looser, with a more typically 19<sup>th</sup> century rubble form. The stonework of this elevation exhibits the original mortar pointing, with some patches of cement repairs. On the ground floor there are two small rectangular low openings with granite reveals and timber lintels, the southern opening ragged and forced at the base. On the upper first floor is a large round-headed opening, with formalised granite block quoins to the reveals and double-row segmental brick arch. On the second floor, just above and to the south is a smaller square opening, with ragged reveals, indicative of possible forcing and a narrow timber lintel. This elevation is in the best condition of the elevations and survives to a greater height, with some ivy to the base.

LEFT: THE FRONT 'BOB WALL'; FROM THE NORTH, NORTH-WEST.

RIGHT: THE LONG SOUTH-WEST FACING ELEVATION; FROM THE WEST

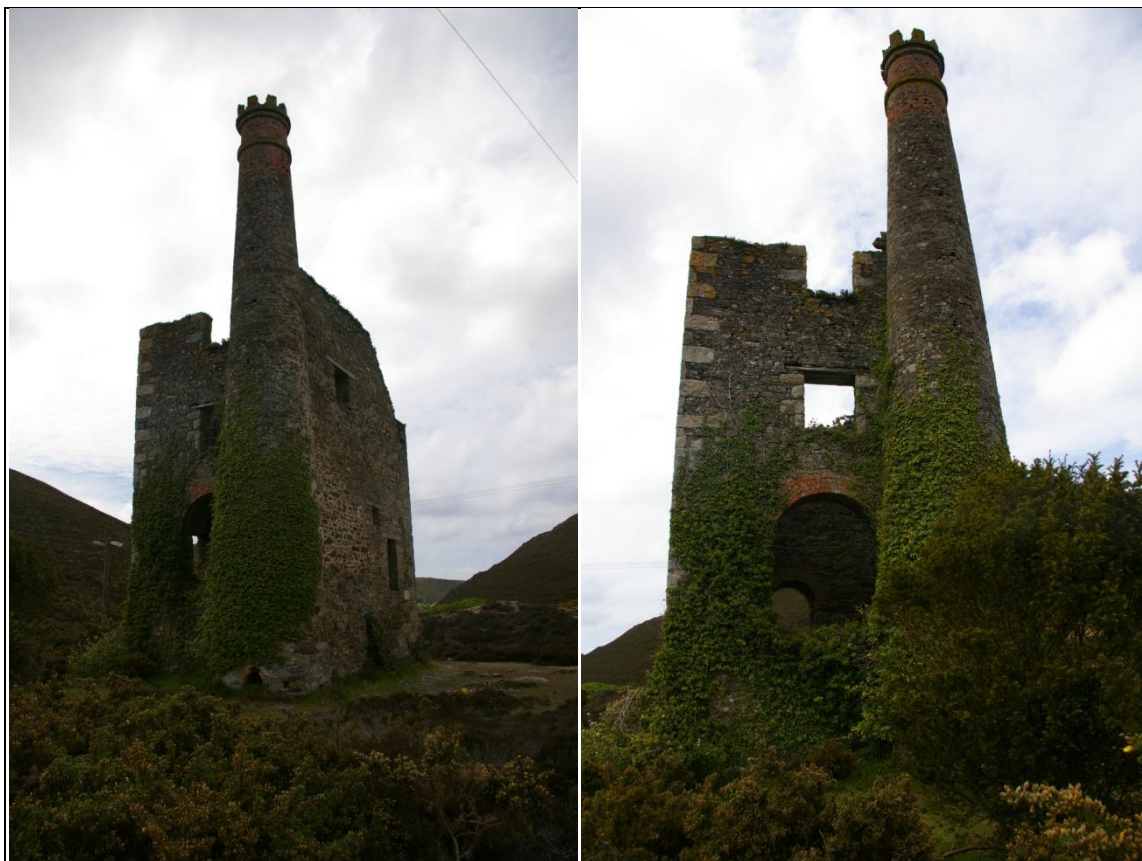
LEFT: THE CHIMNEY WHICH CLASPS THE CORNER OF THE ENGINE HOUSE, FROM THE SOUTH, SOUTH-EAST.

RIGHT: THE REAR WALL OF THE ENGINE HOUSE; FROM THE SOUTH-WEST.

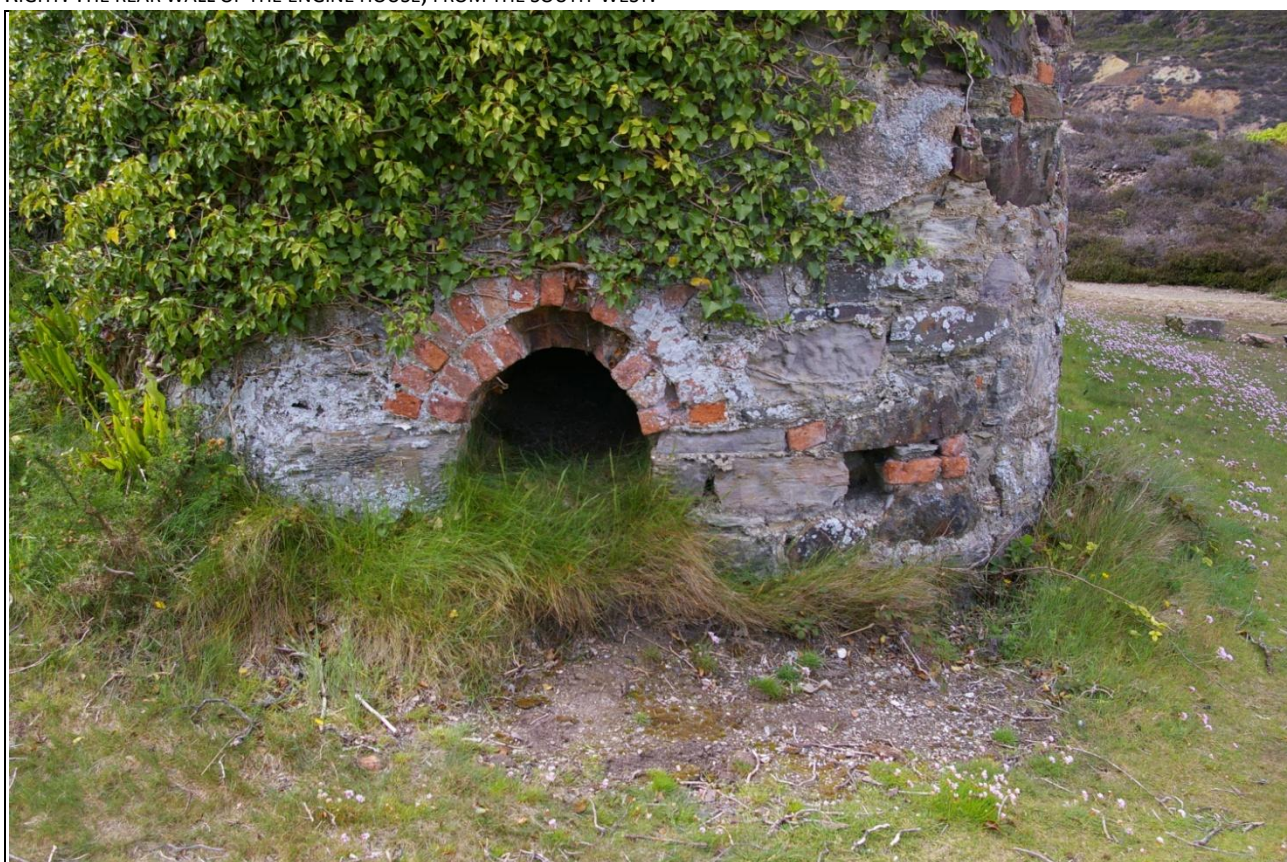
THE OPENING AT THE BASE OF THE CHIMNEY; FROM THE SOUTH.

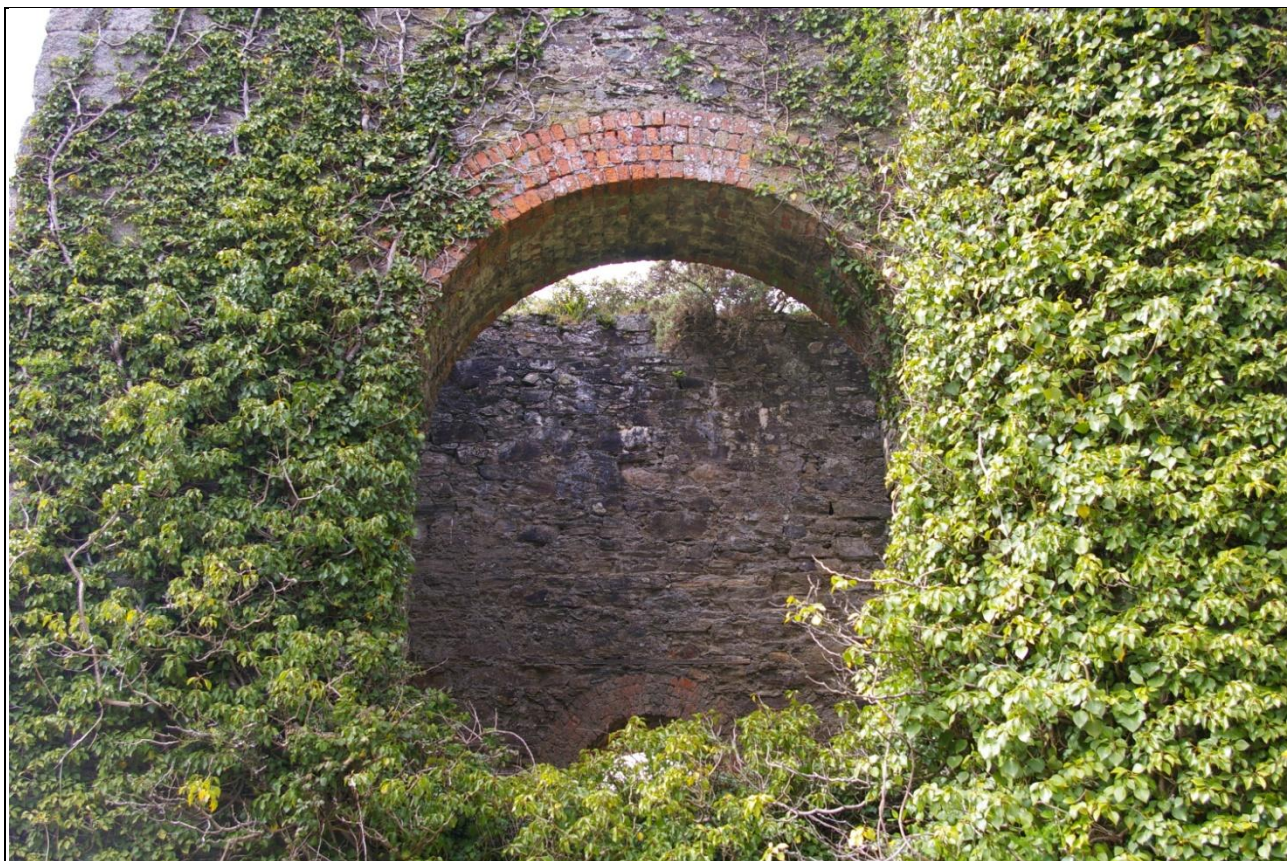
THE LARGE DOORWAY IN THE REAR ELEVATION; FROM THE SOUTH-WEST.

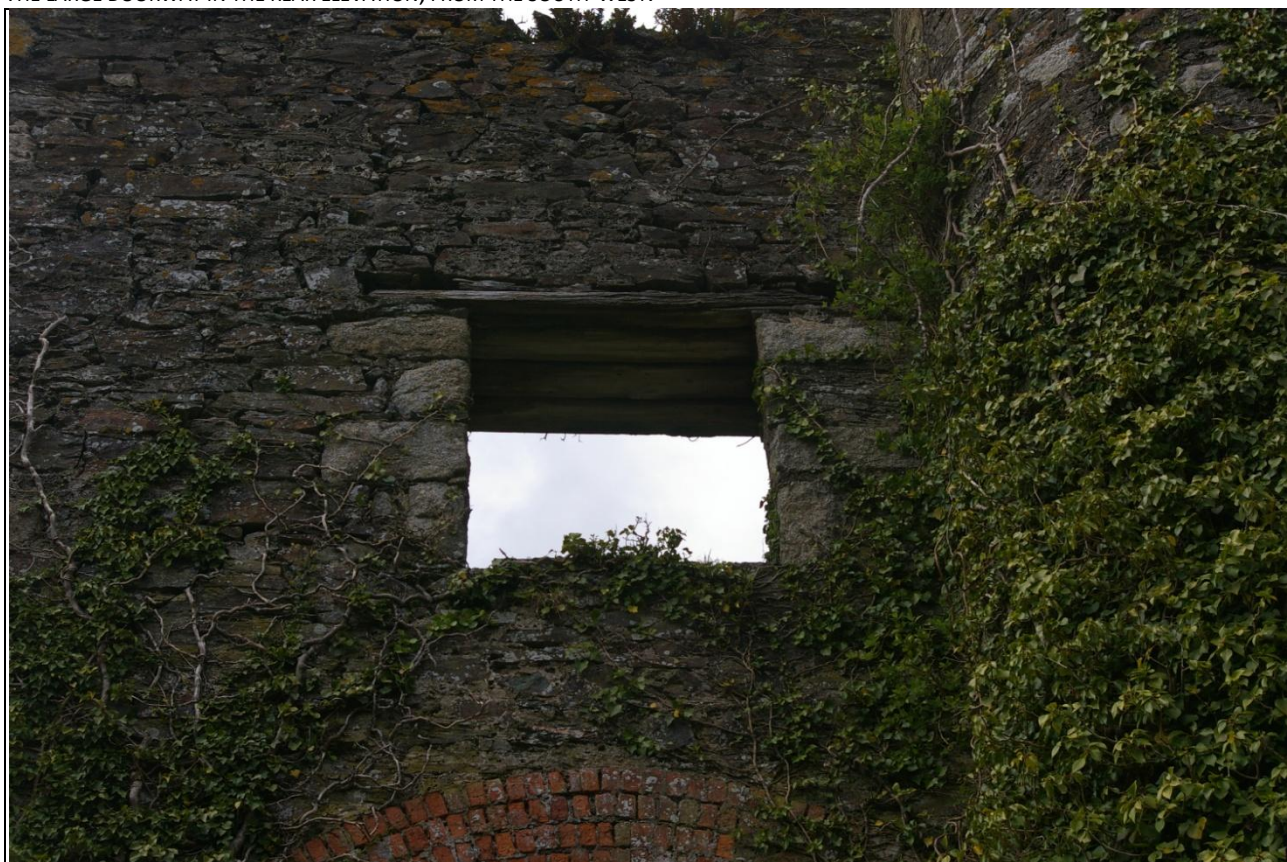
DETAIL OF OPENING WITH A WEATHERED ORIGINAL TIMBER LINTEL, IN THE REAR WALL OF THE ENGINE HOUSE; FROM THE SOUTH-WEST.

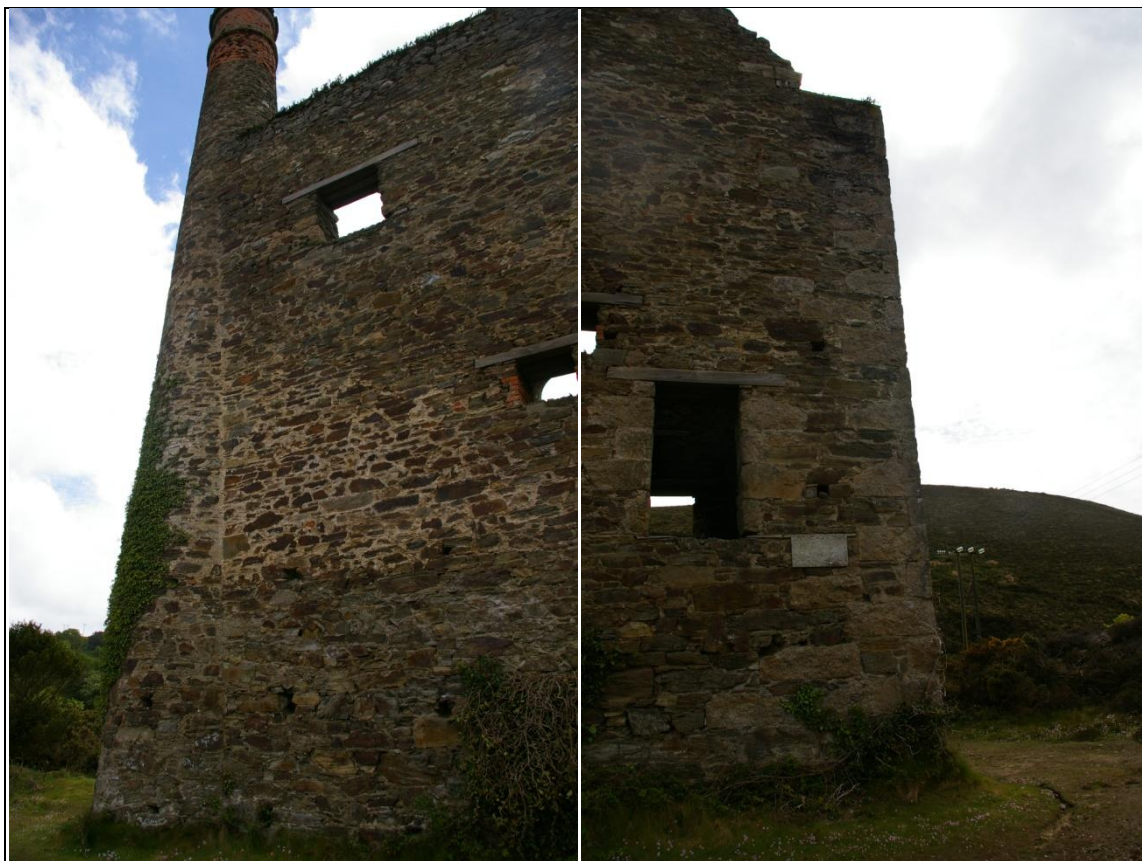
LEFT: VIEW OF THE JOINT BETWEEN THE CHIMNEY AND ENGINE HOUSE; FROM THE NORTH, NORTH-EAST.

RIGHT: THE DRESSED AND FACED QUOINS TO THE NORTH CORNER; FROM THE EAST.

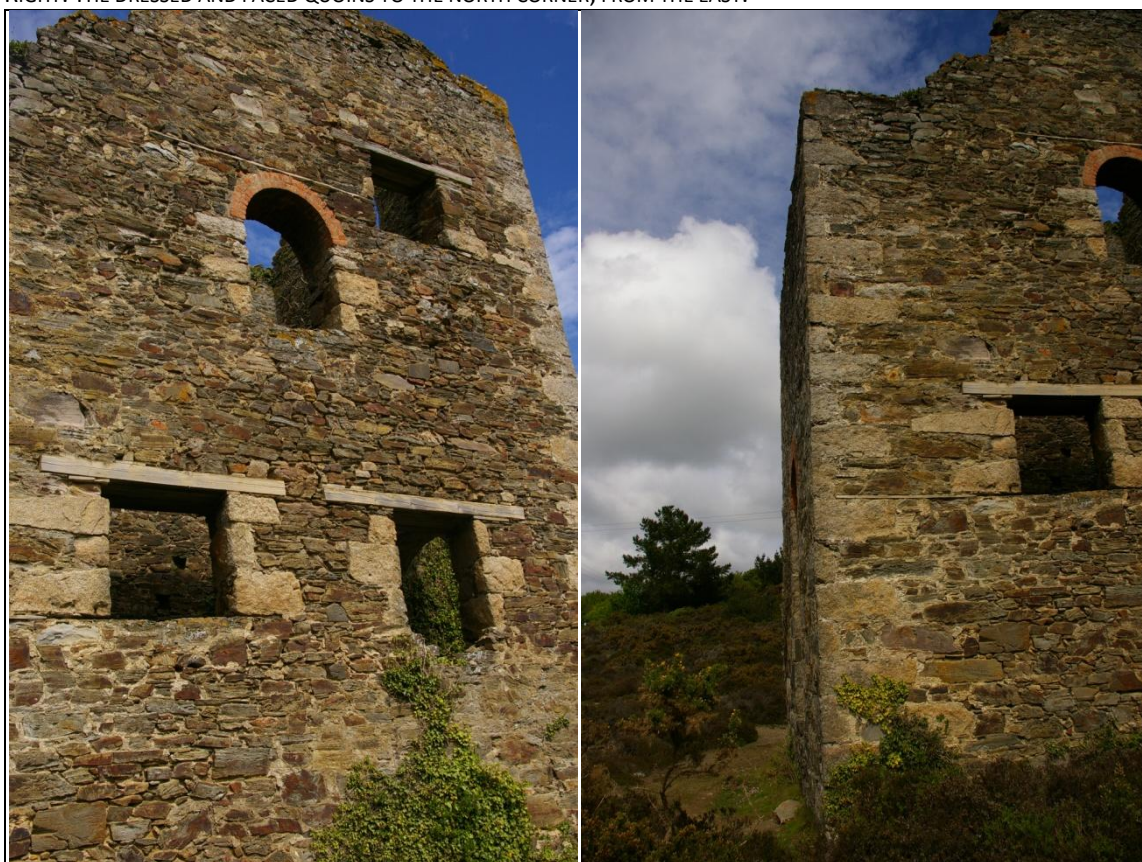
LEFT: DETAILED VIEW OF THE OPENINGS, OF DIFFERING STYLE IN THE LONG SOUTH WEST ELEVATION; FROM THE WEST.

RIGHT: DETAIL OF THE QUOINS TO THE WEST CORNER; FROM THE WEST, SOUTH-WEST.

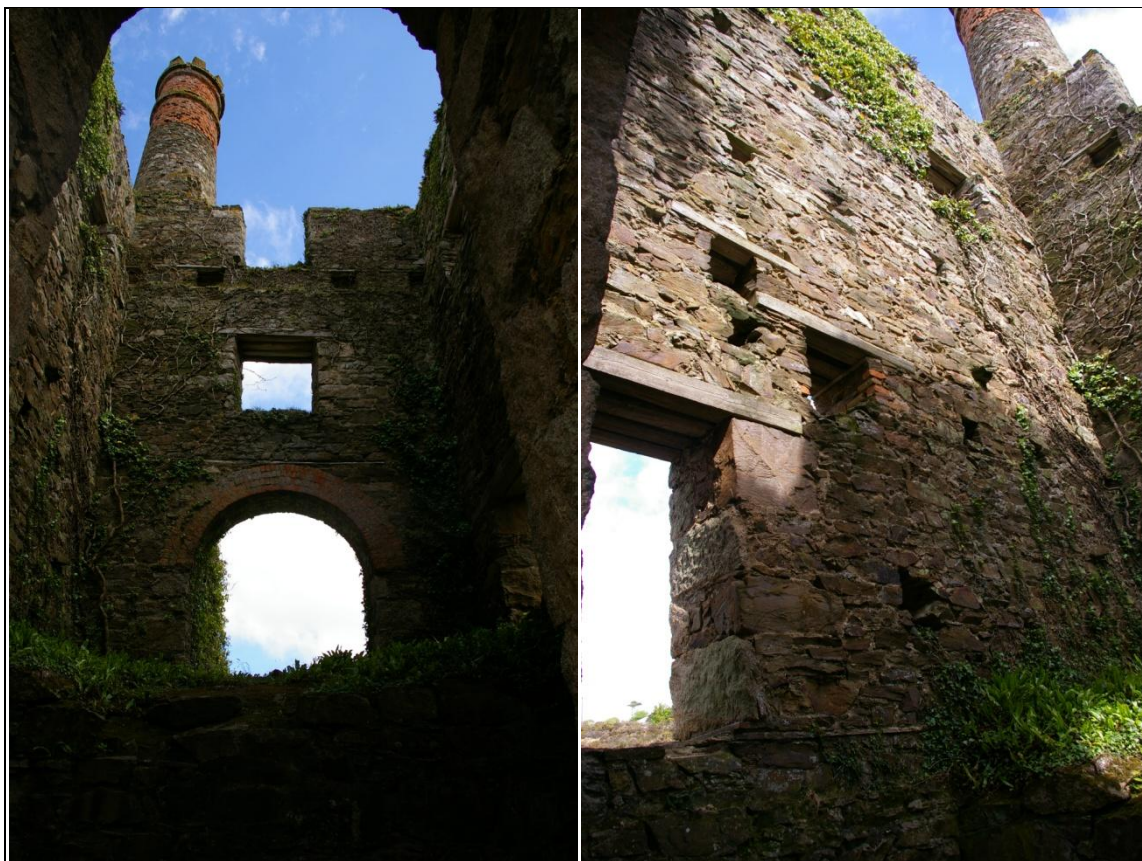
LEFT: VIEW INTO THE INTERIOR OF THE ENGINE HOUSE, LOOKING UP; FROM THE NORTH, NORTH-WEST.

RIGHT: INTERIOR FACES OF THE TWO LONG WALLS IN THE ENGINE HOUSE; FROM NORTH AND WEST.
