Archaeological Desk Based Assessment

Seaton Carew Feasibility Study

Hartlepool

TA09/02

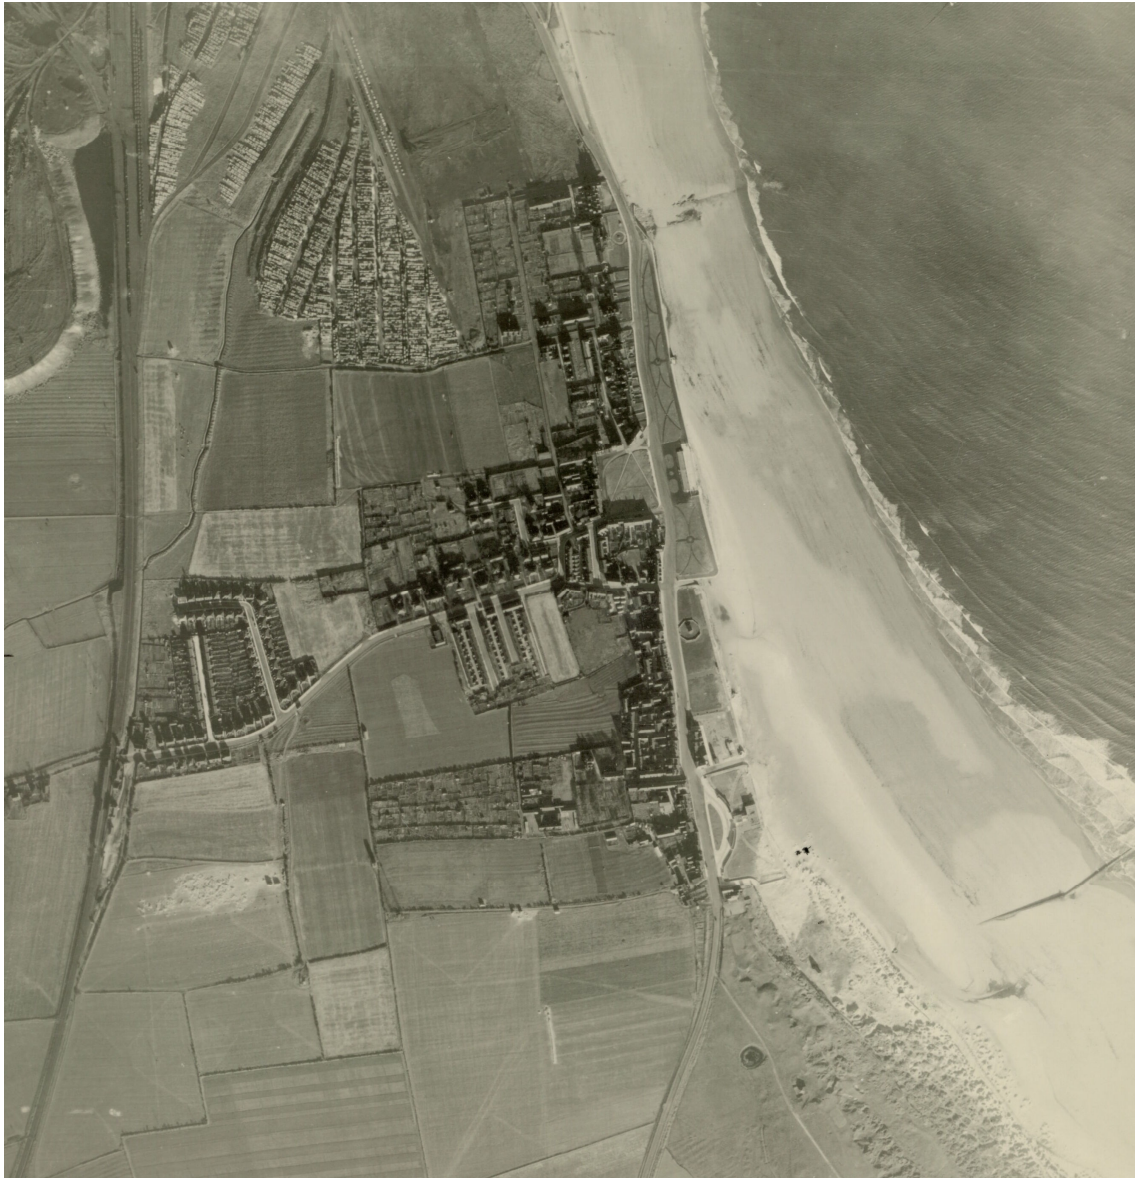
Plate 1: Extract from aerial photograph of 1946 (RAF CPE/UK 1835; Frame 3004)

Aerial photographs of Seaton Carew taken by the RAF in 1946 (Plate 1) give a good indication of this enclosure landscape before it was succeeded by suburbanisation. The field boundary pattern shown in 1946 is very similar to that shown on the first edition Ordnance Survey map of 1857 (Figure 2). It shows a pattern of enclosed fields of various sizes. All boundaries appear to be hedgerows. Approximately half way between the railway line and The Front the photographs show a very regular north-south aligned boundary. Other than this the pattern of the fields is irregular, with various differing shapes and sizes. A number of the fields demonstrate earthwork remains of ridge and furrow ploughing. This is particularly apparent in the field to the immediate north of Holy Trinity Church (approximate centre of Plate 1; Site 37). Here the ridges appear to be broad and with a slight s-curve, typical of medieval ploughing using animal traction. It is possible to see this plough curve fossilised in many of the east-west aligned field boundaries which undoubtedly followed earlier ridges.

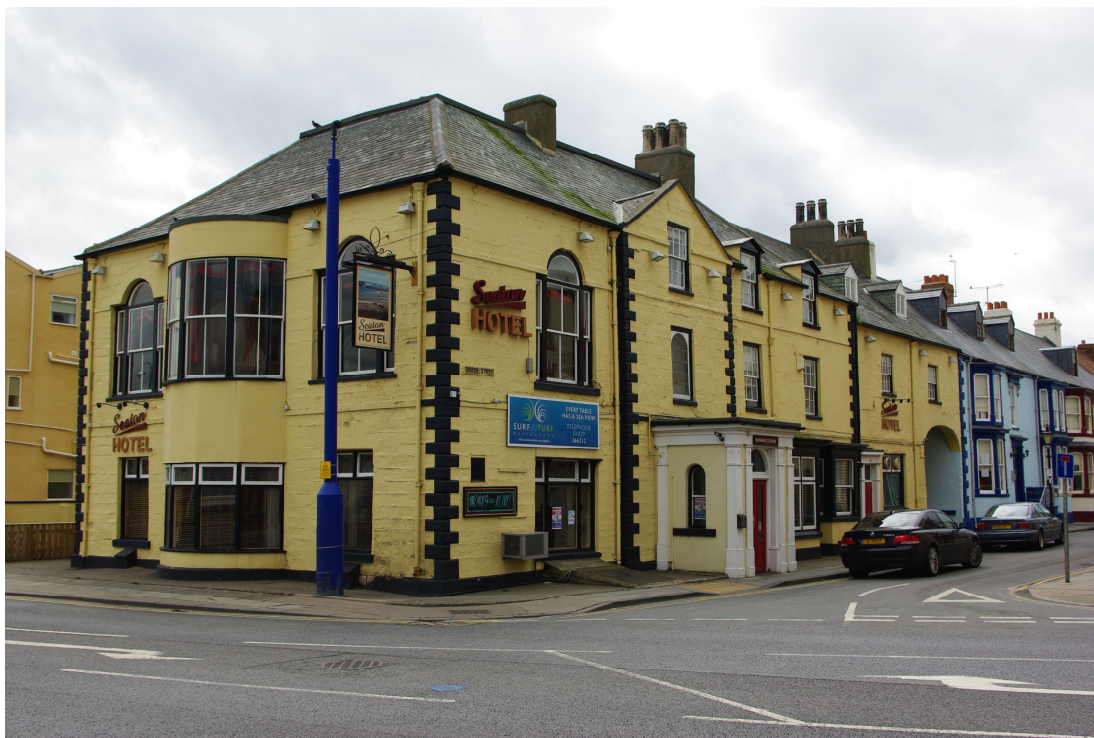
Plate 2: The Seaton Hotel

Seaton Carew became a popular spa-town in the later 18th century. It was described in 1812 by William Tate as '*a watering place of high estimation*' (Tate 1812, 34). Amongst the principal surviving buildings of this era is the Seaton Hotel on The Front (Site 20; Listed II; Plate 2), built circa 1792 by George Pearson of Durham. The Seaton Hall Hotel (Site 9; Listed II) was added on the west side of the green circa 1803.

Tate's account describes some of the hotel facilities in great detail but also mentions that the village contained '*between fifty and sixty inhabited houses*' (ibid, 37). It is likely that the majority of the residents were at least seasonally employed in service industries associated with the new role of the village.

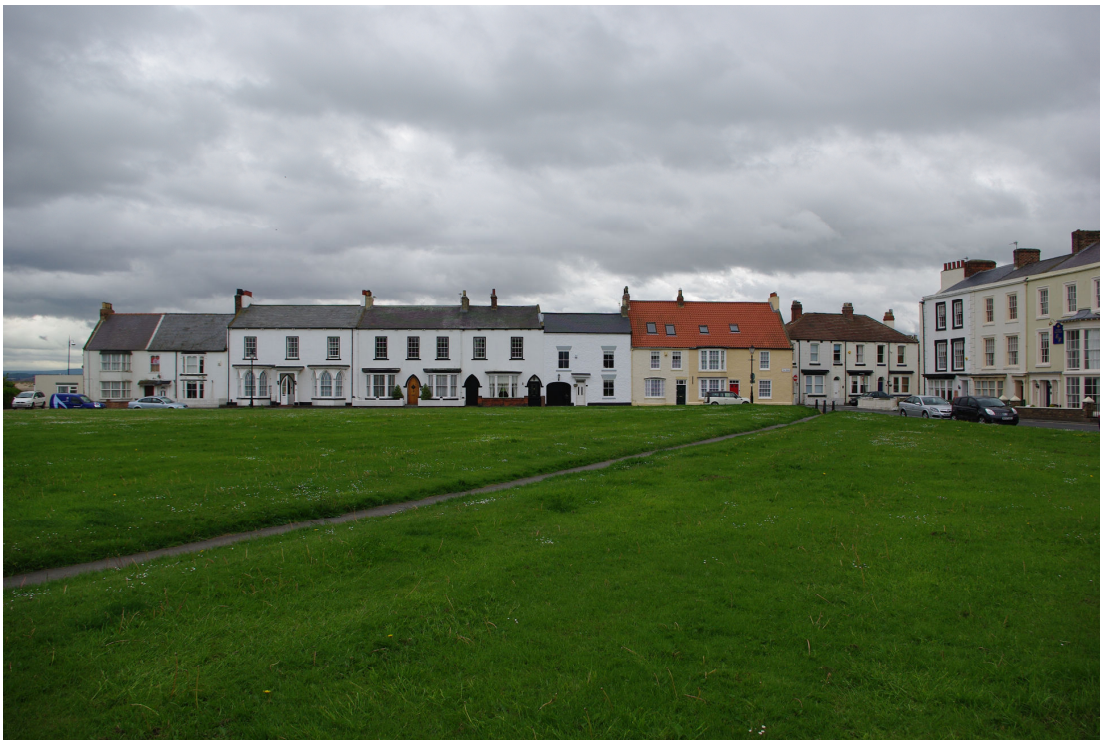
Plate 3 - The Green looking south

It is likely that the existing square green (see Plate 3) was established in the medieval period. If this was the case then the pattern of the medieval settlement is largely fossilised along The Front today. The one row structure, possible vestigial second row and green are shown on the Ordnance Survey map of 1857 (Figure 2).

The layout of the settlement is shown on the first edition Ordnance Survey map (Figure 2) with properties set out along three sides of The Green (Plate 3) with a single row running south along the seafront.

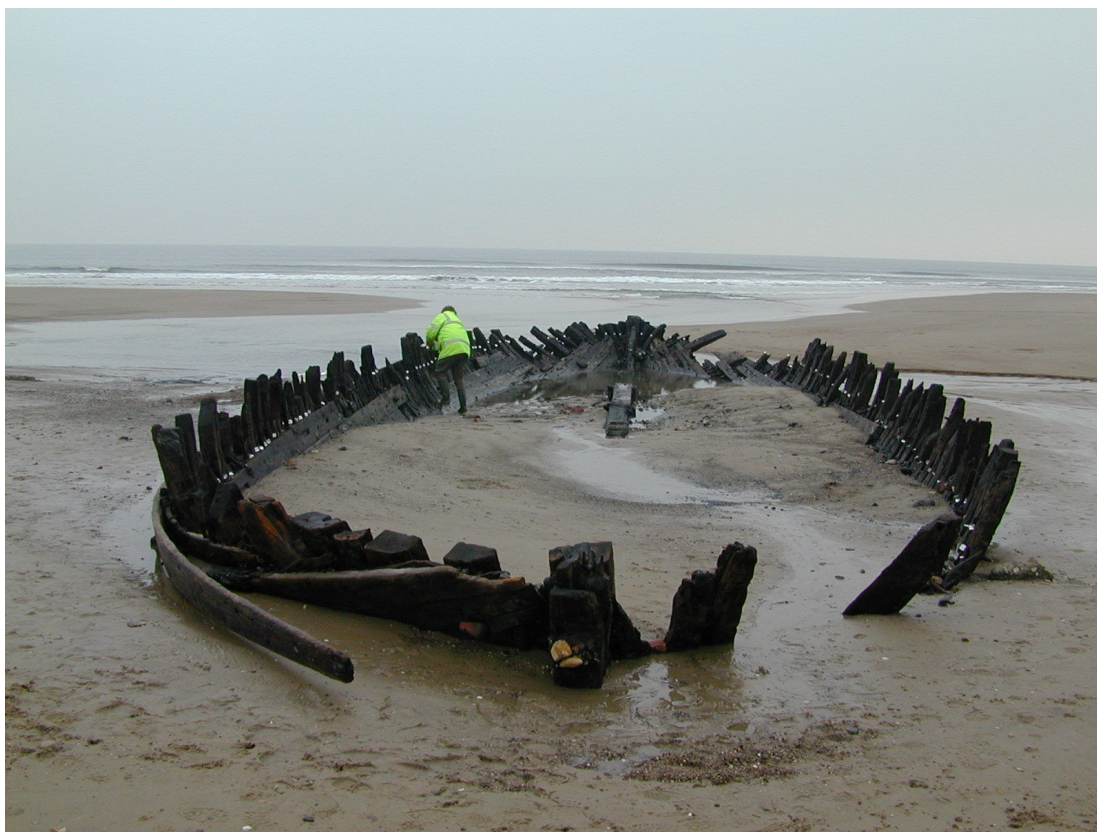
Plate 4: Site 27, remains of a collier brig, a Protected Wreck site

The remains of one of these vessels (Site 27; Plate 4) was discovered in 1996 following unusually low sands. This was a wooden, medium sized, coastal trading vessel (measuring 25.1m in length and 7.07m in breadth) of the late 18th or 19th century. The vessel had been salvaged after its loss with the majority of the upper timbers removed. Despite this the wreck is substantially intact and its importance was marked by its

designation as Protected Wreck Site in August 1996 by the Secretary of State. It is the only wreck with such status between The Wash and the Orkneys.

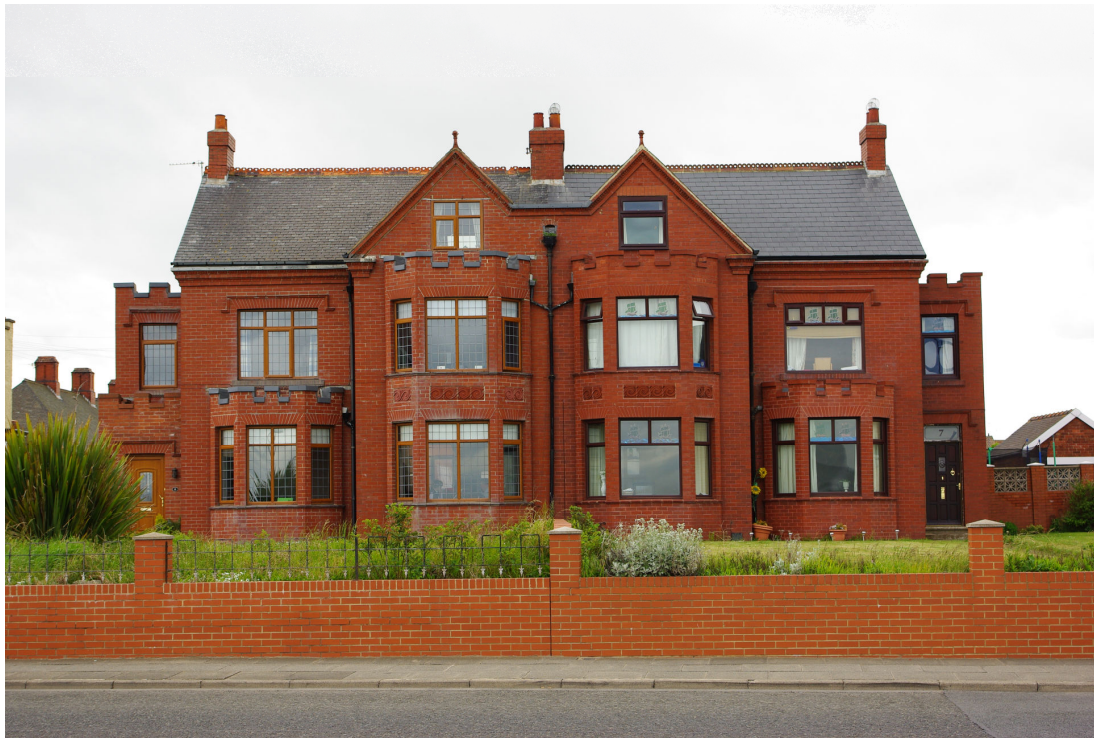
Plate 6: 7-8 The Cliff – High status semi-detached housing of the 1920s with sea views

The beginnings of suburbanisation appear in this period. Inter-war developments include Glentower Grove and Stanmore Grove, to the west of the main settlement beside the train station (see Figure 5). These developments led to the first cul-de-sacs at Seaton Carew lined with bow windowed, semi-detached houses with hipped tiled roofs and well proportioned gardens to front and rear. There is also some infill of high status domestic properties between The Green and the Staincliffe Hotel (see Plate 6) and the addition of Bolton Grove to the west of The Green.

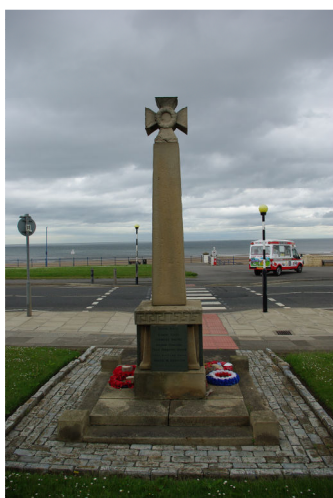
(left) Plate 7: Seaton Carew War Memorial

A war memorial (Site 45; Plate 7) was unveiled on The Green on the 12th February 1921 (www.ukniwm.org.uk; accessed 26/05/2009). This takes the form of a tapering shaft with cross head. It was added to following World War II.

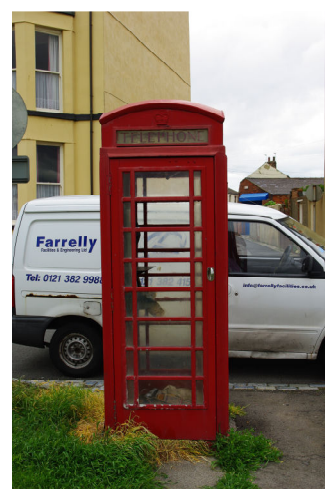
(right) Plate 8: K6 Telephone Kiosk

The final noteworthy item of the period is a traditional K6 Telephone Kiosk (Site 5) which also stands on The Green (see Plate 8). The kiosk is a design of 1935 and painted in the typical pillar-box red. The kiosk is Listed grade II for its group value with other buildings around The Green.

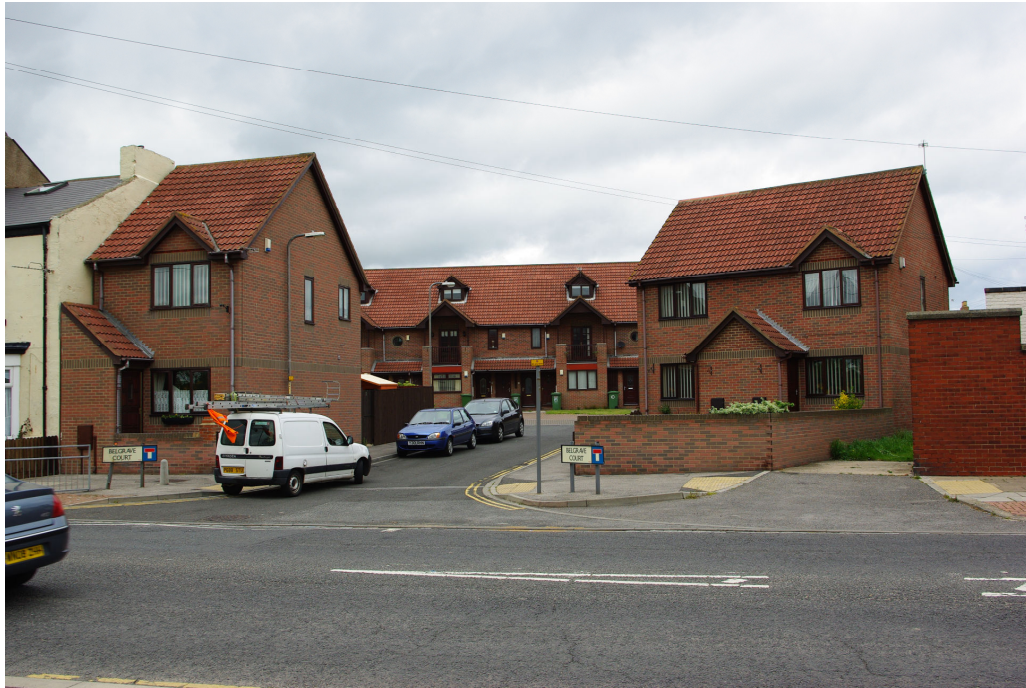
Plate 9: A classic infill development of the later 20th century which fragments the character of the area

As well as the larger planned estates there are also more piecemeal infill developments of this period (see Plate 9), particularly in its later half. A classic example is the development of a number of self build bungalows in the walled garden to the rear of the Staincliffe Hotel.

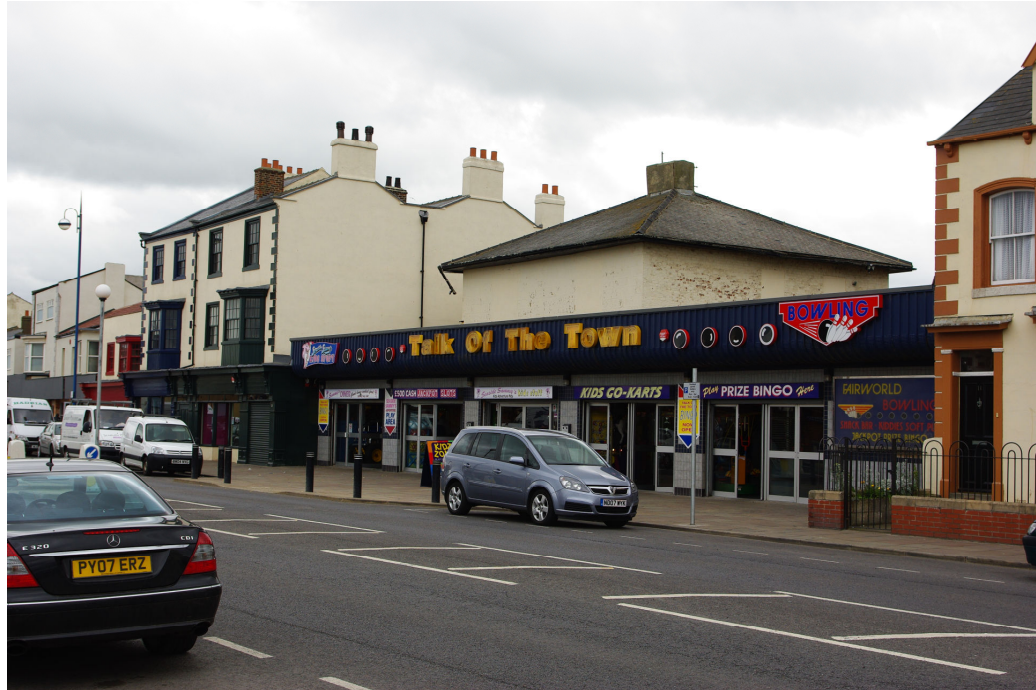
Plate 10: Later 20th century commercialisation along The Front

The southern end of the seafront was heavily commercialised during the period with the opening of amusement arcades and other seaside attractions (see Plate 10). These include the Longscar Centre of 1967 (Anderson 2004, 85) on the east side of The Front which was extended and re-clad in the 1980s. This is an uninspiring red-brick building which detracts from the general historic character of the area.

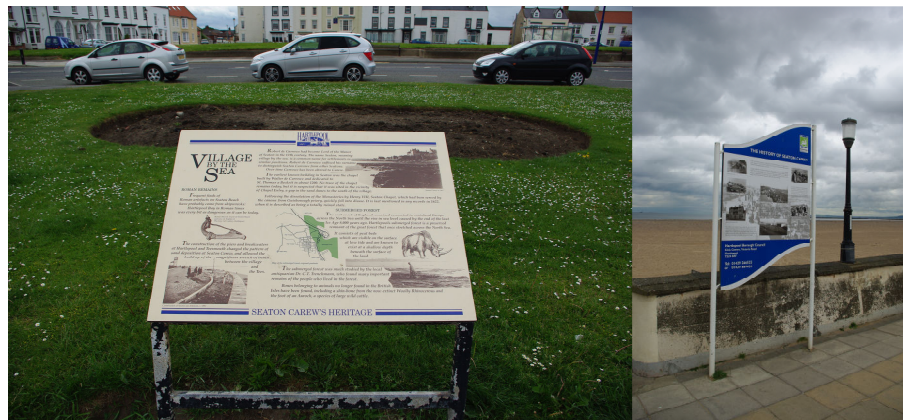
Plate 11: Interpretative panels of varying designs

- **Interpretation panels.** A review is needed of the existing provision of interpretation panels (see Plate 11) which are currently in a range of styles and conditions.
