ARCHAEOLOGICAL STRIP, MAP & SAMPLE EXCAVATION: FAERIE HOLLOW, RINGSHALL DRIVE LITTLE GADDESSEN HERTFORDSHIRE

NGR: SP 9901 1349

April 2013

ASC: 1586/AFH/2

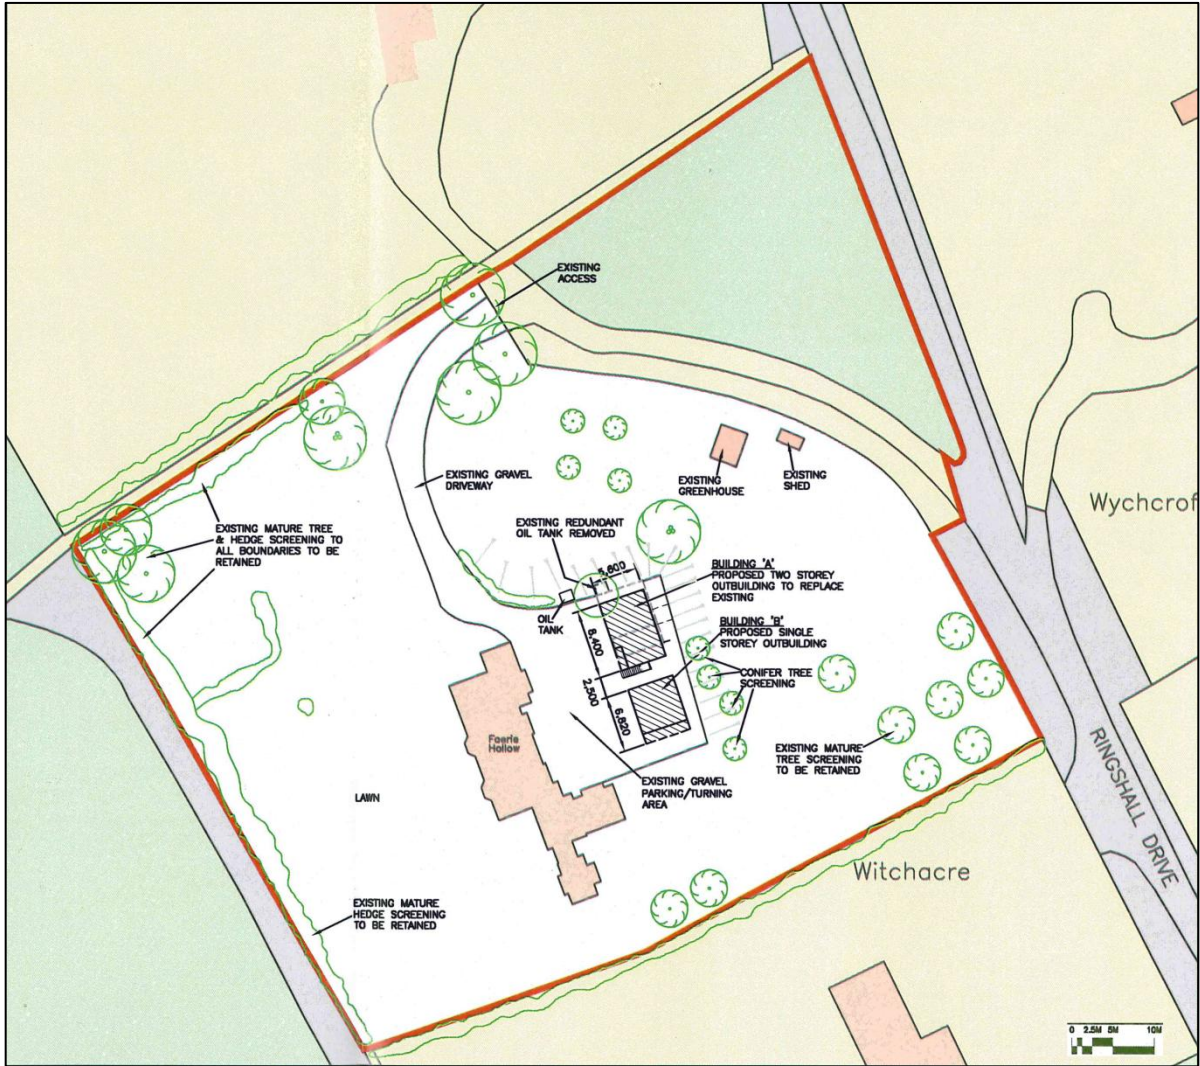
Figure 3: Proposed development (scale as shown)

The proposed development comprises the demolition of the existing outbuilding, and the construction of a detached garage and store with a first floor office/study and a two-bay garage/log store (Fig. 3).

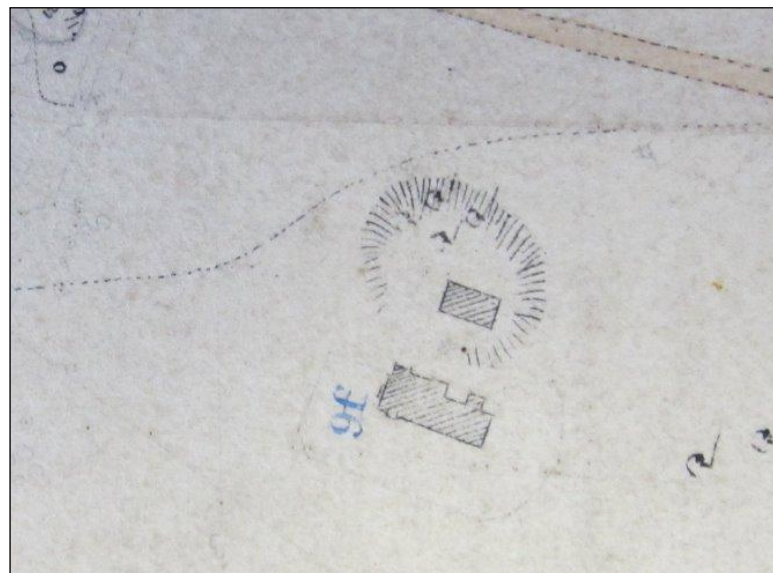
Figure 4: Extract from the Ashridge Estate map, 1828 (HALS 56484)
(not to scale)

Examination of early maps (Figs 4-8) has revealed that the ground to the east of the present house was formerly a quarry. The Ashridge estate map of 1828 (HALS 56484: Fig. 4) shows a roughly circular depression containing a single structure. A similar picture is presented by the First Edition Ordnance Survey 25" sheet of 1879, (Fig. 5) which labels the feature as 'clay pit', though it was more probably dug for the extraction of chalk. The proximity of the pit to the present house, which is believed to have 16th century origins, is of interest in that the pit probably post-dates the present dwelling. However, this is by no means certain and it is conceivable that extraction may have taken place for the purpose of supplying lime mortar to one the many rebuilds of the house in the 18th or early 19th centuries. It would be unwise to infer its absence from the 1762 estate map, illustrated on the front cover of this report, as being significant due to its comparatively small scale (HALS AH 2770).

- 7.3 After chalk extraction ceased in the late 18th or early 19th century the site would have been used as a convenient hollow in which to jettison household waste. A detached structure is shown within the footprint of the quarry in 1828. While it is probable that this structure was associated with the cottages (as an outhouse or wash house) it is also conceivable that it could have been associated with the chalk pit, possibly as a lime kiln. However, no evidence for this was found on site.

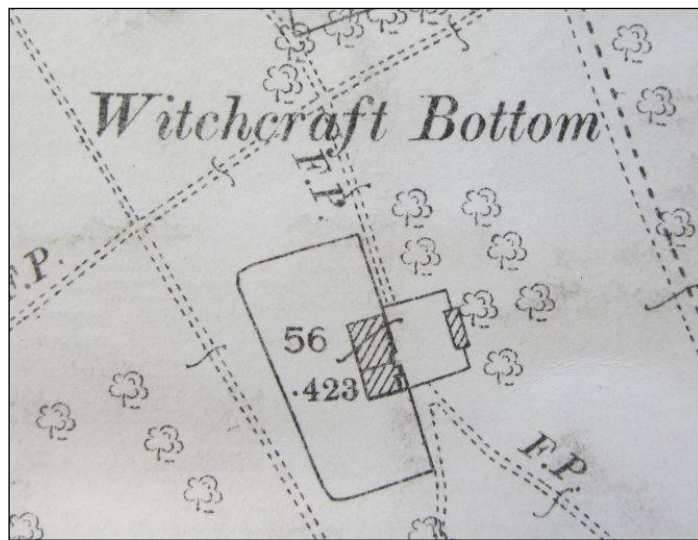
Figure 6: Extract from OS Second Edition 25" sheet, 1901 (*not to scale*)

After chalk extraction ceased in the late 18th or early 19th century the site would have been used as a convenient hollow in which to jettison household waste. The later Ordnance Survey sheets for 1901 and 1925 (Figs 6 & 7) show a smaller building in the former quarry area, possibly an outhouse or wash house, facing the house across a rectangular enclosure. This was presumably demolished before the present garage building was constructed in the 1930s, though part was retained as a 'lean-to'.

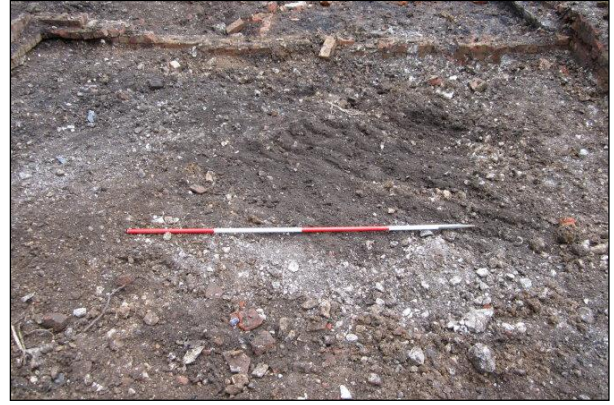
Plate 2: Soil deposits within garage

The reduced level revealed that the ground was composed of a series of loose deposits comprising a mixture of dark soil, brown clay, chalk, coal and tile fragments. Amongst this material were observed late 19th-century ceramics, bone, glass bottles and tile fragments. A worn penny of Edward VII dated 1908, was also found within the footprint of the old garage. The exact depth of these deposits was never established.

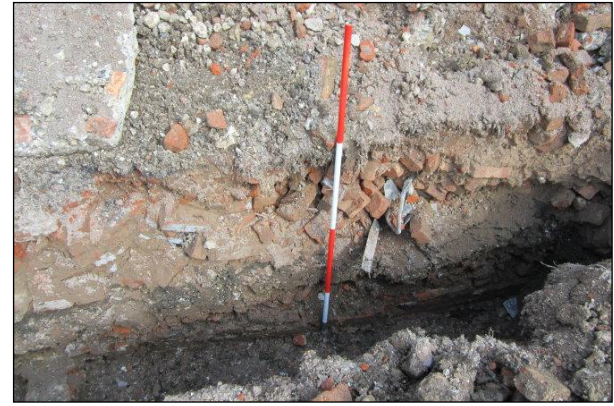
Plate 4: West facing section of trial trench across area of former 'sunken garden'

After the initial clearance of the site was completed, a machine-cut 'sondage' was made to the south of the former outhouse and about 12m to the north of the house (Fig. 8), to ascertain the nature of the deposits within what was referred to as the 'sunken garden'. The upper deposit [1] comprised loose rubble some 0.6m deep. This overlay [2], mixed dark grey soil and chalk about 0.22m thick, which in turn overlay [3] a mix of very sticky clay, brick, tile and slate to depth of 0.35m (Plate 4). Within this third deposit a stepped, brick-built channel was revealed at a depth of about 0.8m, orientated approximately north-south. It had an overall length of c.5.6m and its lower channel was 0.47m wide (Plate 5). A curious feature of this channel was the way the bricks stepped down (Plate 6). At its southern end only 4 courses of brick survived whereas at its northern end the brick courses rose to ground level (Plate 7). In the middle of the channel there was a short east-west brick wall 0.22m wide. This subdivided the channel into two equal 2.7m lengths. The prevailing type of brick used in the construction of this subterranean structure was reddish brown, slightly frogged and measured 220 x 110 x 65mm.

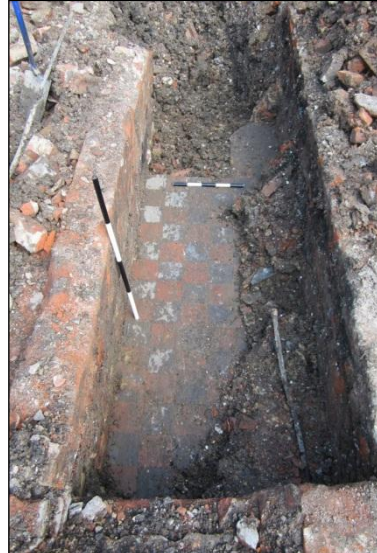
Plate 8: Sunken floor of lavatory looking east

4.5 Immediately north of the brick-built channel was a sunken floor within what was once the south-west corner of former outhouse. This part of the structure was just under 1m wide and about 3m in length. The floor was at a depth of 0.7m and comprised red and white(?) quarry tiles each 150mm square, laid in a chequerboard pattern (Plate 8). This extended across an area 2.25m in length, at which point the tiles terminated where a WC had been inserted at a later date. The area around the WC had been

finished off with cement. The waste pipe ran in a north westerly direction towards the present septic tank which lies in the garden beyond the modern pergola.

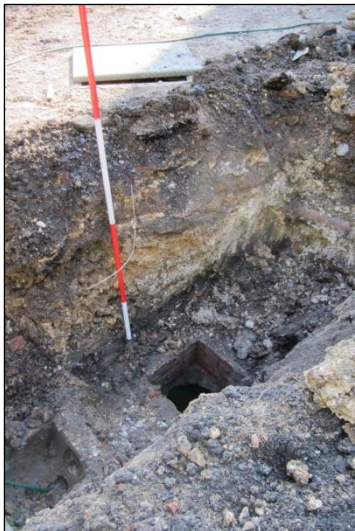
Plate 9: Section of overlying fills sealing the soakaway, looking south west

Less than 2m west of the now demolished outhouse / lean-to a brick built soakaway was located, at a depth of 1.45m below the present land surface (Fig. 8; Plate 9). A rectangular former had been placed over a narrow circular aperture which had a diameter of 0.35m. This led to a domed, circular brick lined chamber approximately 1m in diameter and 3.75m deep (measured from its entrance). The brickwork extended downwards until it met the solid rock chalk (Plate 10). The cut of the shaft for this feature was estimated to be about 1.5m in diameter. As far as could be ascertained a single ceramic pipe c.150mm dia. fed into this chamber. There was little debris present at its base and it appeared to be relatively dry.
