Archaeological observations at 63 Castle Street, Reading

An engineering test trench was observed on May 4th 2005 on the above site (see sketch plan below).

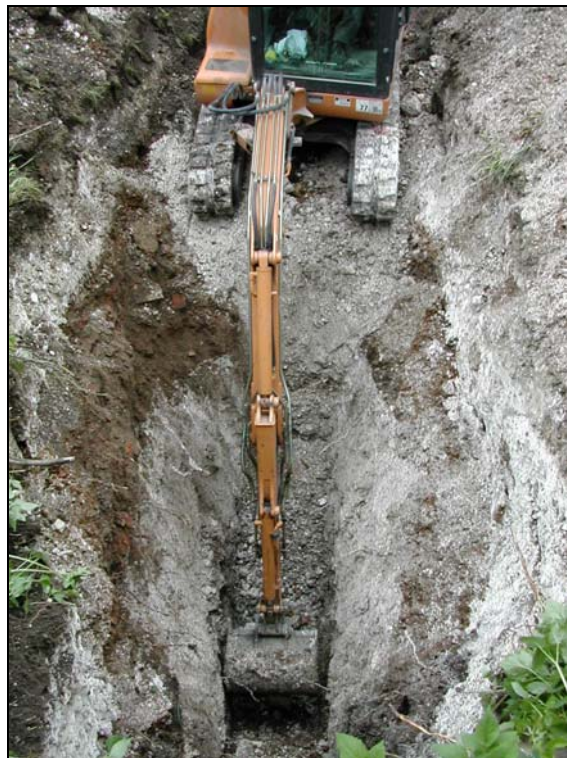
A test trench was observed which was *c.* 6m long and orientated N-S. It measured initially 1.5m wide. Due to the instability of the ground and successive collapses this was increased to 3m wide. The trench went to a depth of 4m before the main storm water pipe was encountered running NW-SE. The ground immediately below the wooden fence is topsoil, the brown soil and then chalk about 2m down. Further to the south the ground is entirely artificial, as follows:

1. Top soil 0.2m thick
2. Layers of tipped chalk 0.35m thick
3. Brown, rubble soil *c.* 1.35m thick
4. Loose back-filled chalk and occasional lines of tipped soil.

At about 2m down there was another pipe and no sign of natural ground.

Plate 1: View looking south along the axis of the trench
