**Boars Tye Barn, Silver End, Rivenhall, Essex.**

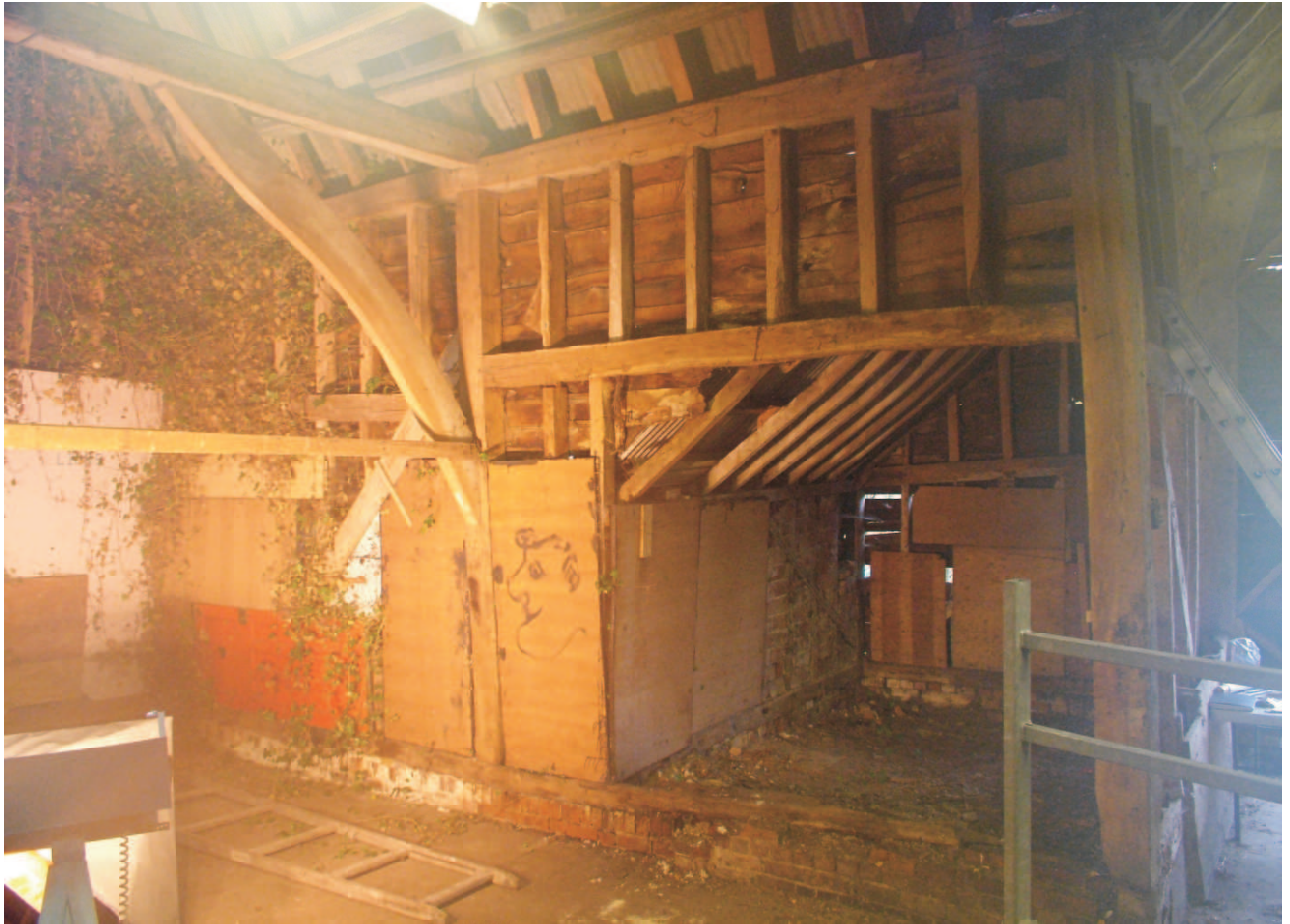
View towards the south east into the lean-to. Note heavy main framing timber to barn and large serpentine brace. Visible brick plinth of barn with top course of brick on edge as is remaining wall infill to lean-to.

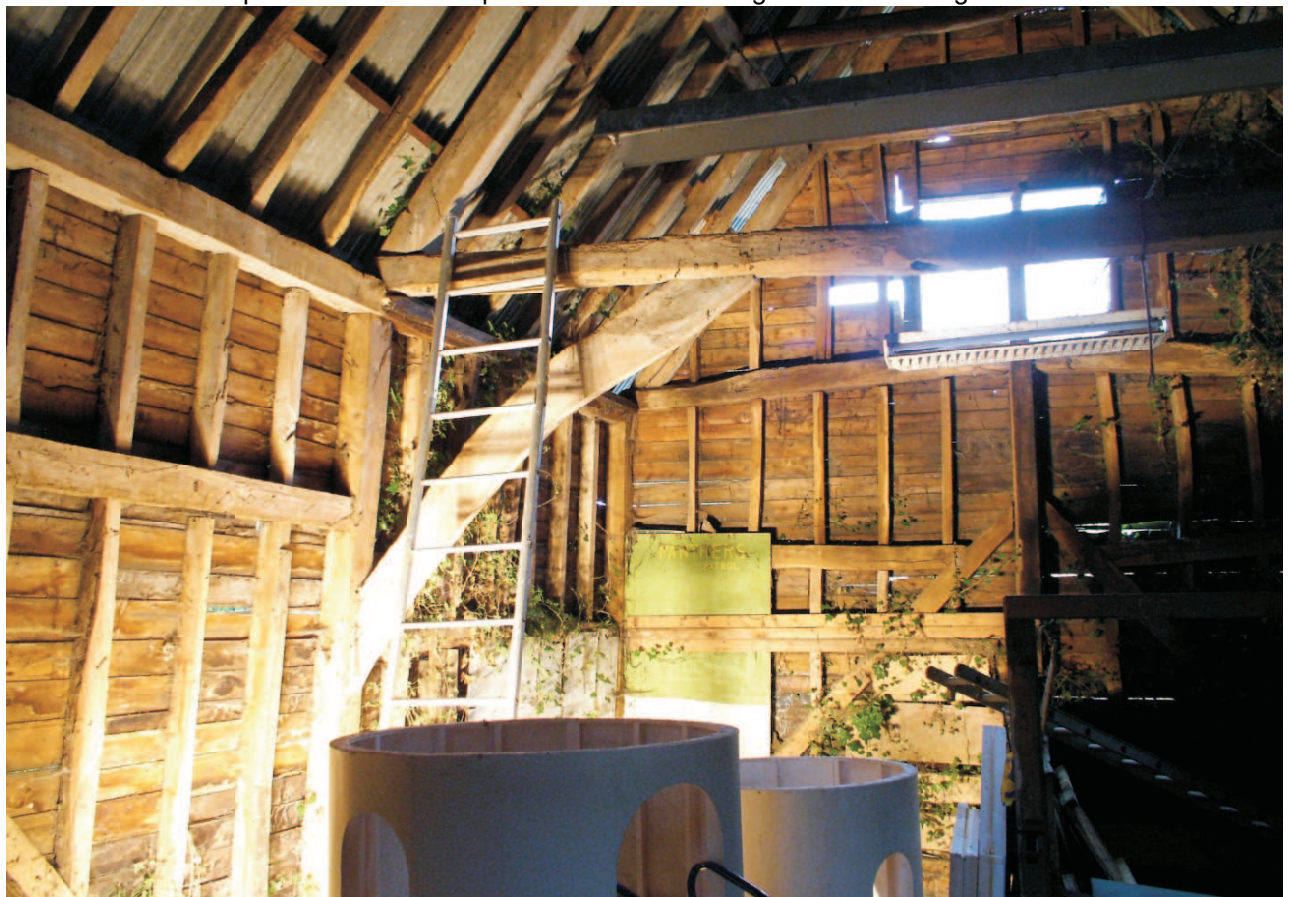
View towards the north east clearly showing the unusual framing to the barn. High heavy section primary wall braces with a midrail into them two-thirds of way from sill to wallplate. Stud lengths vary as to position in barn, being unusually short above midrails in bays with primary braces..
