Boars Tye Barn, Silver End, Rivenhall, Essex.

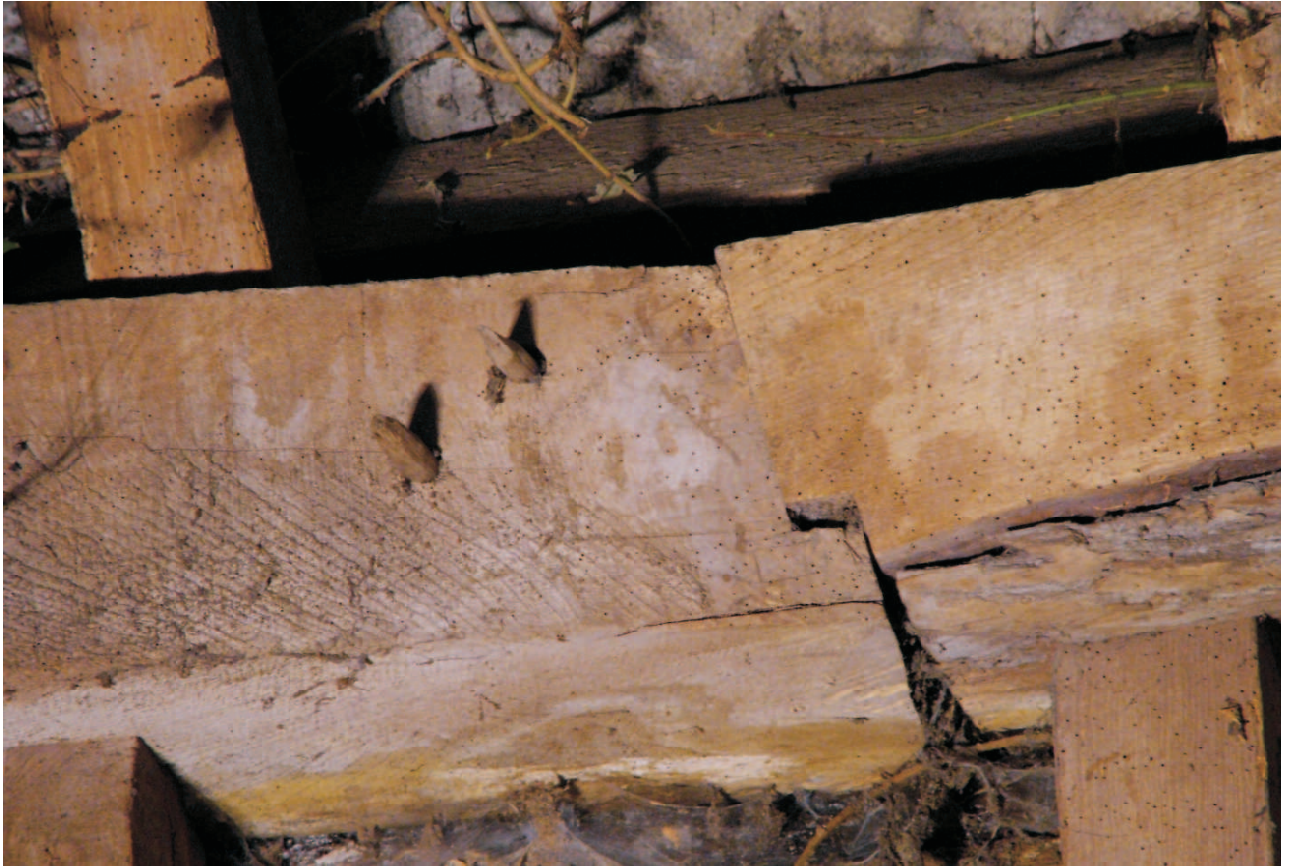
The one visible original scarf joint on the rear wallplate. Housed bridled undersquinted abutments with lower lip and two edge pegs. This is a type very commonly found in groundsill plates from the medieval period onwards but rarely as a wallplate scarf.

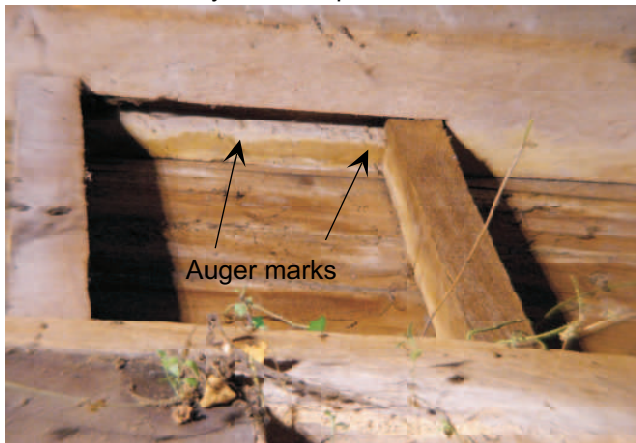
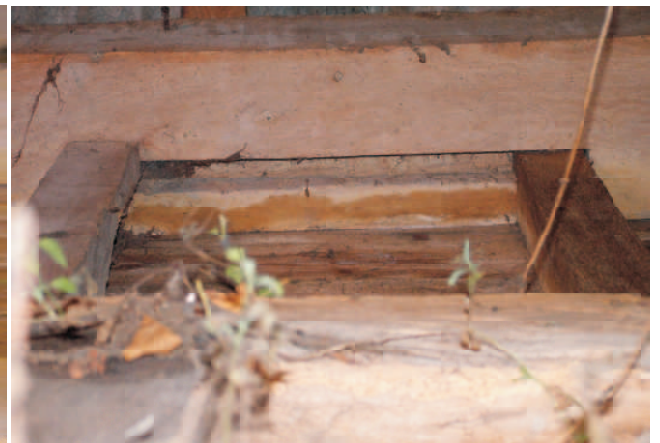
Wall studs fitted above the midrails were fitted in pairs. One end was mortised into the rail - in this example the midrail and the area between the two studs was cut out as a long mortise. This enabled the studs to be placed into the frame after the main frame was assembled. Note the auger marks to sides of mortise.

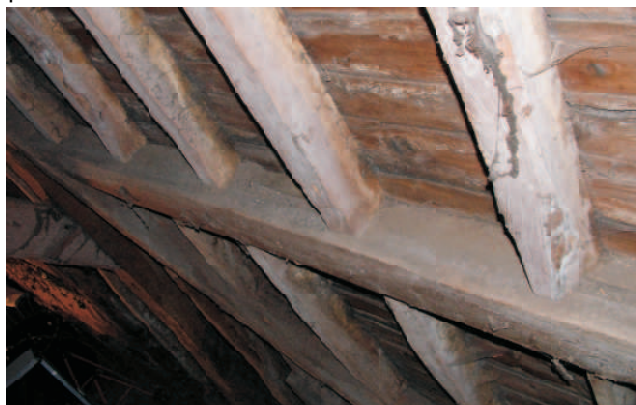
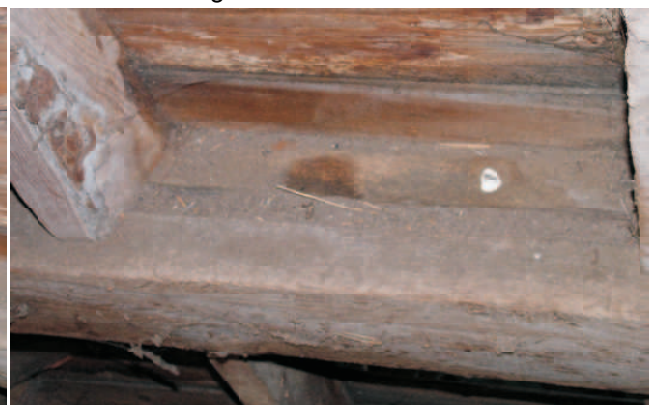
Most examples in the barn have the long mortise as the lower element. They have filled over the years and are not easily visible within the structure unless viewed from a high level.
