Boars Tye Barn, Silver End, Rivenhall, Essex.

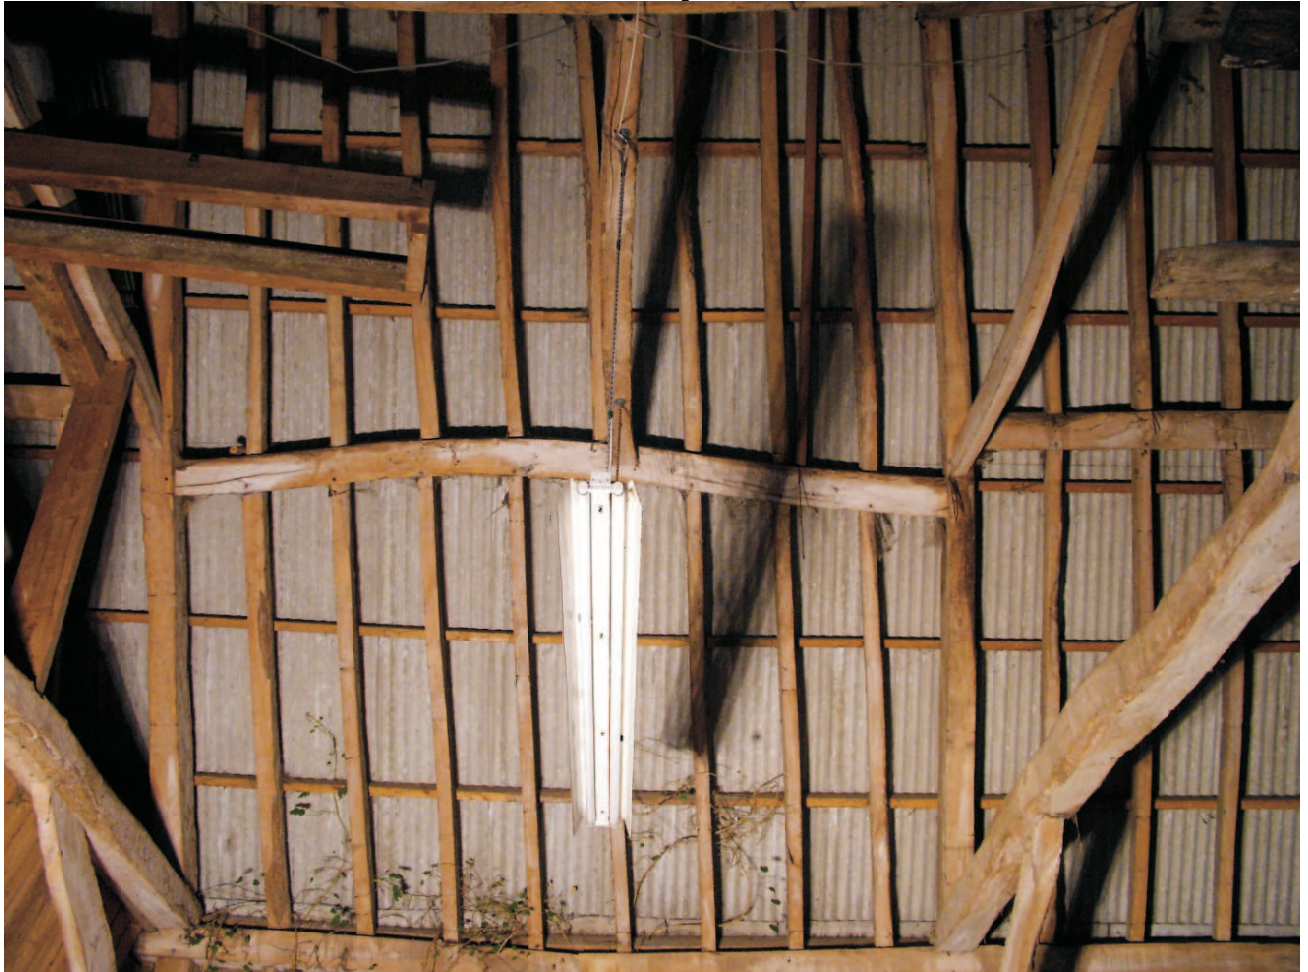
Roof of the main barn. Joggled side purlin providing strong single joints into the principle rafters above and below collar mortise. The lower run of intermediate rafters are mortised and pegged at the upper end into the purlins. The upper run of rafters not pegged. Intermediate birds mouth collar in most bays.

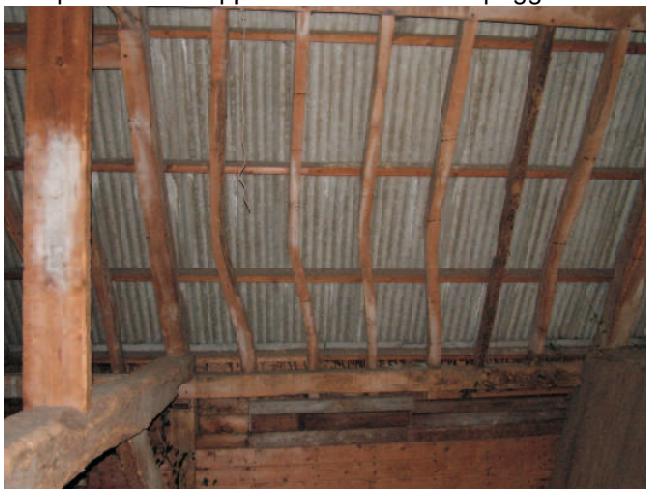
Run of intermediate lower rafters in the fourth bay from the east. Note the four from the left made from one tree sawn through to produce four good rafters. As long as the saw cuts or conversion follows the natural grown shape of the tree all pieces will have maximum strength for section size. Other examples of this method of conversion occur within the barn structure.

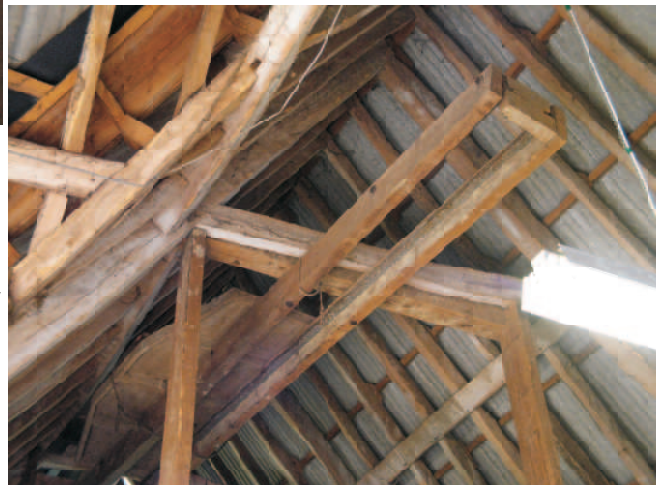
Supported over bays four and five from the east is a tracked runway system supported by sub-framing up from the tiebeams. It relates to an access hatch cut into the west gable of the barn and projects sufficiently into bay three from the east to allow loads to be lifted from the midstretey area. No trolley or lifting apparatus survive. This is thought to be from the time when the barn was used by the Crittall Company for storage.
