Midstrey at south end, inside view from A towards F. Bay 1 1-2

Midstrey at north, inside view from A towards F. Bay 5 5-6

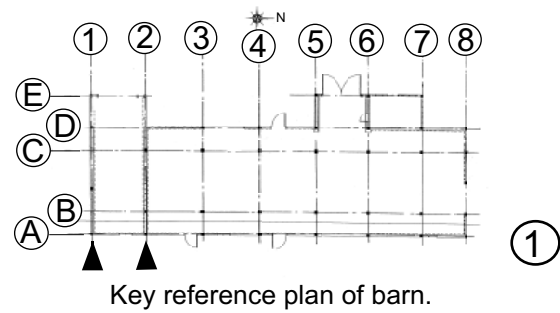
Present hip is possibly a change from a gabled end

Collars have double cuts suggesting a change to the roof or reuse of the collar rafter truss.

Dragon ties are nailed on across tiebeam to wallplate on each side.

Post 170 x 170

Post 170 x 165

Standard type drop in door bar security mortises

Unusual direct drop into slot version for the lower bar

Brick plinth

This area of roof is plastered internally as the large overhang of the roof, supported on brackets, precludes from fitting boarding on outside

Area shows remains of dove boxes set between tiebeam and lower tie. Area has modern board infill. Along the lower tie are a series of large peg holes for supporting the base boarding of the boxes. At each end a timber survives to control the position of the base. Three board support pegs survive.

Tiebeam average 200 x 170

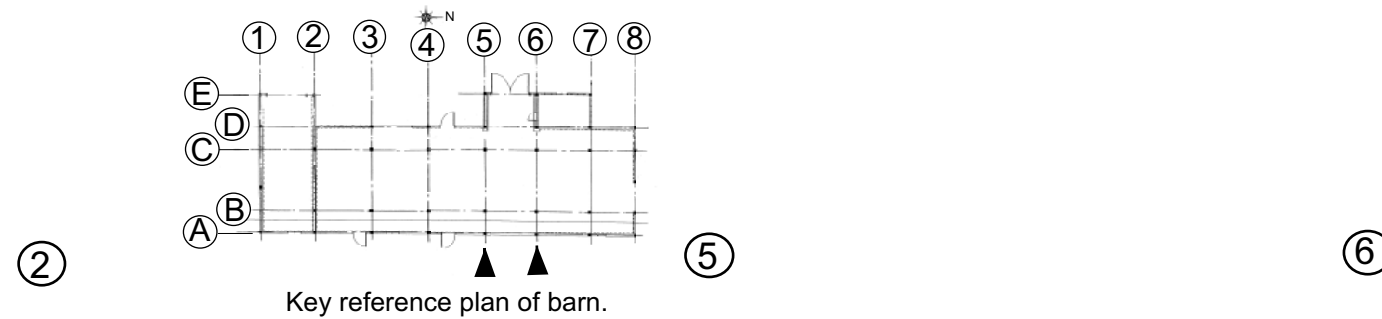
Post 170 x 160

Post 160 x 155

Brick plinth

Collar is bird's mouthed over purlins and hip rafters are partially housed over the purlins

Bottom of post swelled for leap boards but no board slot evidence as present doors cut further in removing any evidence
