Building C west building. The Cowhouse timber framed & weatherboarded with later lean-to and plain tile roof.

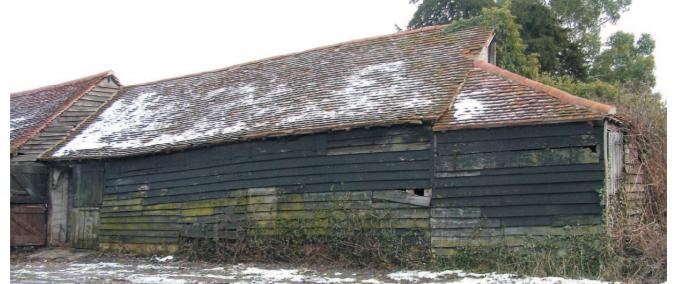
Front, north, wall of cowhouse, primary braces & knees. East wall timber framed much reused timber.

Rear, south, wall with buttresses is the north wall of the garden. Floor now mainly covered in concrete was all brick.

West end now has a small loose box with a feed trough set infront of door into the garden.

Added lean-to to the west end with stall divisions having linking gates for selection of animals or as calve pens. End wall of cowhouse opened up to allow access.
