Essex Historic Environment Record/Essex Archaeology And History

Summary Sheet

Newhouse Farm, Purton End, Debden, Essex.

Copy of list description for Granary.

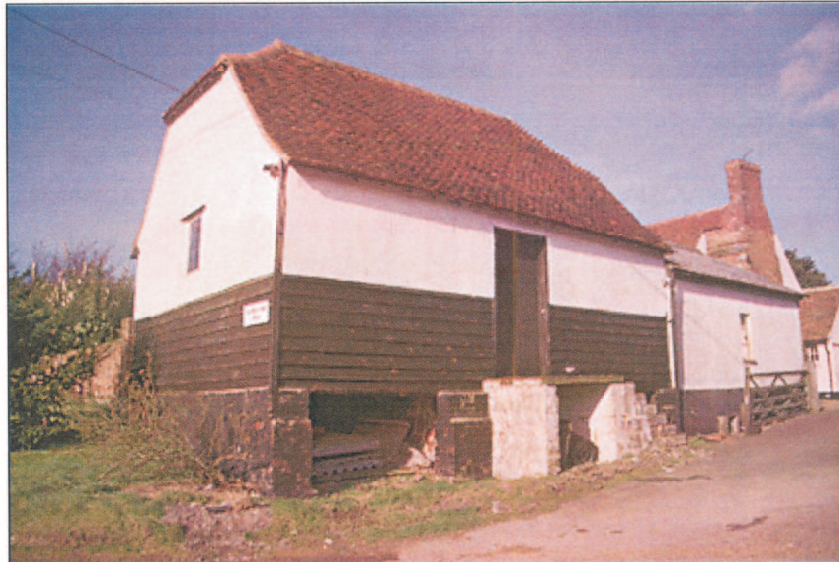
IoE Number: 121672
Location: TIMBER FRAMED GRANARY IMMEDIATELY SOUTH
WEST OF NEWHOUSE FARMHOUSE ON EAST SIDE OF ROAD, PURTON END
DEBDEN, UTTLESFORD, ESSEX
Photographer: Mrs Charmain Hawkins
Date Photographed: 09 March 2003
Date listed: 22 February 1980
Date of last amendment: 22 February 1980
Grade II

DEBDEN PURTON END 1. 5222 Timber-framed granary immediately south-west of Newhouse Farmhouse on east side of road TL 53 SE 18/1063B II GV 2. C18. Timber-framed granary with a weather-boarded base and plastered upper part. Roof tiled, half hipped.
