THE SILL PROJECT, ONCE BREWED, NORTHUMBERLAND

Conservation Management Plan

Document Type: Conservation Management Plan

Client Name: NORTHUMBERLAND NATIONAL PARK AUTHORITY

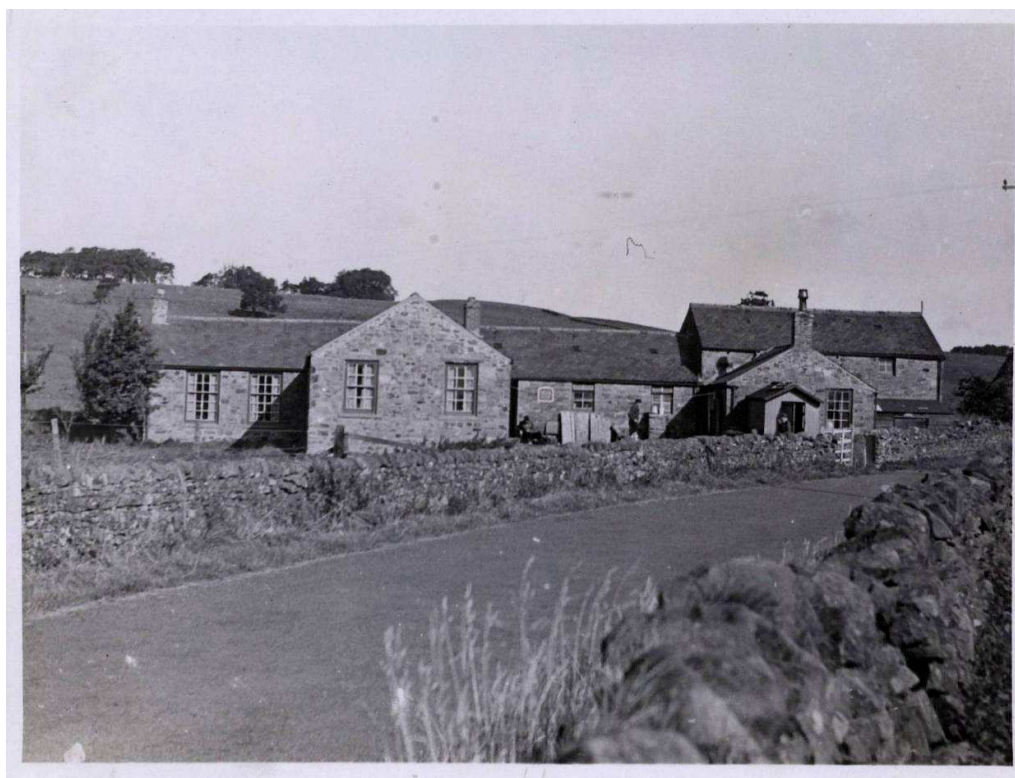
Plate 2: An early twentieth-century view of the Once Brewed Youth Hostel at East Bog Farm, looking north from the road to Henshaw (CRL Y050001: Heslop 953)

- 2.2.44 The early Demonstration Hostel at Once Brewed was established on part of East Bog Farm in 1934 and was a gift to the YHA from either Professor GM Trevelyan or his brother Sir Charles, supported financially by the Carnegie and Cadbury Trusts (CRL Y900003). The plans for the youth hostel building were prepared by the YHA architect F Austin Childs and Lady Trevelyan, and the building was completed and opened in 1934 (*ibid*). Indeed, it has been repeated anecdotally that Lady Trevelyan was responsible for coining the name ‘Once Brewed’, inferring that tea was a more suitable drink at the youth hostel than the beverages at the pub (*ibid*). Part of the land was purchased and passed to the YHA in 1934 and part was purchased in 1947 (*ibid*). The site was purportedly used as a land army hostel during World War II (G Atkins pers comm). The land at Once Brewed was donated to the YHA in the will of Sir Charles Trevelyan, who died in 1958 (CRL Y900003). The hostel has been in constant use since its opening, apart from temporary closure at the outbreak of the Second World War, and subsequent opening for weekends from November 1939 to March 1940 (*ibid*).

building appears to match those shown on Plate 2. Comparison of the YHA sign shown on the historical photograph (Plate 6) and the triangular YHA sign hanging at the current youth hostel (Plate 7) shows that they are not the same sign.

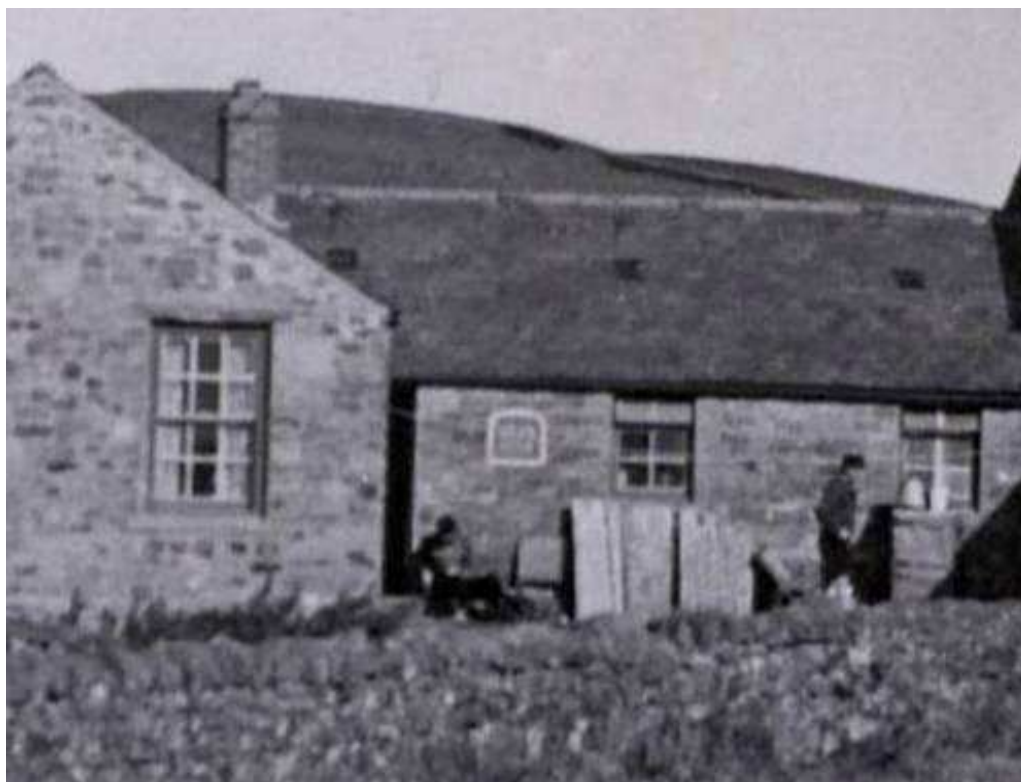
Plate 3: A detail from Plate 2, which appears to show an inscribed stone

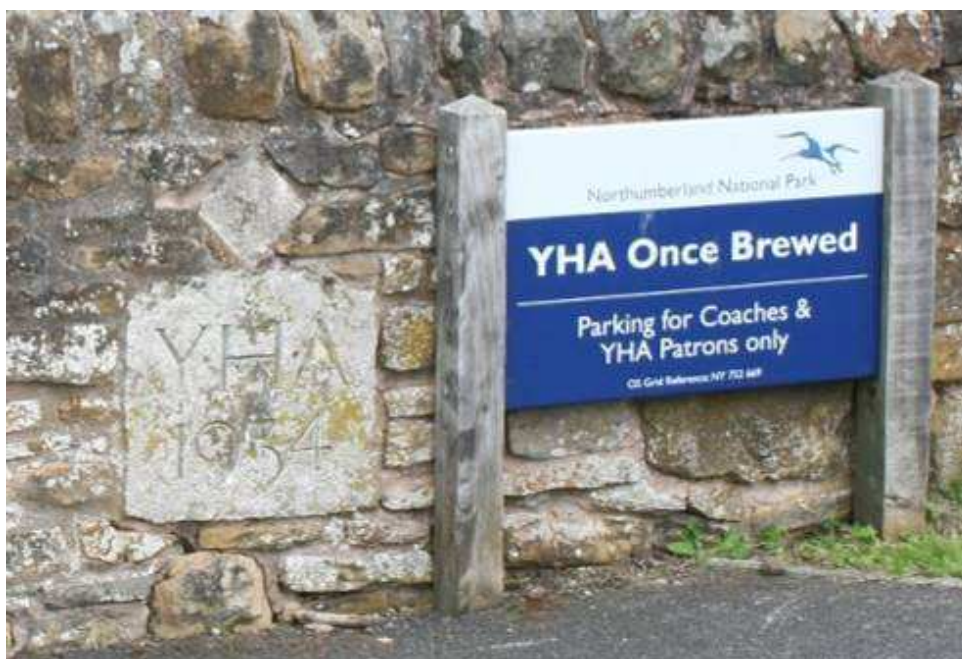
Plate 4: The date stone from the 1934 youth hostel set within a car park wall at Once Brewed

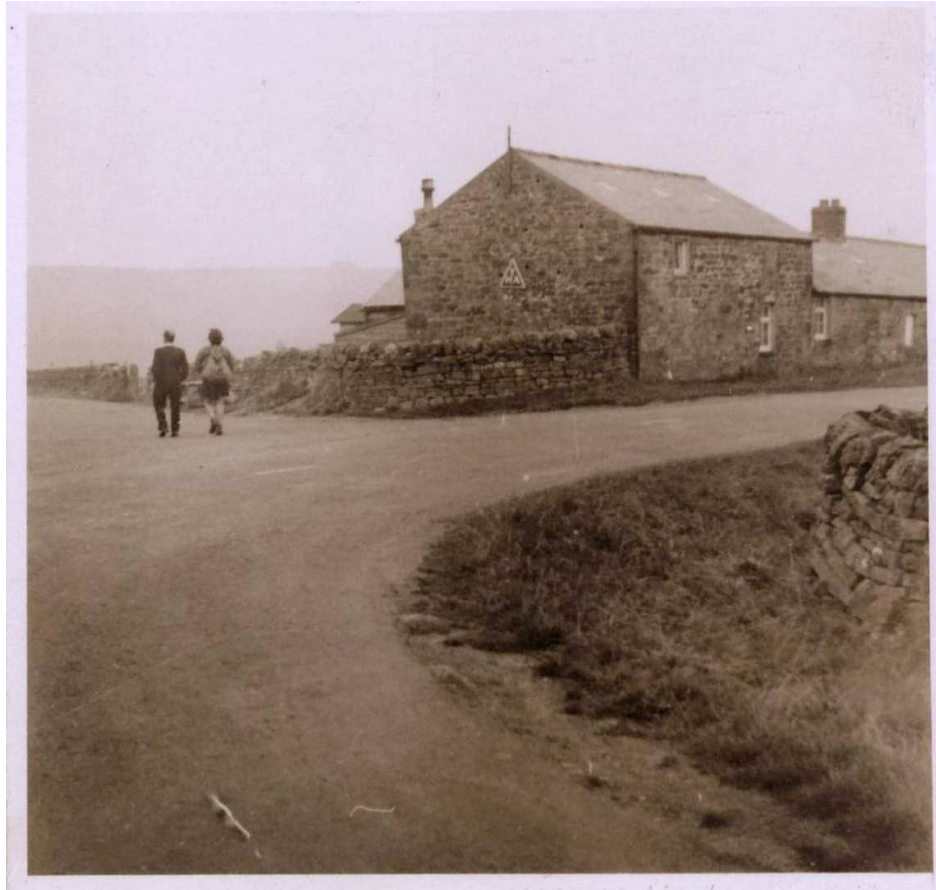
Plate 5: A view of the eastern end of the Once Brewed Youth Hostel at East Bog Farm. The B6318 runs across the image from left to right and the walkers are descending towards Henshaw

- 2.2.46 A second undated photograph (Plate 5) shows a view of walkers passing the eastern end of the Once Brewed Youth Hostel. The additional buildings at the western end are not visible from this vantage point but the iconic triangular logo of the YHA appears as a sign on the exposed gable-end. The precise date is not known, but the protruding element of the south-eastern side of the

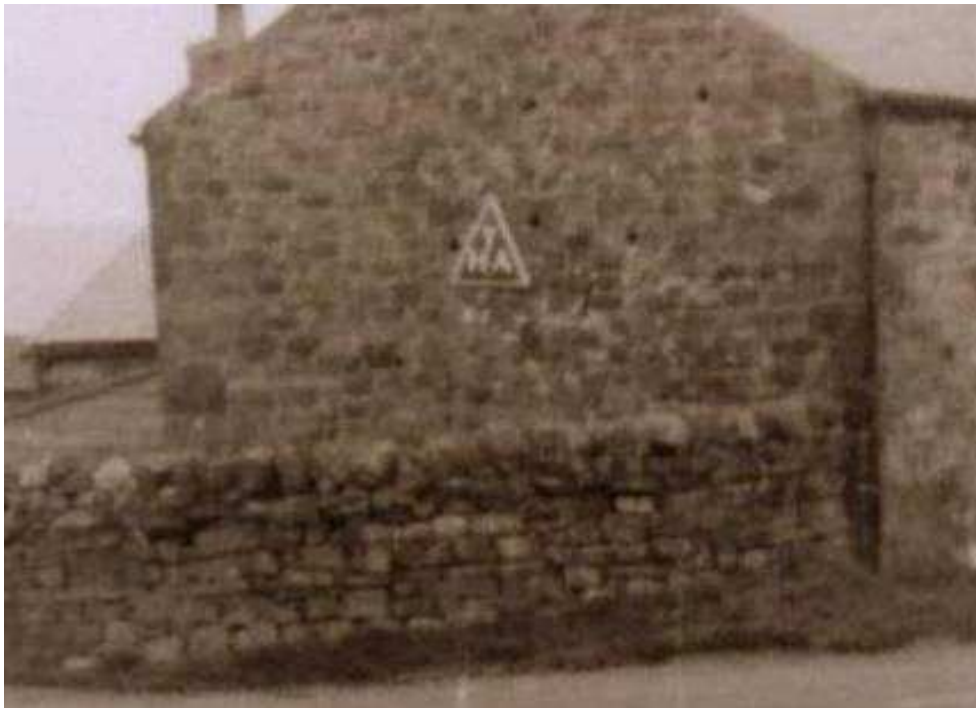
Plate 6: Detail of the triangular YHA sign on the western elevation of the Once Brewed youth hostel at East Bog Farm

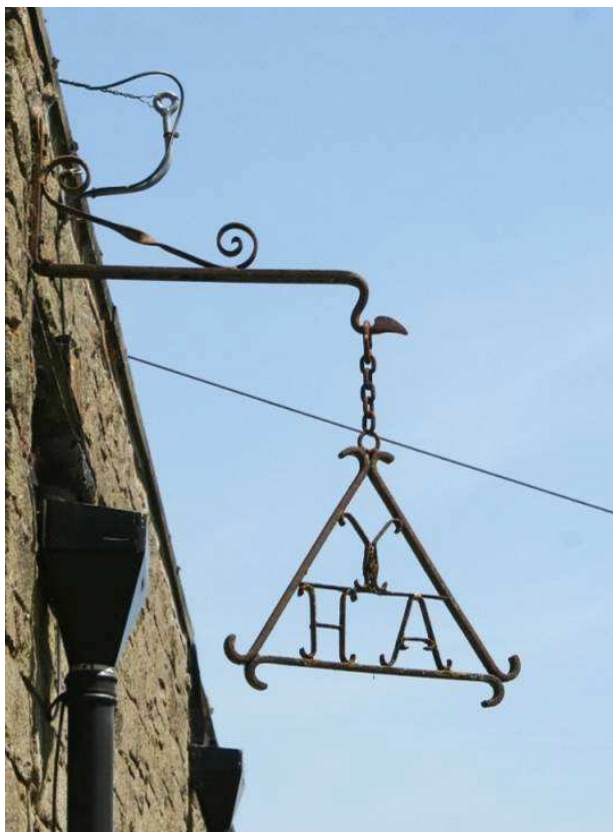
Plate 7: Comparison with Plate 6 shows that a triangular YHA sign hanging at the current youth hostel is not the same sign that was pictured in the earlier image

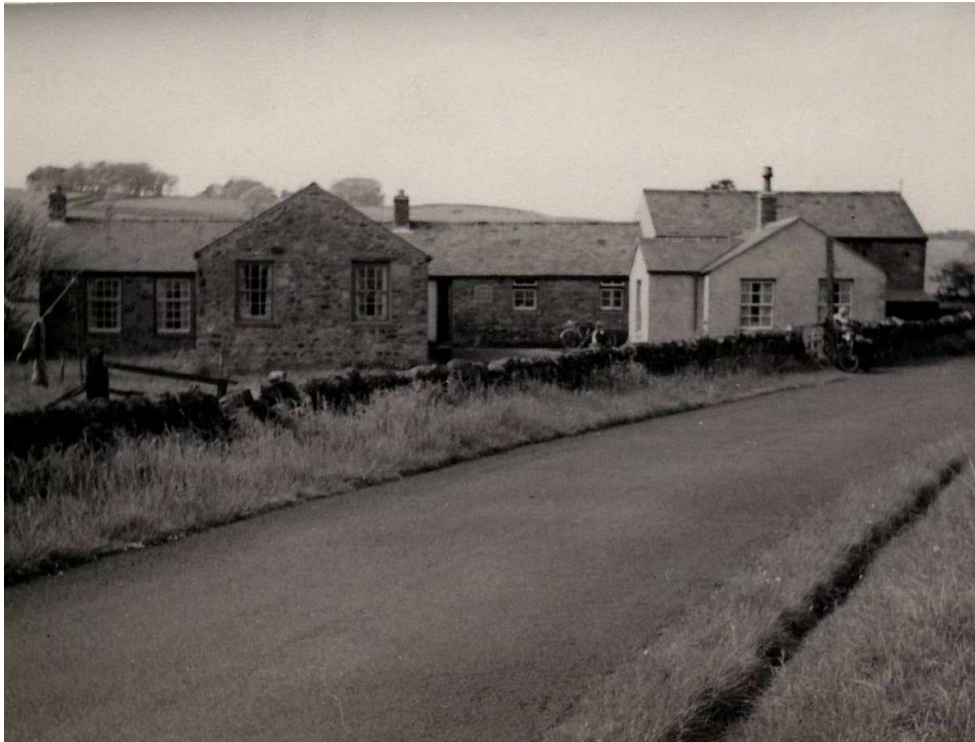
Plate 9: A view of the youth hostel looking north, following the addition of a rendered extension at the eastern end of the building between 1934 and 1968

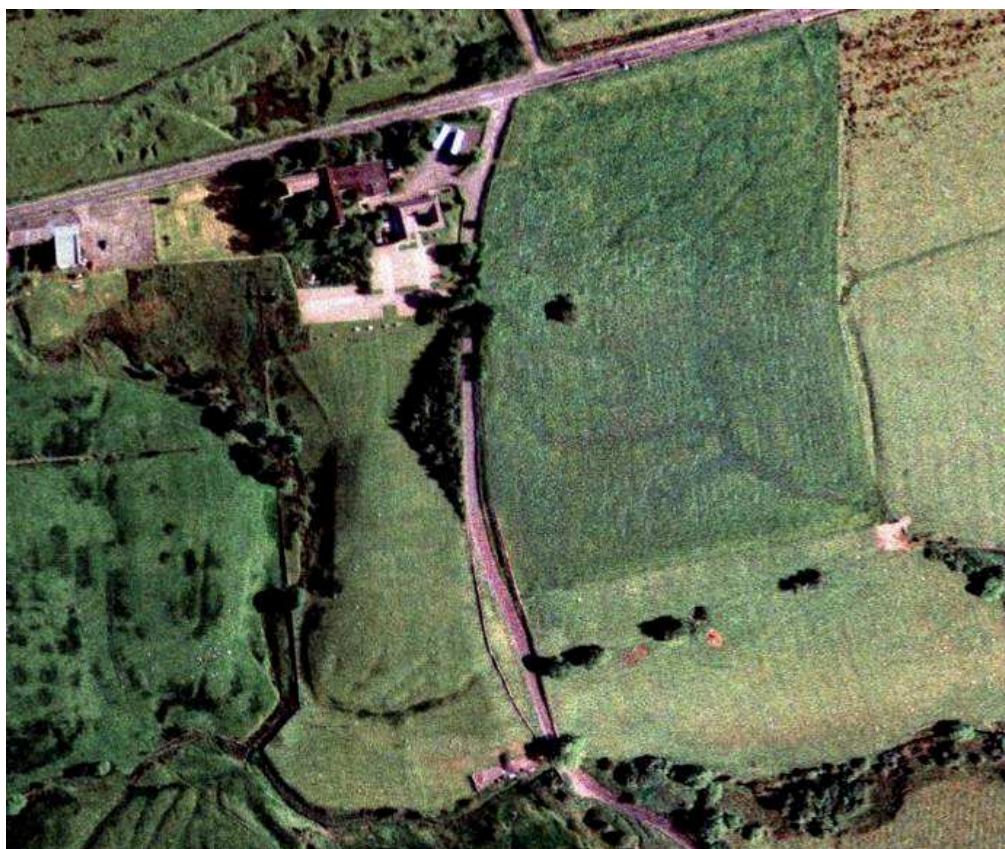
Plate 14: A current aerial view of the CMP area showing patterns of palaeochannels

2.3.4 The field lying to the east of the road to Henshaw is occupied by several palaeochannels, which are visible as dark curvilinear patterns on aerial photographs (Plate 14). Some of these are also conspicuous at ground level as linear hollows and waterlogged areas draining towards the south-eastern corner of the field, particularly those flowing from the north-west to the south-east through the field and from north to south along the eastern boundary. The CMP area also contains current and former stream channels forming tributaries of Brackies Burn. A current channel flows southwards along the western side of the CMP boundary and diverts sharply west before continuing southwards into Brackies Burn (Plate 15). However, a former channel flowed directly southwards rather than diverting to the west, and then curved eastwards around an area of raised ground to run parallel with Brackies Burn (Plate 14). The palaeochannels within the CMP area have the potential to contain preserved waterlogged plant remains, including pollen, which could provide information relating to past environmental conditions at the site, the development of, and changes in, the local ecology, and indicators of former human activity and land uses in the local area.

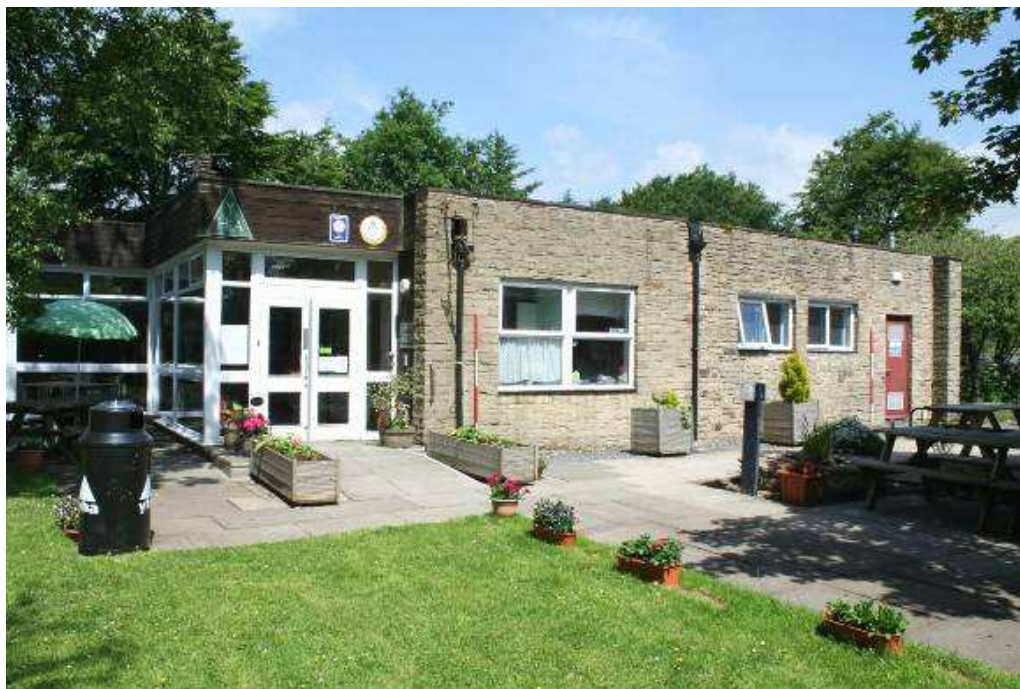
Plate 16: Once Brewed Youth Hostel entrance viewed from the south

2.3.6 *The Once Brewed Youth Hostel:* the extant Once Brewed Youth Hostel was constructed in 1968 to replace an earlier structure to the north-east that had been built in 1934 and demolished in 1968 (Site 41). A relict date stone inscribed 'Y.H.A 1934' is situated at the entrance to the youth hostel car park and is the last vestige of the earlier Youth Hostel building visible above ground level. This may have been set within the southern wall of the building (Plates 3 and 4). The original core of the building is L-shaped and is built from squared quarried yellow sandstone. It consists of a north/south-orientated two-

storey dormitory building with a flat-roofed single-storey communal and administrative eastern wing (including school rooms, offices and kitchens). A single-storey glass-fronted entranceway corridor/vestibule on the southern side of the eastern wing (Plate 16) is likely to have been constructed later, and a much later two-storey dormitory wing extension, associated with a structure that is likely to have been a manager's residence, lies at the western end.

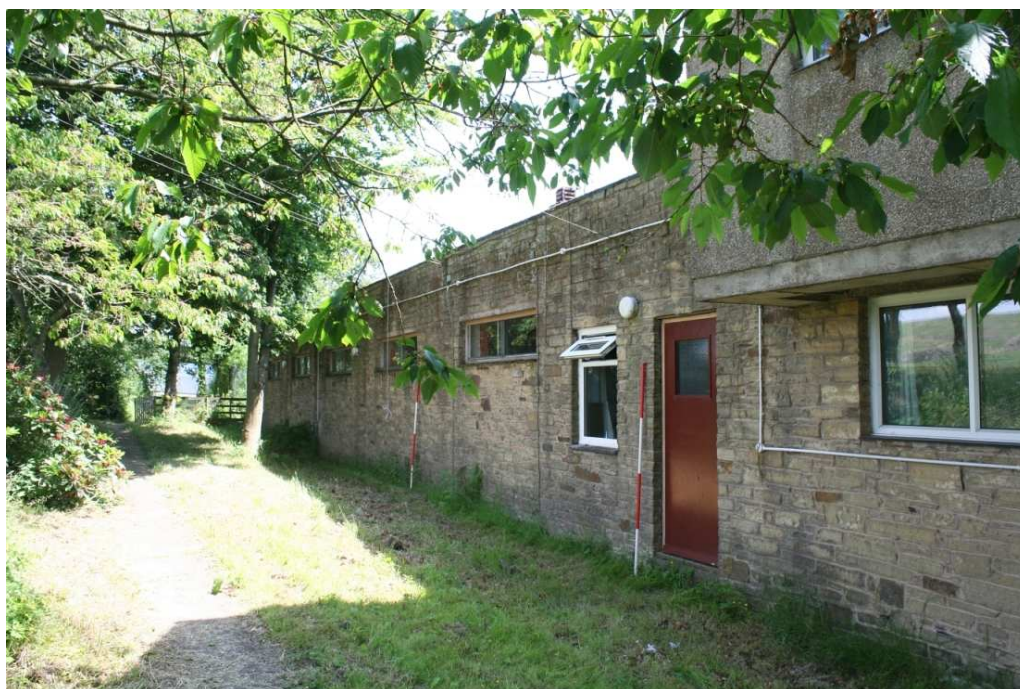
Plate 17: North-facing elevation of the communal part of the 1968 YHA building

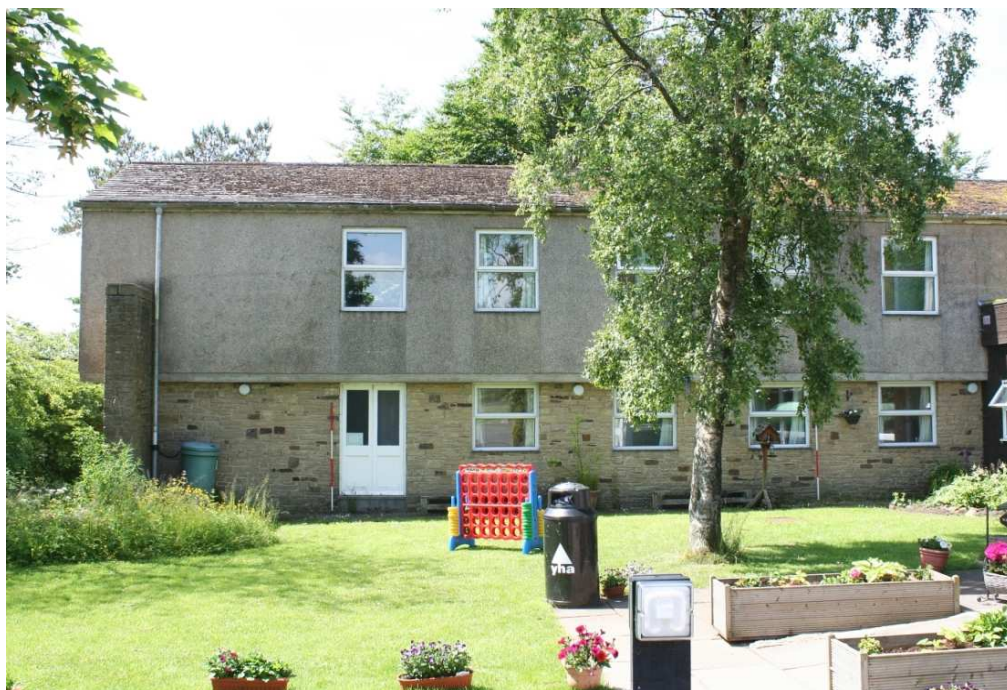
Plate 18: East-facing elevation of the original dormitory wing of the 1960s YHA building

- 2.3.8 A rectangular two-storey dormitory range is orientated north/south and is situated at the western end of the 1968 YHA building (Plate 18). The ground floor is constructed of yellow sandstone and has a second floor of rectangular pebble-dashed segmental concrete slab construction that is set on a concrete slab floor that overhangs the ground floor significantly at both gable ends (Plate 19). The range has a pitched slate roof and modern uPVC windows with concrete sills and lintels. The north-western end of this range is attached to the newer dormitory extension by a recessed two-storey wood-clad corridor (Plate 19). An east/west-orientated two-storey dormitory wing has been constructed adjoining the north-eastern corner of the 1968 YHA building. It has been built in the same style as the main dormitory range, although the sandstone blocks are of a greyer colour on the ground floor and the first floor is rendered in grey pebble dash rather than being constructed of concrete slabs. The western end of the dormitory extension is likely to have consisted of the manager's accommodation, as it lay behind a fence with privacy signs and backs onto a private garden (Plate 20).

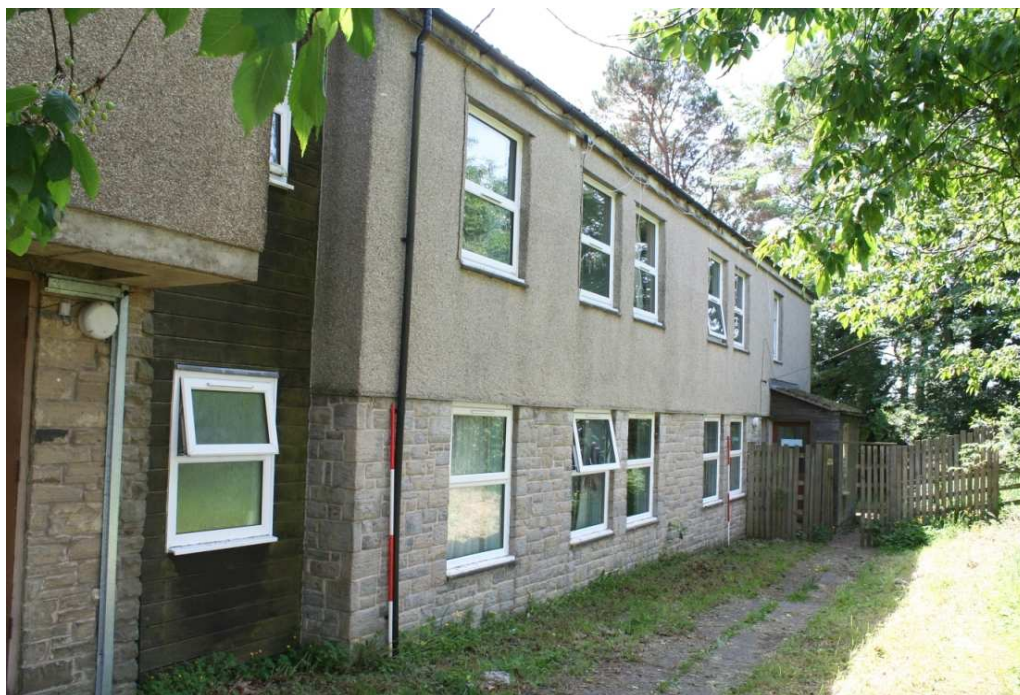
Plate 19: North-facing elevation of western dormitory wing extension and the wood-clad corridor adjoining it to the 1960s YHA building

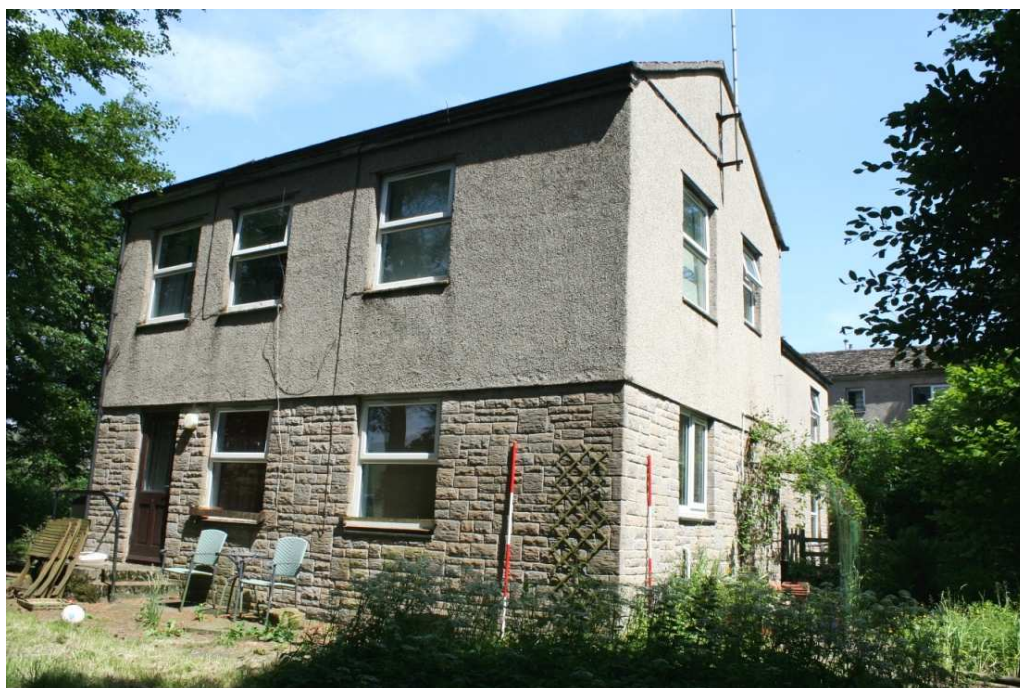
Plate 20: Manager's living accommodation, on the end of the western dormitory wing extension

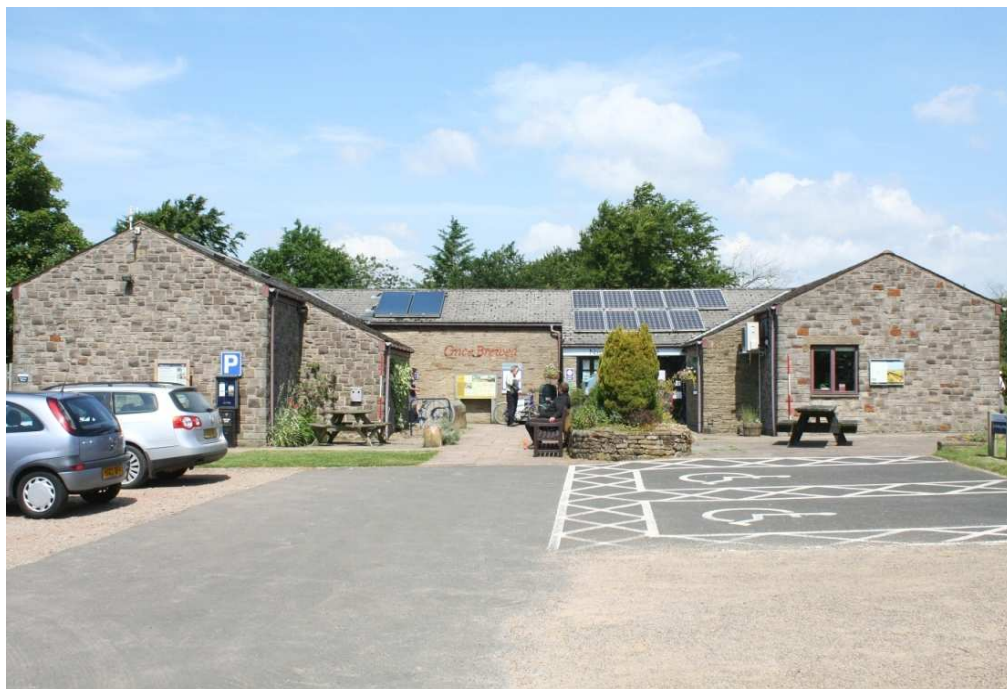
Plate 21: NNPA Visitor Centre viewed from the south

2.3.9 *The Northumberland National Park Visitor Centre*: the visitor centre (Plates 21 and 22) is a rectangular single-storey sandstone structure with a pitched slate roof, a wooden-clad garage/store on the western end and two small southern wings flanking the main entrance and facing onto a modern car park. The original rectangular section of the building was depicted on the 1977-8 OS mapping, with the wing extensions having been added at a later date. There is a commemorative stone located to the east of the entrance (33).

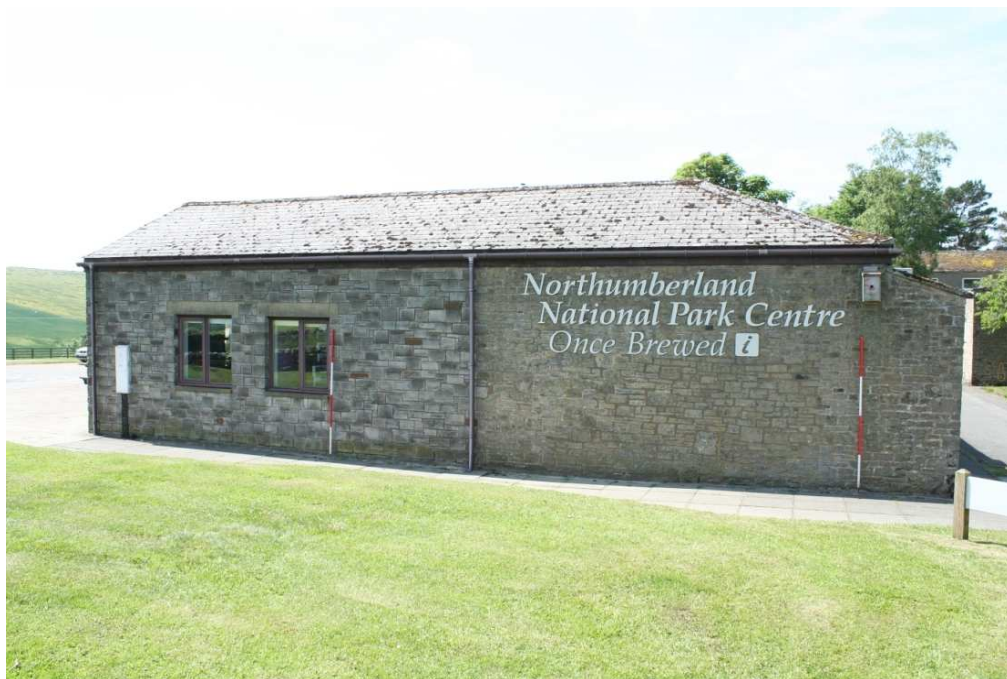
Plate 22: The east-facing elevation of the NNPA Visitor Centre, showing the wall scar where the east wing extension has been constructed (left of photo)

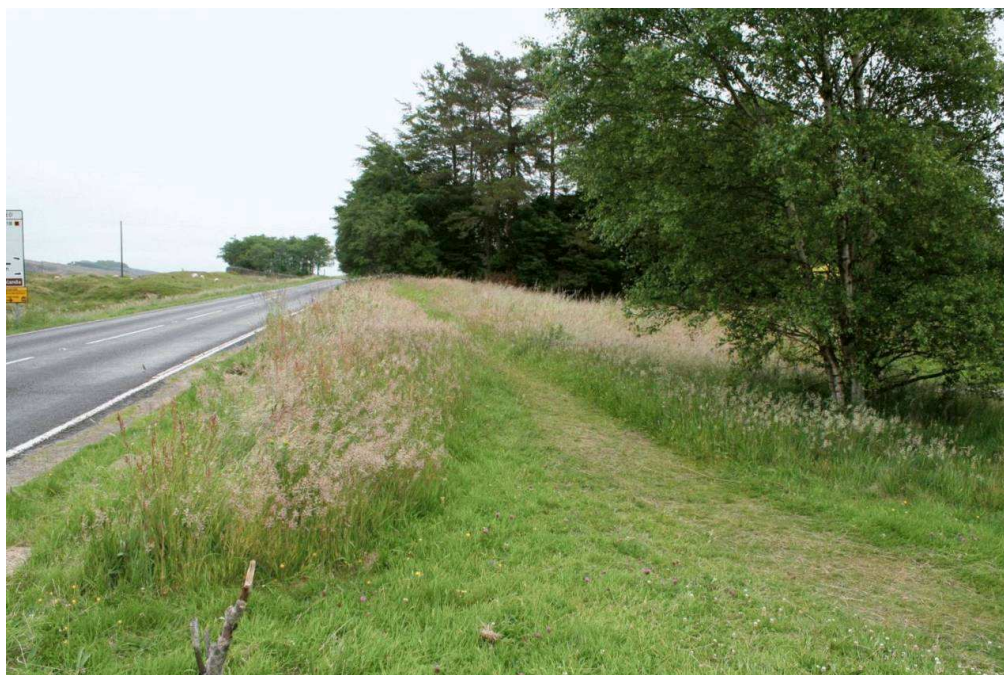
Plate 23: The Vallum mound to the north and south of the B6318, which runs along the ditch, looking eastwards towards the north-western corner of the CMP area from the vicinity of the Twice Brewed. Damage to the Vallum from quarrying is visible to the north of the road

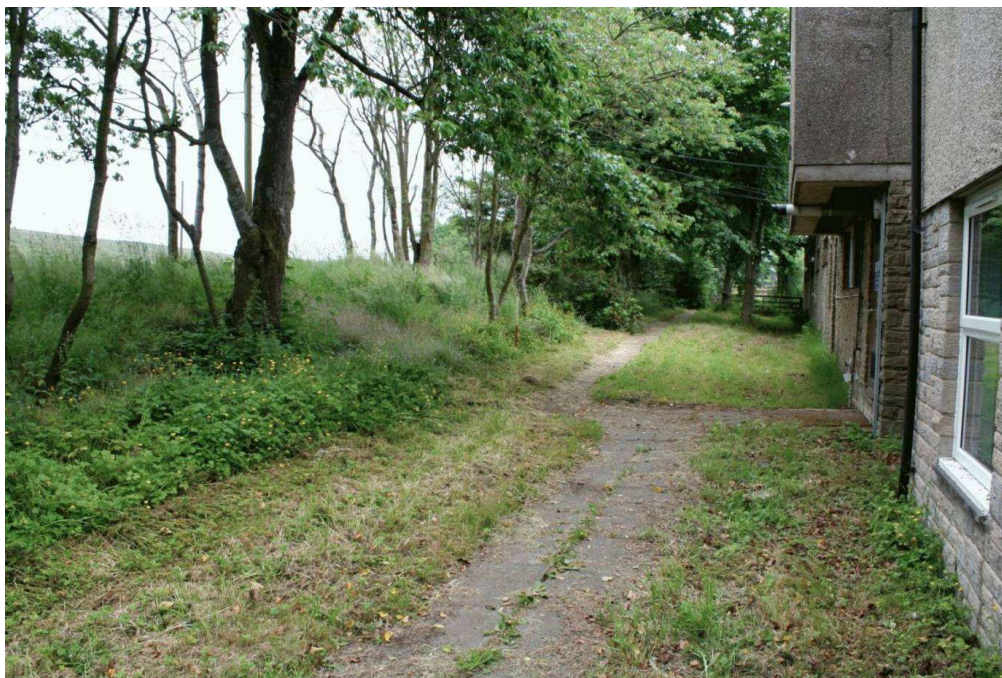
Plate 24: The Vallum mound (Site 26) within trees to the north of the youth hostel

- 2.3.13 Although the Wall in this area follows the line of the steep topography of the Winshield and Peel Crag, at a distance from the CMP area, the Vallum curves to the south to follow an area with a gentler gradient (*ibid*) and straddles the northern boundary of the CMP area. The Vallum comprises a ditch measuring up to 6m wide and up to 3m deep, with a flat bottom some 2.5m wide. It is flanked on either side by mounds that measure 6m wide at the base, which are set back from the ditch by ‘berms’ that are up to 9m wide, although in the vicinity of East Bog, to the west of the CMP area, the berm measures slightly less, at 6m in width (OA North 2005). The portion of the Vallum ditch at the north end of the site is largely overlain by the B6318 (Plate 23). The south mound of the Vallum within the CMP area measures up to 6m wide and 1.5m high.

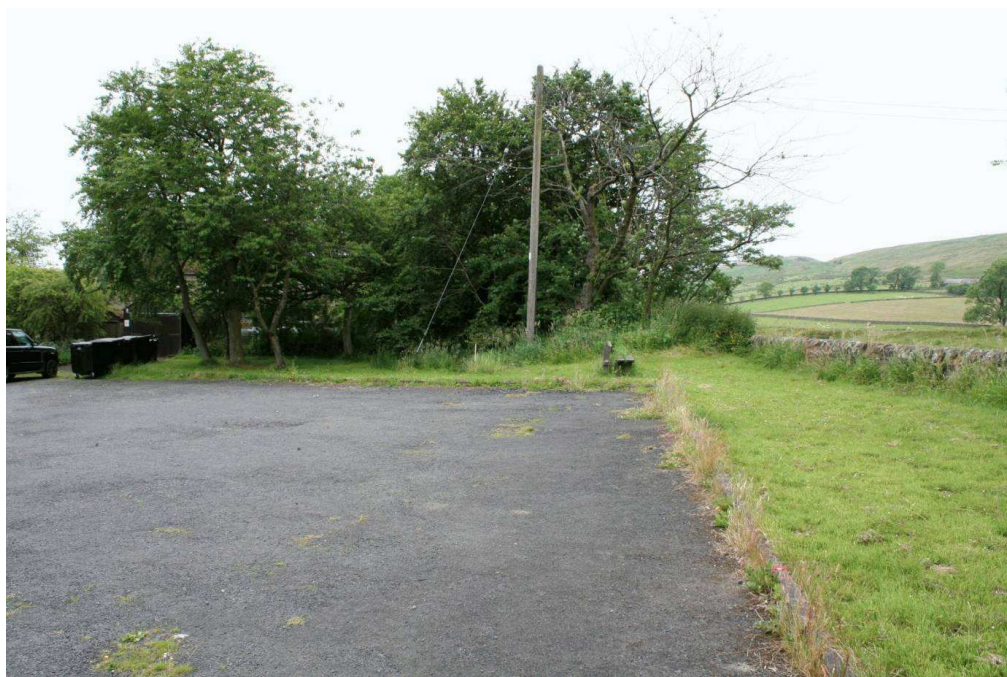
Plate 25: A truncated portion of the south mound of the Vallum (Site 26) in the vicinity of the car park where the earlier youth hostel (Site 41) was situated

2.3.14 Earthwork remains of the Vallum are visible on both the eastern and western sides of the crossroads (Sites **03**, **26**, and **29**), although the best preserved portion of the southern Vallum mound within this area lies to the west of the crossroads (Site **26**; Plates 23 and 24). There, parts of the Vallum to the north of the road have been damaged by quarrying (Site **47**; Plate 23) and part of the south mound (Site **26**) has been truncated near to the car park of the Twice Brewed Inn. The south mound is visible to the north of the Youth Hostel, where it lies within mature woodland (Plates 23 and 24). The mound tapers slightly and becomes narrower to the east of the buildings, before petering out as a visible earthwork to the north of the Youth Hostel car park (Plate 25). This part of the Vallum will have been cleared during the construction of the Youth Hostel building in 1934 (**41**).

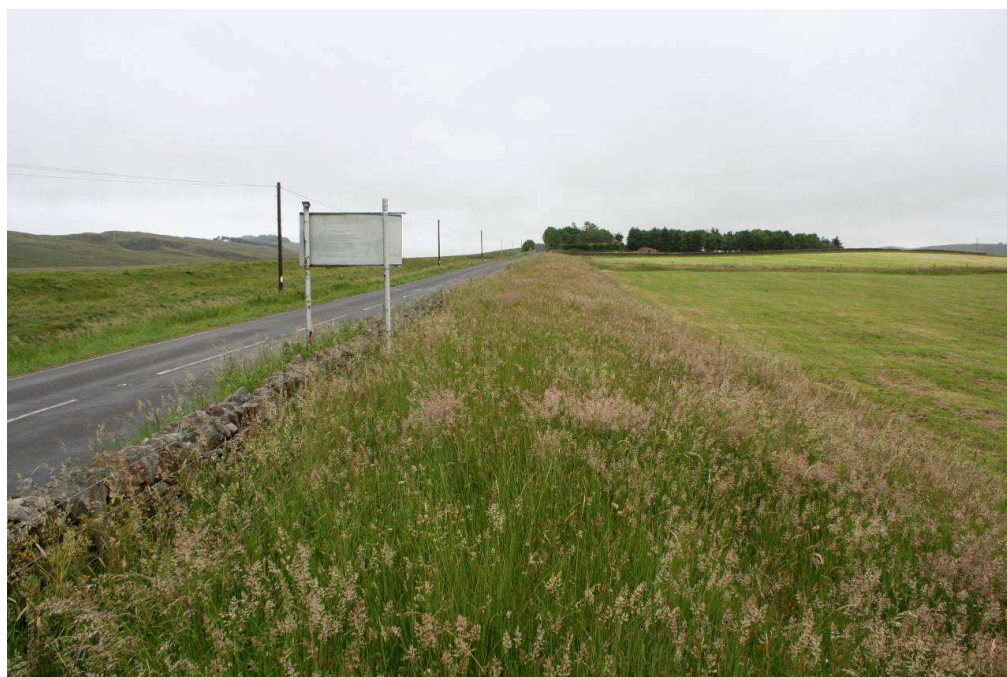
Plate 26: The conspicuous portion of the Vallum (Site 03) extending eastwards from the CMP area

2.3.15 To the east of the crossroads, the western end of the south mound (Site 03) has been truncated by quarrying (Site 02), and a gap where a trackway would have led to a farmstead crosses the Vallum near the eastern end (Site 35). However, this portion of the Vallum (Site 03) remains as a conspicuous monument (Plate 26). A well-preserved section of the Vallum ditch, berm, and north mound (Site 29) lies within scrubby woodland in the pinfold/enclosure (Site 27) at the north-western corner of the crossroads (Plate 27).

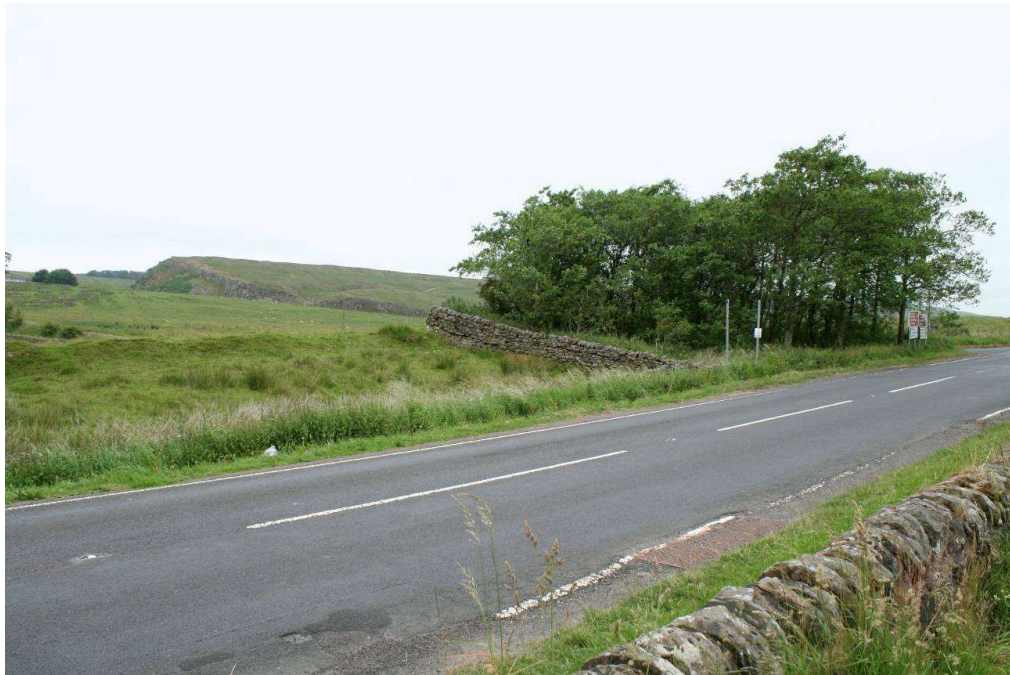
Plate 27: The portion of the Vallum to the north of the road (Site 29), overlain by the pinfold/enclosure (Site 27)
